## EXTERIOR WALLS

BUILDINGS IN USE STUDY

EXTERIOR WALLS

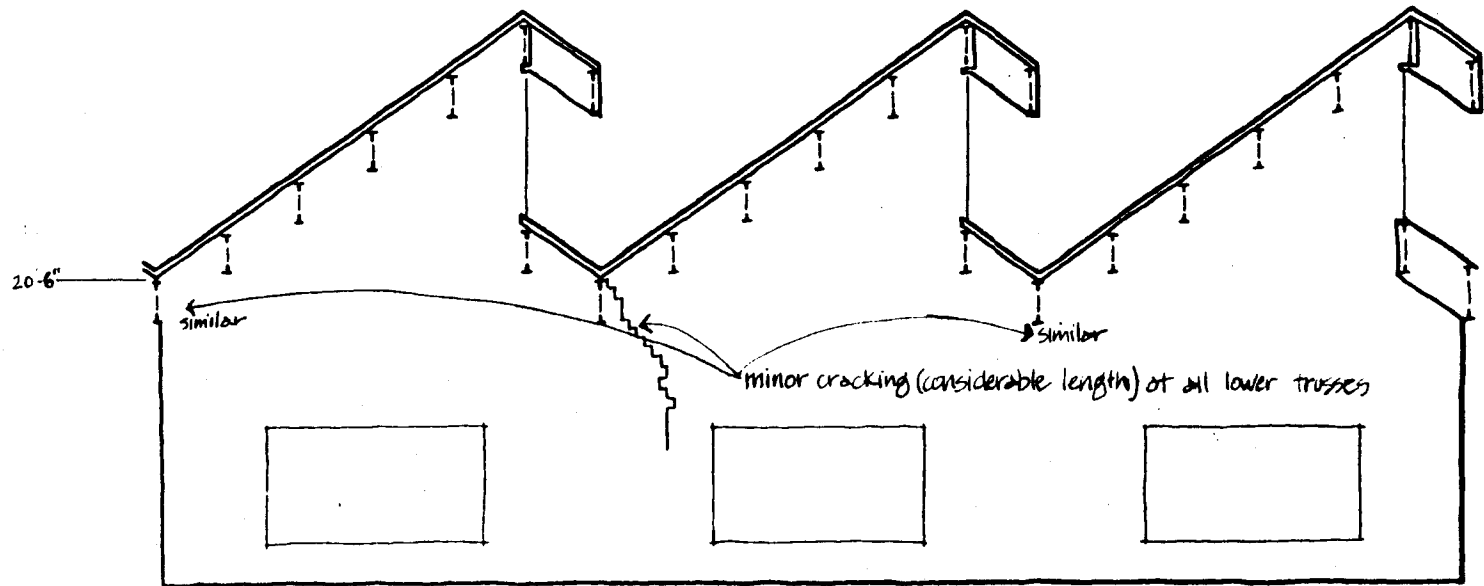
fig. A.5  
RICHARDS SCHOOL / SECTION - MULTIPURPOSE ROOM

Results: Performance was satisfactory at the Parkside and Mt. Healthy Schools. Performance at the Richards School was at the 75-85% level due to cracking evident under major roof truss supports in the multipurpose room.

Probable cause: Richards School. Probably due to actually higher loads than allowable under original design conditions or to expansion of restrained truss.

Discussion: There is a long vertical stepcrack emanating from each of the lowest spanning trusses of the multipurpose room. The cracking is long (over 10' is typical), visible but minor (1/16" or less). Due to the age of the building one can assume that this structural adaptation has been completed and that further consequences will not occur. There are no problems other than aesthetic directly related to this phenomenon, however, there are more serious indirect effects (see roofs). The probable cause of this phenomenon is an excessive loading on this lowest truss due to water trapped in the drainage valley directly above it. Other possible causes are: bearing seat improperly specified or installed; transfer of some loading from upper trusses to this one and; high stresses caused by thermal expansion and the restrained nature of these trusses (see Roof P. B-5).

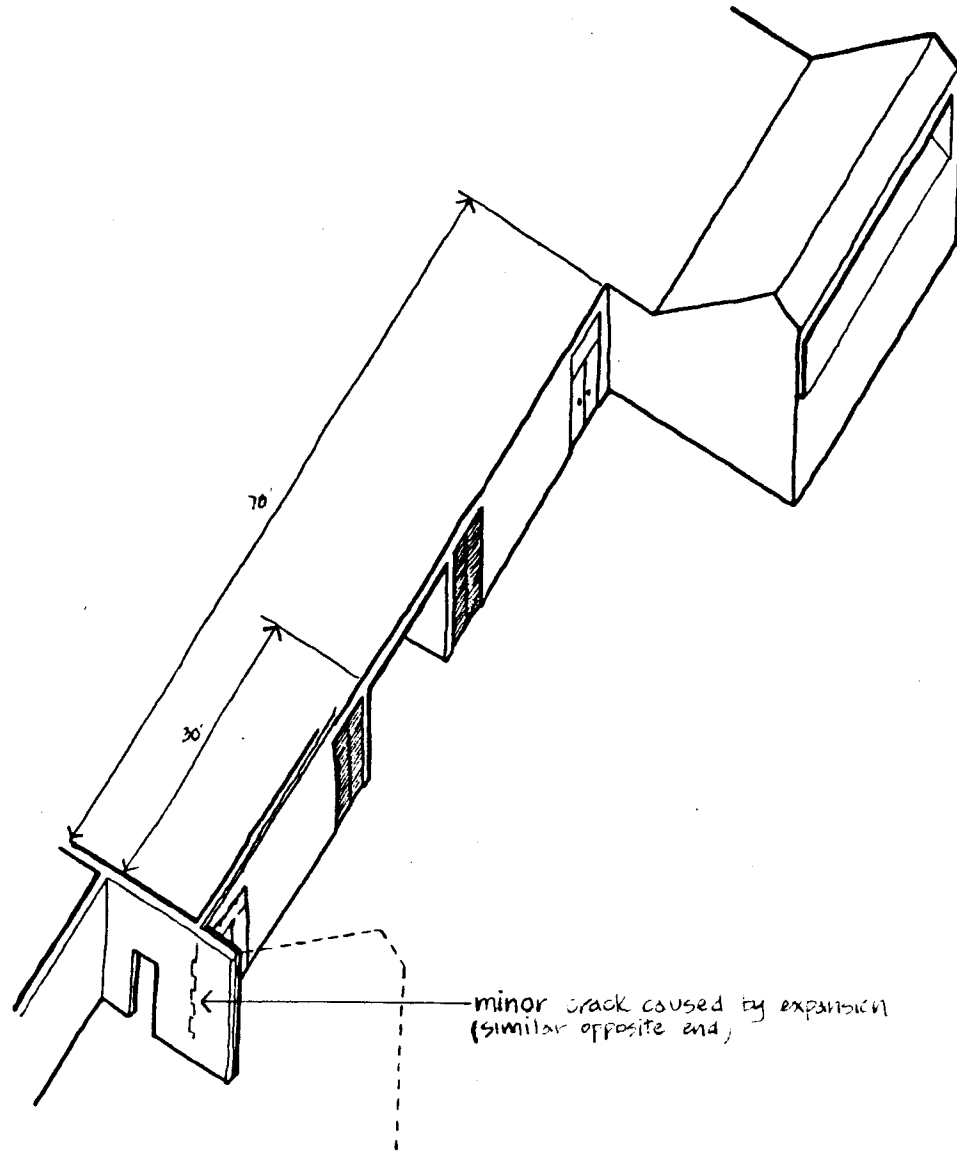
fig. A.6  
RICHARDS SCHOOL / EAST END

Results: Performance was satisfactory at the Parkside School. Some minor accommodation in the exterior wall at Mt. Healthy has taken place. The performance was below the 75% level at the Richards School. Expansion of roof truss over the multipurpose room causes wall movement which, in turn, causes moisture infiltration.

Probable cause: Lack of provision for the expansion of a long span truss.

The long (78 feet) north-south wall forming the eastern end of the school has expanded and cracked the two perpendicular walls at their common T-joint. This cracking, while easily visible is minor and is only an aesthetic problem. This long wall, while designed without an expansion joint is broken up by entrance doors and an air intake grill. Notwithstanding these potential places which could have provided relief from expansion the wall did expand (fig. A.6)

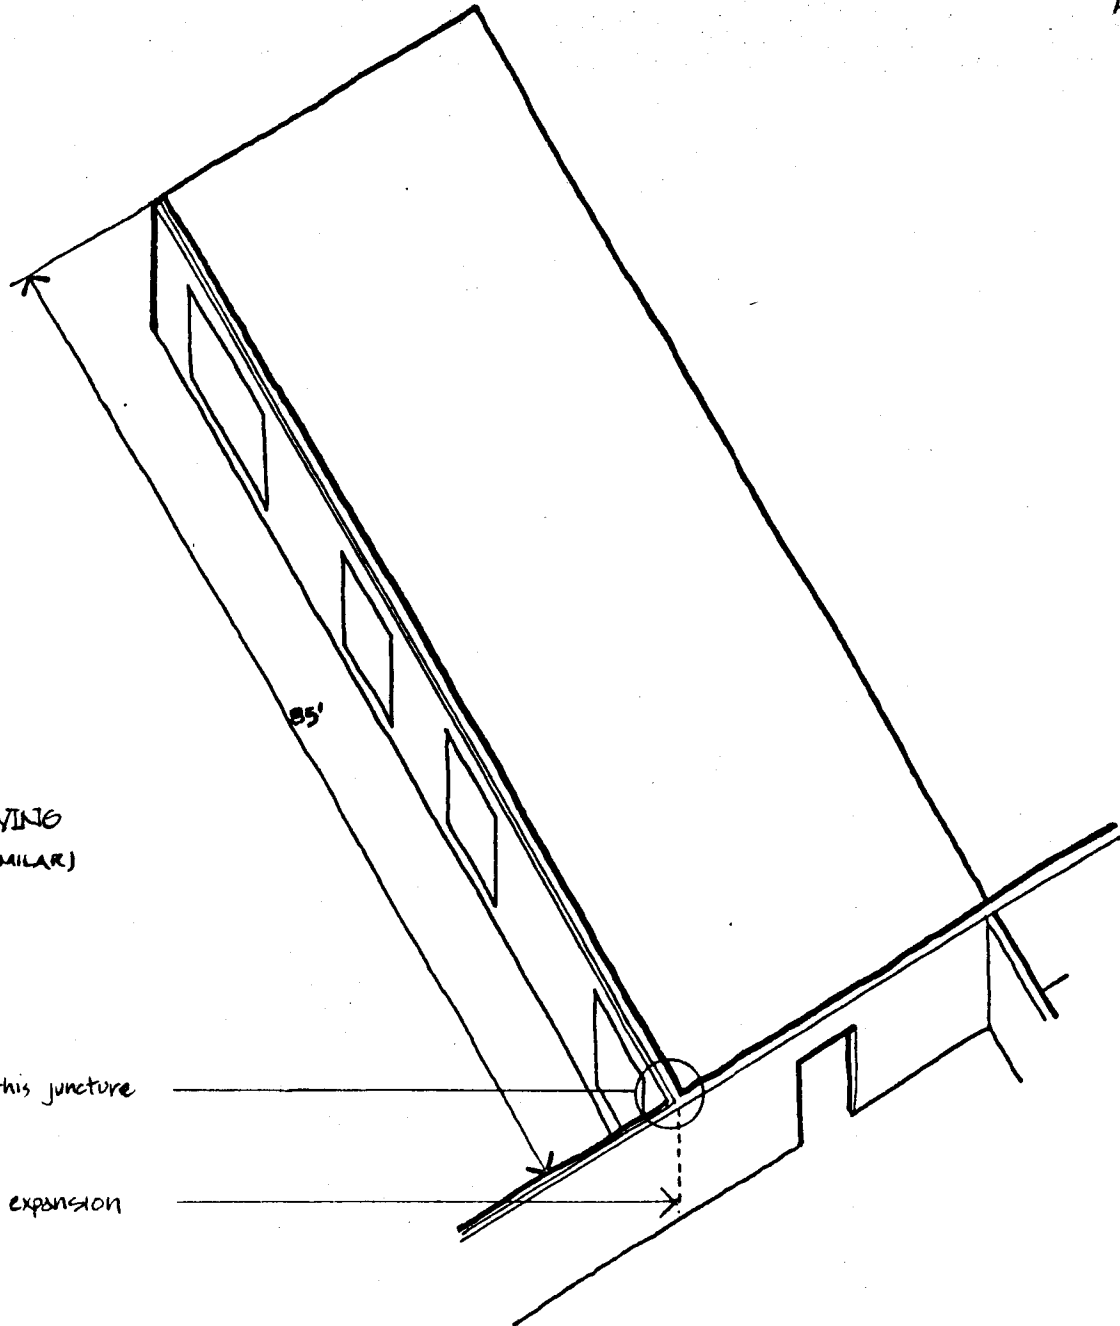
fig. A.7  
RICHARDS SCHOOL/NORTHWEST WING  
(SOUTHWEST WING SIMILAR)

At the west end of the school there are two wings with 84 foot masonry walls perpendicular to the main body of the building. Though an expansion joint is provided at this juncture there is easily visible, though functionally harmless, cracking at this T-joint. Though we have not dissected this area we believe a logical explanation is an incorrectly constructed joint which

allows a rigid connection at the point and in essence not allowing proper expansion.

expansion joint at this juncture

minor cracking caused by expansion

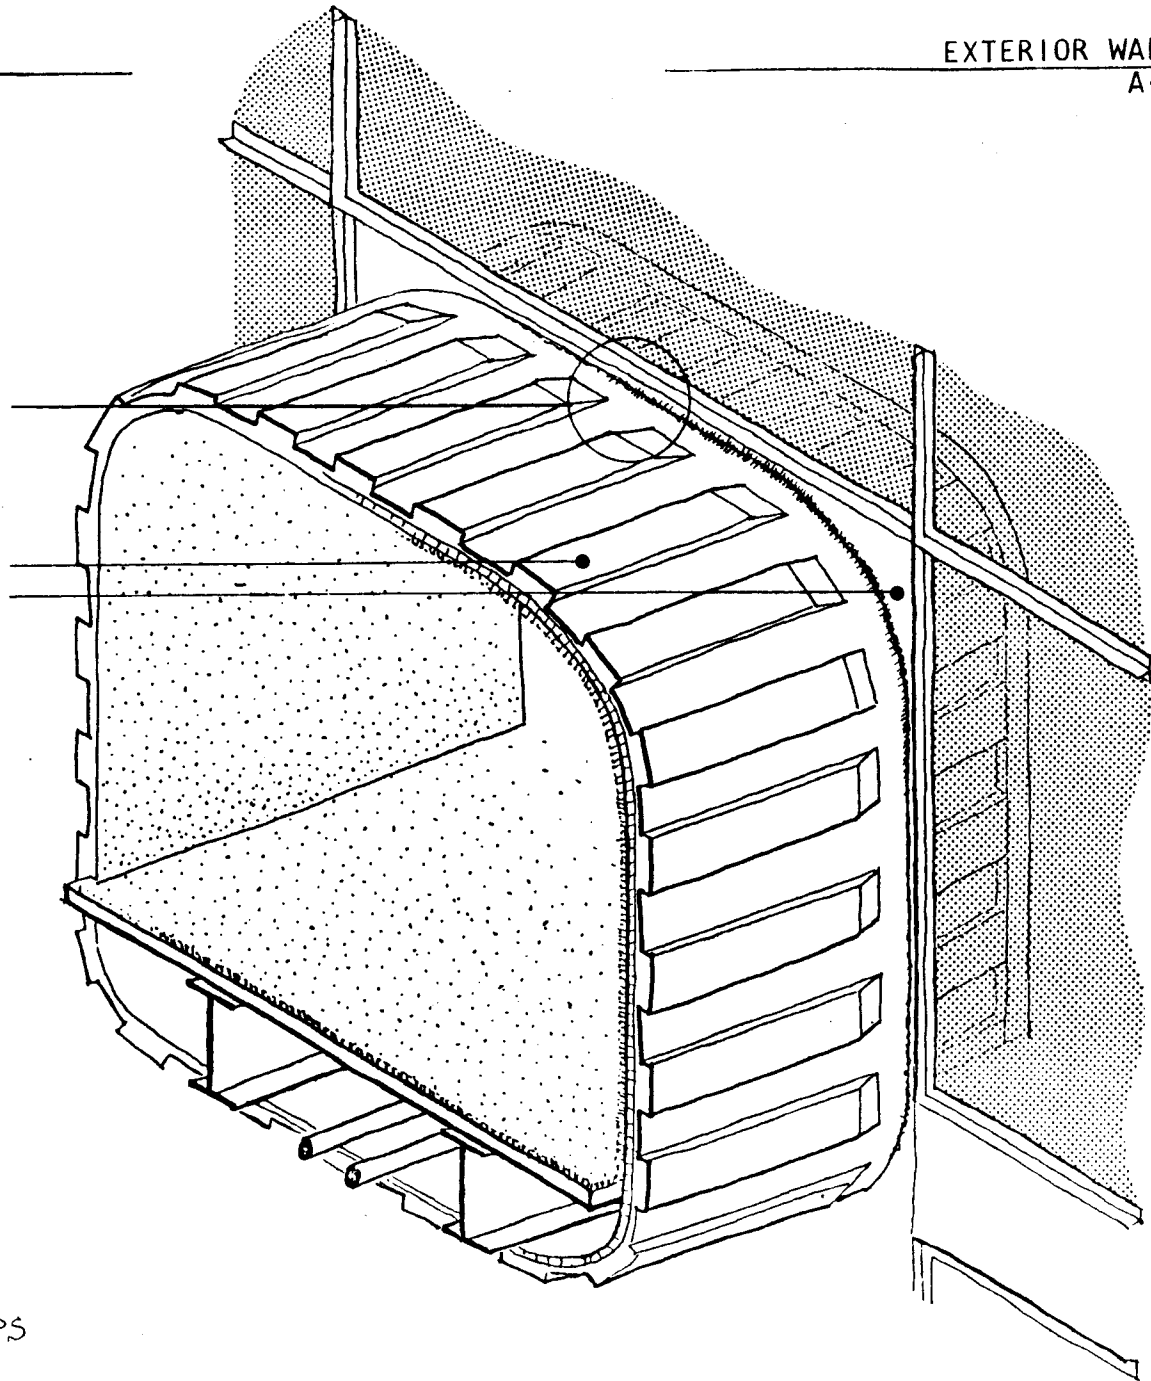
fig. A.8  
SMITH SCHOOL/SLOPED RAMPS

of the ramps and has entered the building. This has been corrected. Probable cause: The original detailing, weathering and the removal of caulking by students have all contributed to deteriorated performance.

At the Smith School the detail at the lower end of the sloped ramps is extremely difficult to solve with the use of the corrugated steel exteriors. The water races down the valleys of the corrugated metal exterior and is directed with some force at the joint with the curtain wall which could not perform adequately. The original detail has been modified with silicone caulk which seems to be performing adequately. It should be noted that the working drawings examined used the corrugated steel wound around the ramp which would have simplified the detail. The ramps were built with the metal corrugations running longitudinally.

water running down sloped corrugations enters  
via weld line or sealant (corrected)

corrugated steel siding  
10 ga. steel gusset
