ROOFS

INTRODUCTION

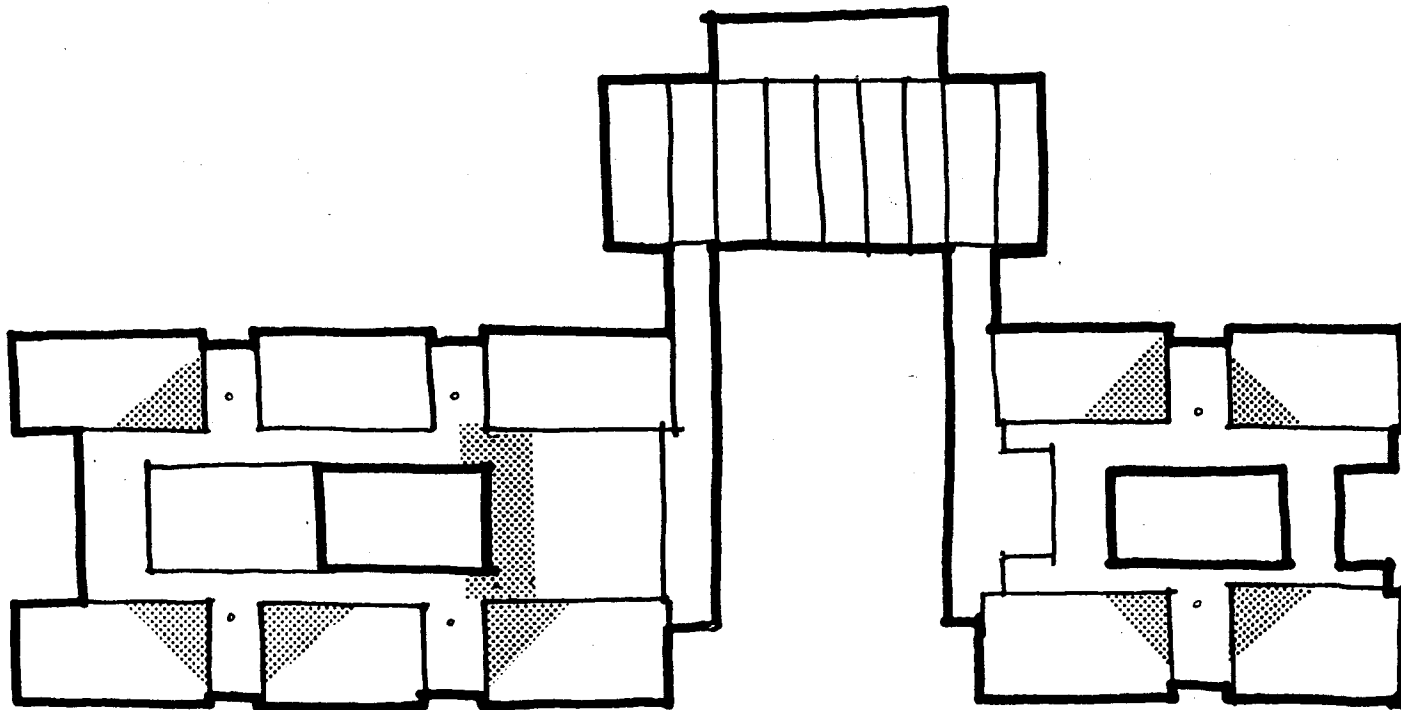
FIGURE B-1

Results: Performance was generally satisfactory at the Parkside and Mt. Healthy Schools. Ponding due to inadequate drainage is a problem at the Richards (below 75%) and the Smith (85%) Schools. Within 1 year of occupancy all of the built up roofing at Richards had already been replaced when core samples revealed total saturation of the roof membrane and insulation. Richards Elementary School has the most extensive ponding closely followed by Smith. Roof construction at Smith is of such high quality, which is rare, that existing ponding does not now, and may not, cause future moisture penetration. The Richards School has a less well constructed roof and alligating, brittleness and membrane movement due to ponding caused many problems in the past and may well cause future problems.

Results: Performance was satisfactory (85%) at Mt. Healthy, at the 85% level at Parkside, but unsatisfactory (75% or below) at the Smith and Richards Schools where a lack of slope results in ponding.

PARKSIDE SCHOOL: PONDING

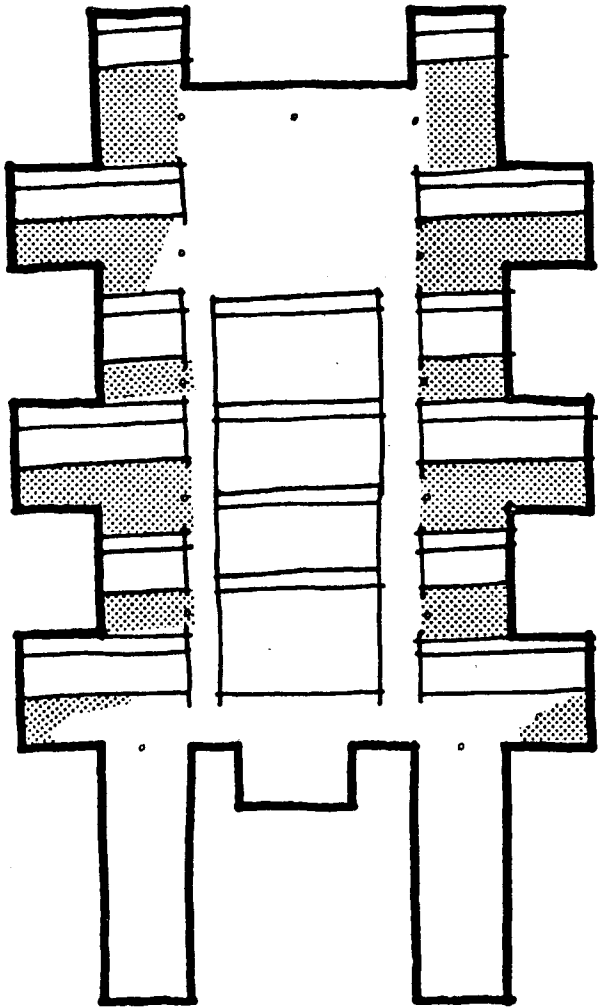
Discussion: This, of course, is the primary cause of ponding. 'Dead' flat roofs were specified at the Smith and Richards Schools. At Richards the roof actually slopes away from the drain. This, we believe, is caused by some small amount of settlement in the exterior wall or poor construction which at

first caused minor ponding. The weight of this additional water gradually caused the roof membrane to sag in this area and increased its capacity to hold water, producing a cycle of increasing ponding.

RICHARDS SCHOOL: PONDING
FIGURE B.2

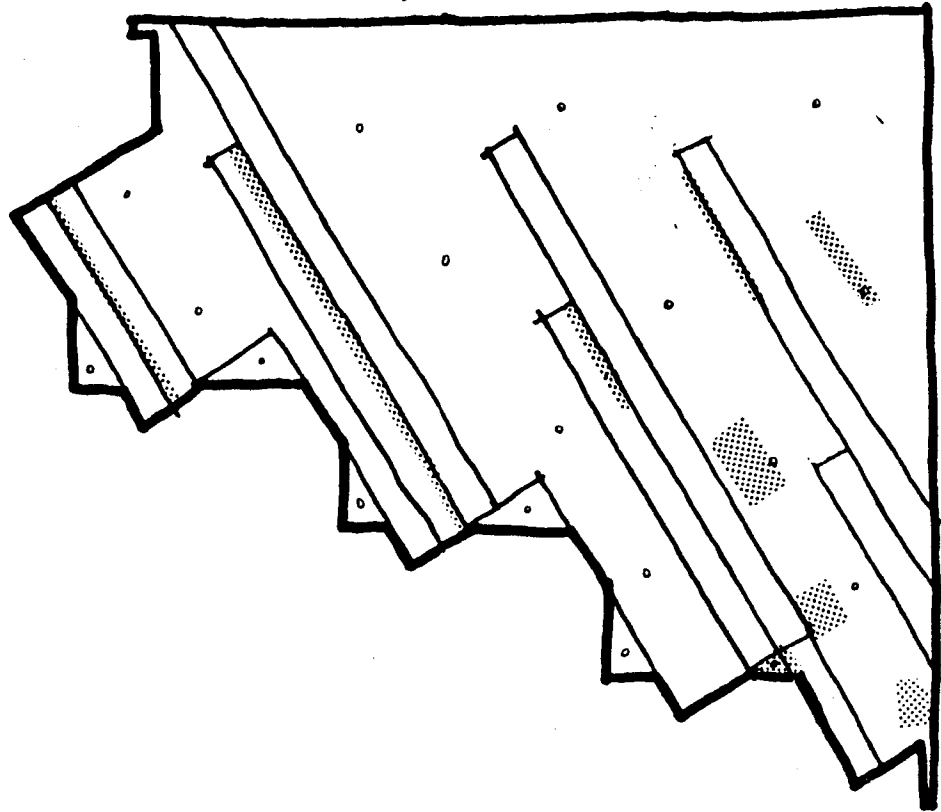
MT. HEALTHY SCHOOL: PONDING
FIGURE B.3

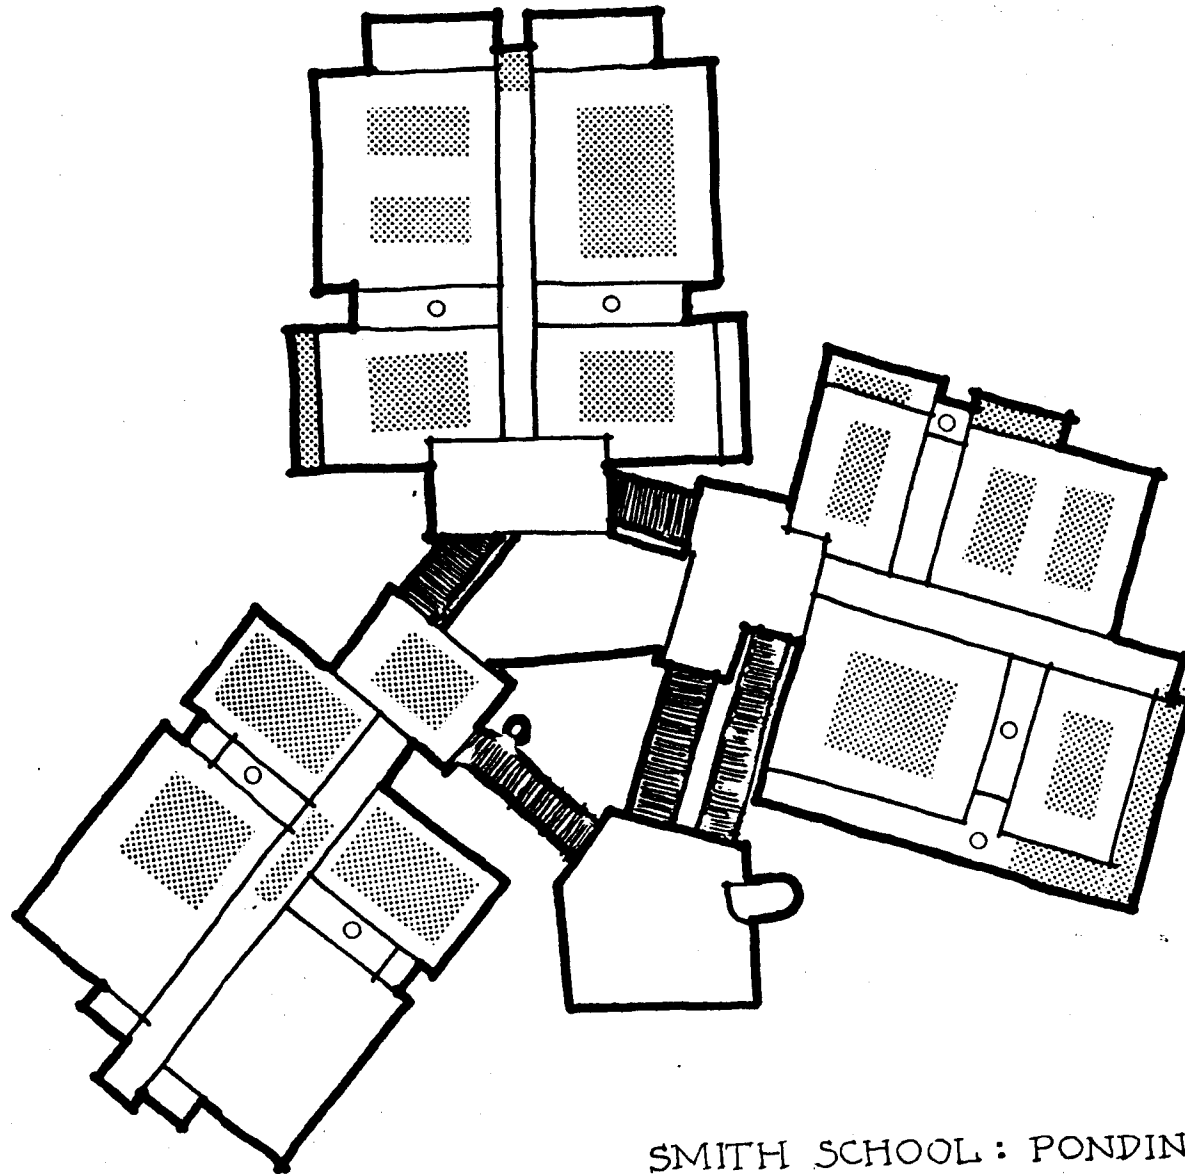
FIGURE B.4

The Smith School has two roof levels over each typical wing, the higher draining via scuppers to the lower on which are located the roof drains. Ponding is extensive on the upper roof levels. Extensive water protection raises the roof edges enough to prevent water from reaching the scuppers. This results in an extensive pond at the center of each upper roof area. The roof construction, though, is excellent and does not allow any moisture penetration.

SMITH SCHOOL : PONDING

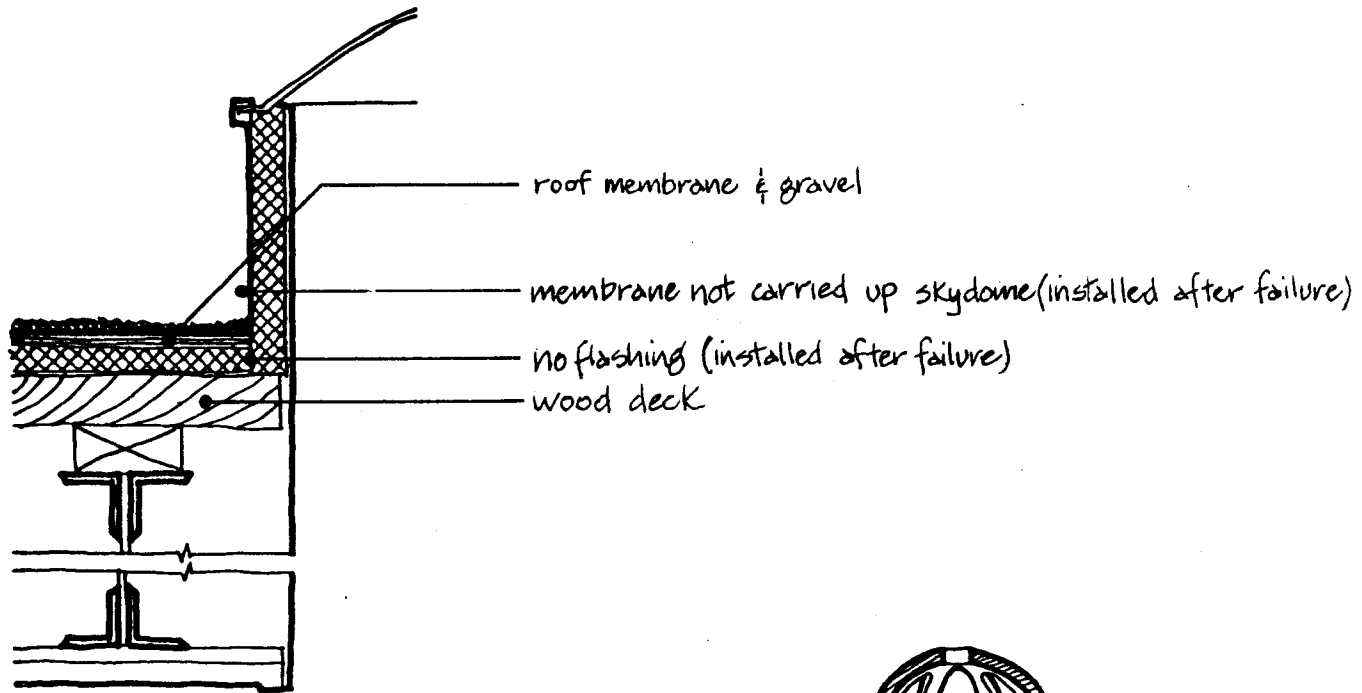
Results: Performance was satisfactory (85%) at Parkside and Smith, unsatisfactory (below 75%) at Richards and Mt. Healthy. Detailing permitted water to penetrate the roof.

Probable cause: Inadequate detailing and/or unsatisfactory construction practices at locations of potential moisture penetration.

Discussion: In general all roof penetrations and changes in levels are well detailed in terms of tolerances and materials at all schools. A notable and inconsistent exception is the circular skylight details at the Richards School in which upstand flashing is omitted and the roofing felts are not carried up the edge of the raised skylight. These omissions provided a direct path for moisture and extensive leakage and water staining occurred inside the building. This may have been the major factor which caused total saturation and replacement of the roof a year after occupancy. This has been corrected. The valley flashing over the multipurpose room was incorrectly installed--the flashing was improperly soldered--and this too caused leakage and was corrected.

RICHARDS: SKYDOME
FIGURE B.5

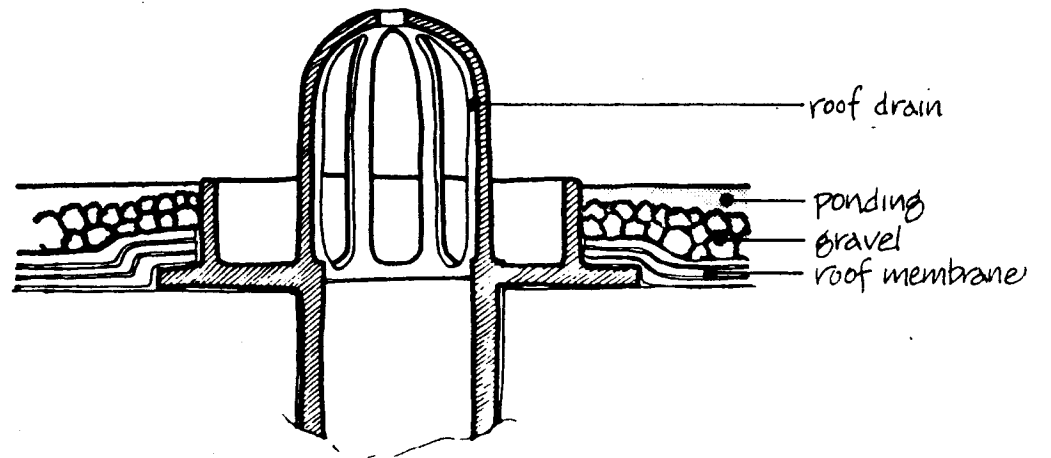
Results: Performance was adequate at all facilities examined. Drains can sometimes be higher than the roof surface due to additional flashing and therefore cause or exacerbate ponding conditions. Gutters between adjacent skylights at Mt. Healthy were found to be a trap for leaves and a potential source of blockage.

Probable cause: Architectural detailing and construction tolerances due to flashing, protection around drains.

Discussion: Typically all openings through the roof are protected by additional layers of roofing felt and flashing materials. This causes the roof to pitch up slightly at the drain. If a drain is chosen or installed in a manner which also raises it above roof level--the combination of the higher drain and the additional protection can actually be 2-3" above the roof level which will cause ponding in this location.

RICHARDS: ROOF DRAIN
FIGURE B.6

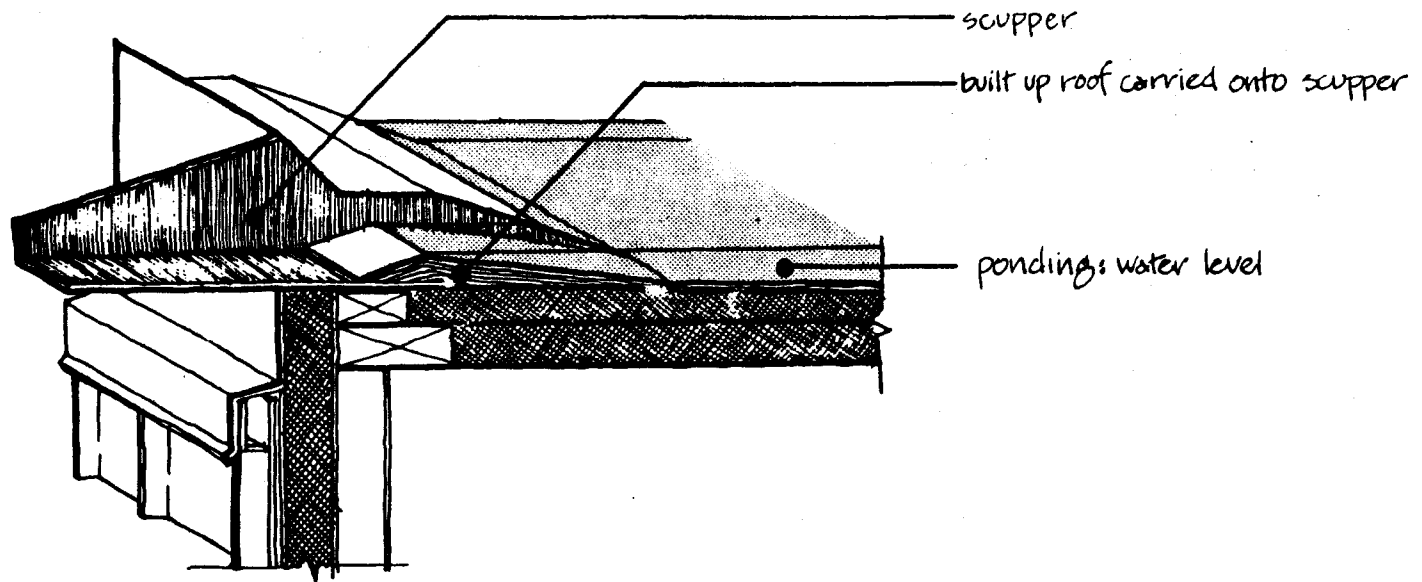
FIGURE B.7

SMITH: SCUPPER

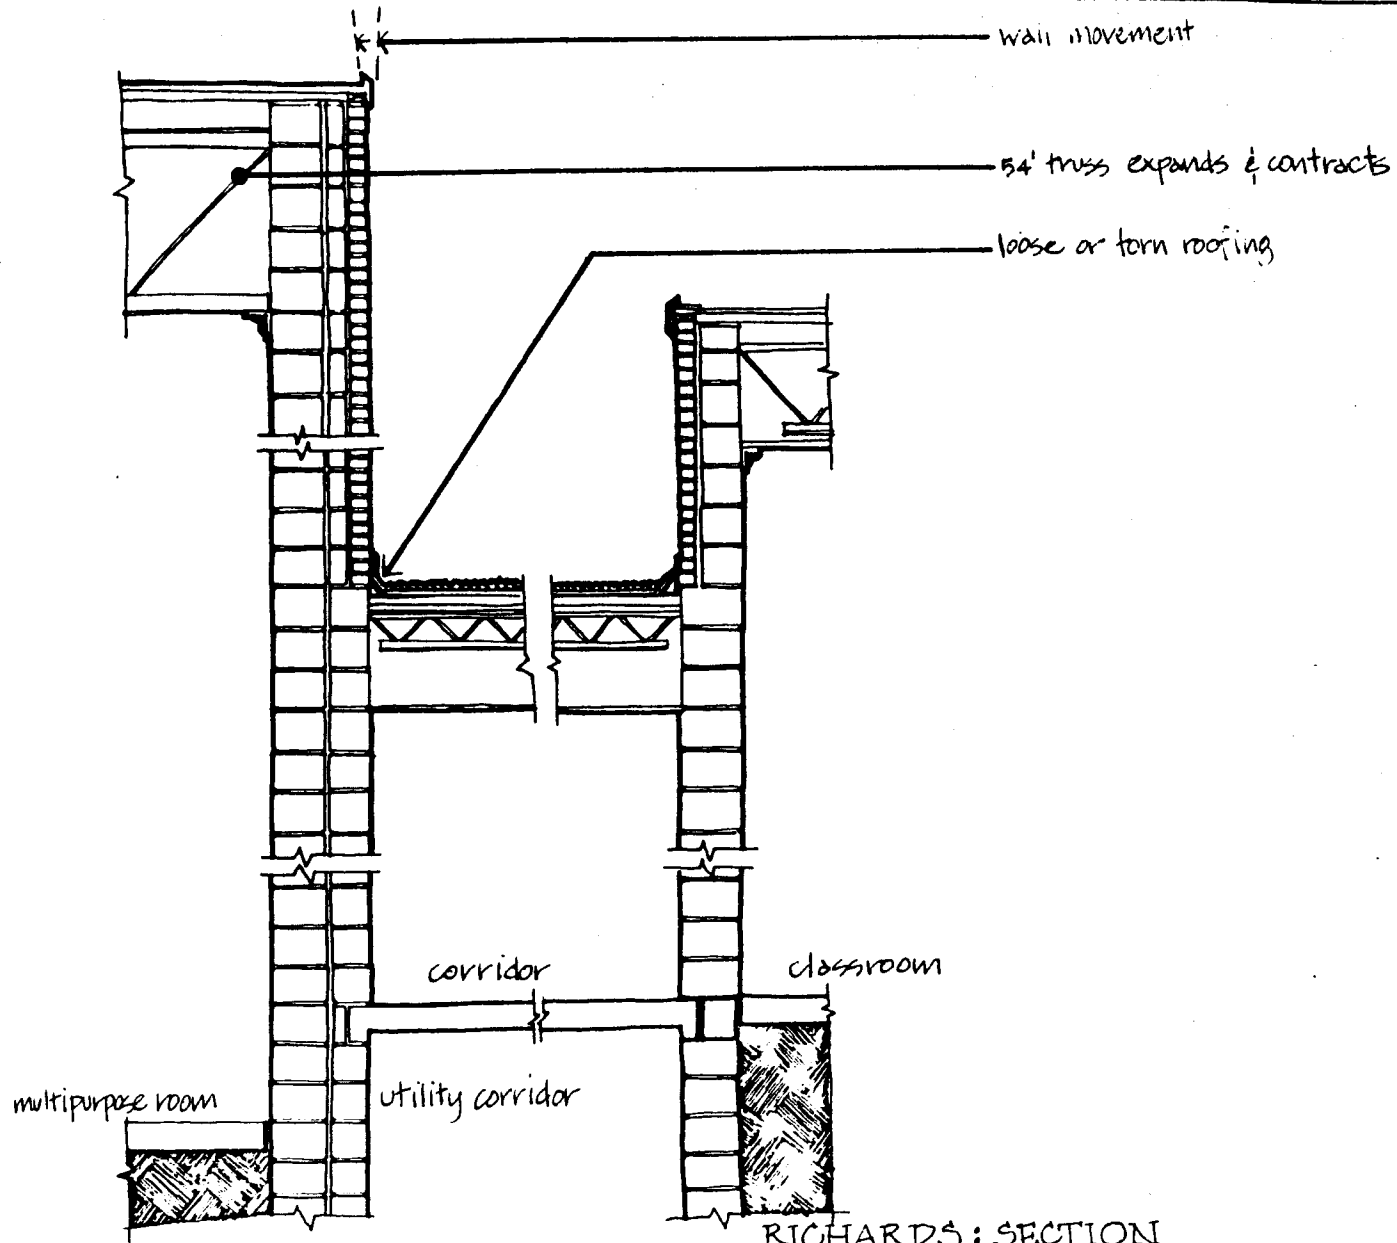
Results: Performance is satisfactory (95%) at all schools with the exception of Richards (below 75%) where structural movement has resulted in moisture penetration through the roof membrane.

Probable cause: Thermal expansion and contraction of the 54 foot trusses over the multipurpose room causes openings in the roofing membrane.

The 54 foot long roof trusses over the multipurpose room are not free to move at their ends. Since the school is not air-conditioned and the trusses are at the top of this high space they are subject to considerable thermal expansion (and contraction). As they expand and contract they push the exterior walls in and out. This exterior wall is, in turn, restrained at its midheight by the adjacent corridor structure and this joint between the lower (corridor) roof and this moving wall is constantly opening and closing. This is beyond the capacity of the membranes and flashing to absorb this movement leads to water leaking in. This condition exists in the corridors at every point where the lowest roof truss abuts the corridor wall.

RICHARDS: SECTION
FIGURE B.8
