Rolling Contact Fatigue of Low Hardness Steel for Slewing Ring Application

A Thesis Submitted in
Partial Fulfillment of the
Requirements for Degree of

Master of Science

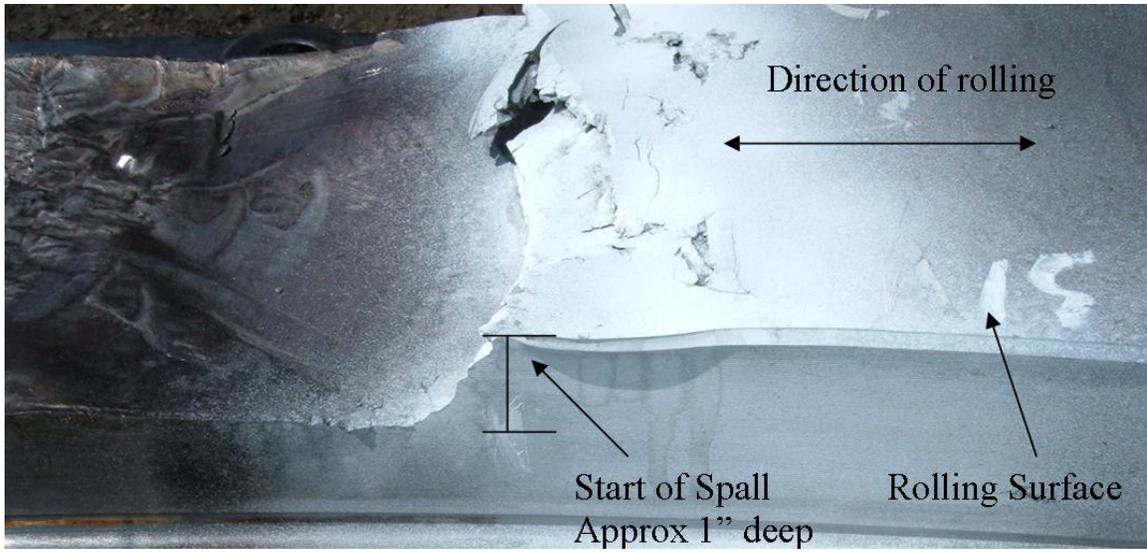
Figure 2.1: Medium carbon alloy steel application failure

The severity or depth of spalling/pitting depends on the location of the shear plane. If the shear plane is close to the surface, light pitting will occur and the crack will propagate to the surface. With increased loading beyond the material's dynamic capacity, the plane will be driven deeper within the material. Field reports for the slewing ring application considered in this thesis have demonstrated that cracks initiated at the deep shear plane will tend to travel inward (away from the rolling contact surface) and then turn parallel to the surface. The crack will propagate until the cyclic load causes bending stresses near the crack tip driving the crack to the surface. (Figures 2.1-2.3)

The expected life of the application's slewing ring is five to seven years. After two years of the application utilizing the medium carbon alloy steel, there were reports of catastrophic failures of the raceway. These failures resulted in relatively large chunks of material breaking off and seizing up the application's rotation. This failure was deemed catastrophic due to the lack of notice prior to raceway failure, causing the application to become inoperable. Several raceways were returned for analysis. Figures 2.1-2.3 show examples of the medium carbon alloy steel failure. The rate of failures while using the new material was becoming more prevalent than the rate of failures utilizing the high carbon steel on the smaller applications. Additionally the failures utilizing high carbon steel were not deemed catastrophic, due to the predictability of raceway wear. Applications that utilized the high carbon steel did not experience large chunks of material breaking off and seizing up the applications rotation. The failure of the high carbon steel was found to be surface pitting causing excess surface wear (Figure 2.5). This type of failure was more acceptable to the application's user, allowing them adequate time to plan for the application's outage.

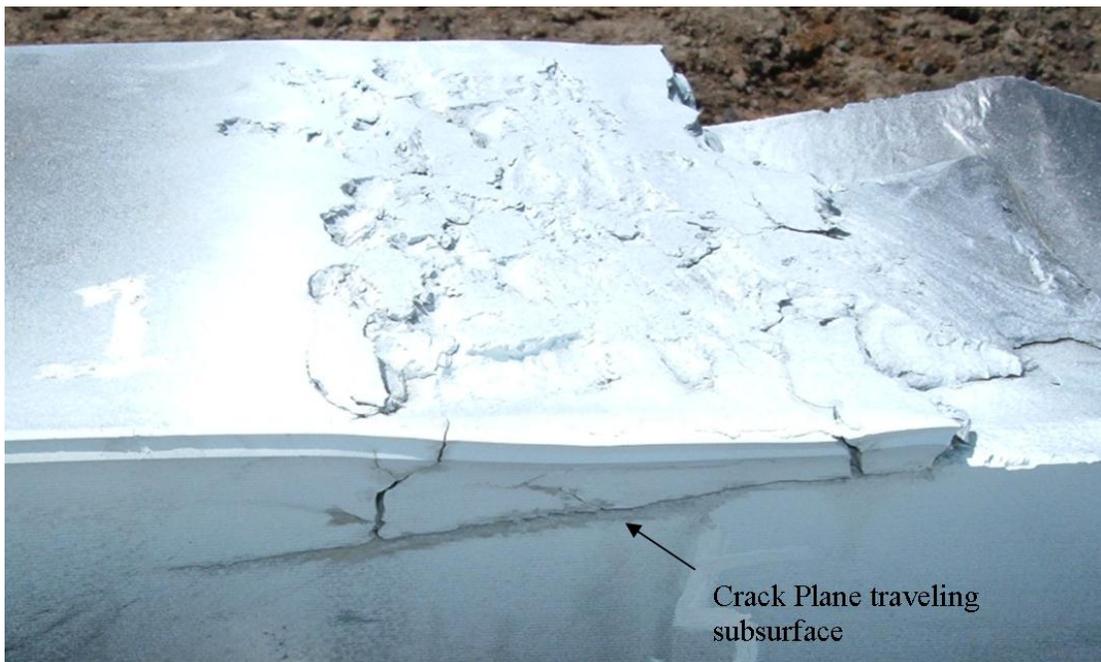
Figure 2.2: Medium carbon alloy steel application failure subsurface crack

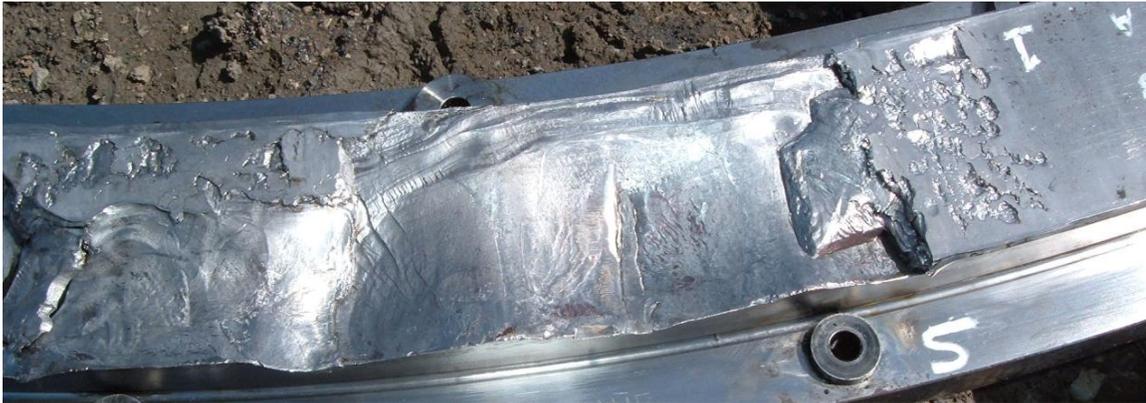
Figure 2.3: Top view of medium carbon alloy steel failure

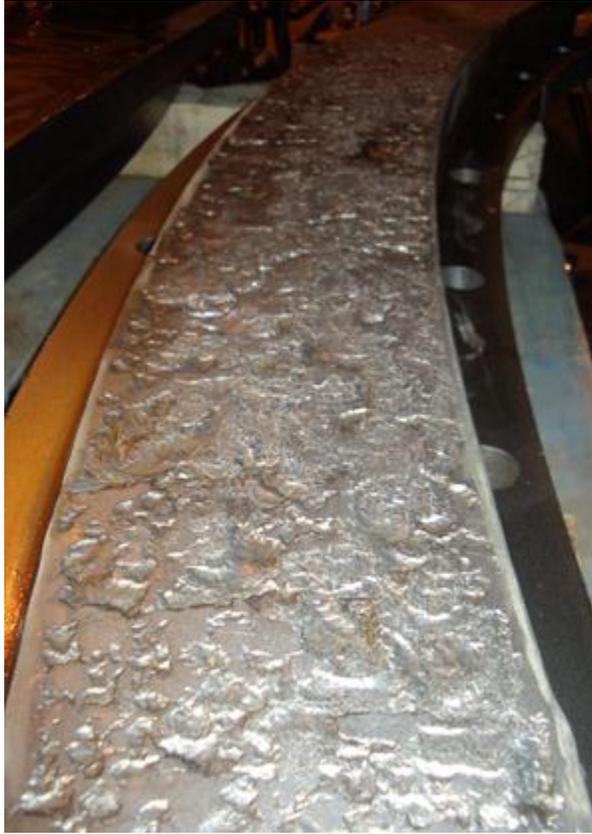
Figure 2.5: High carbon steel application failure mode

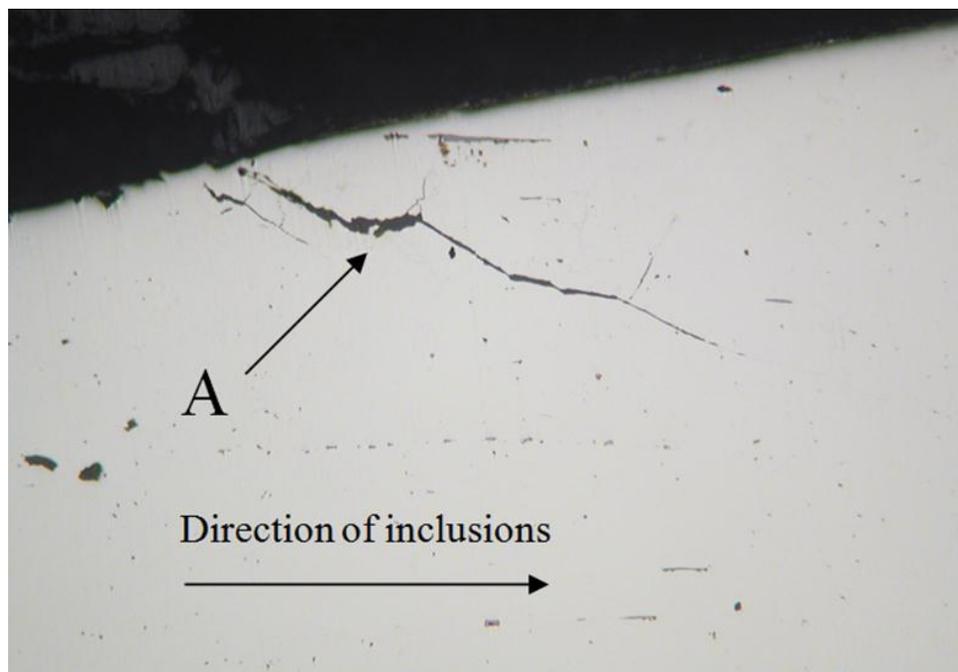
Figure 4.4: RCF-1-01-PRE Crack location

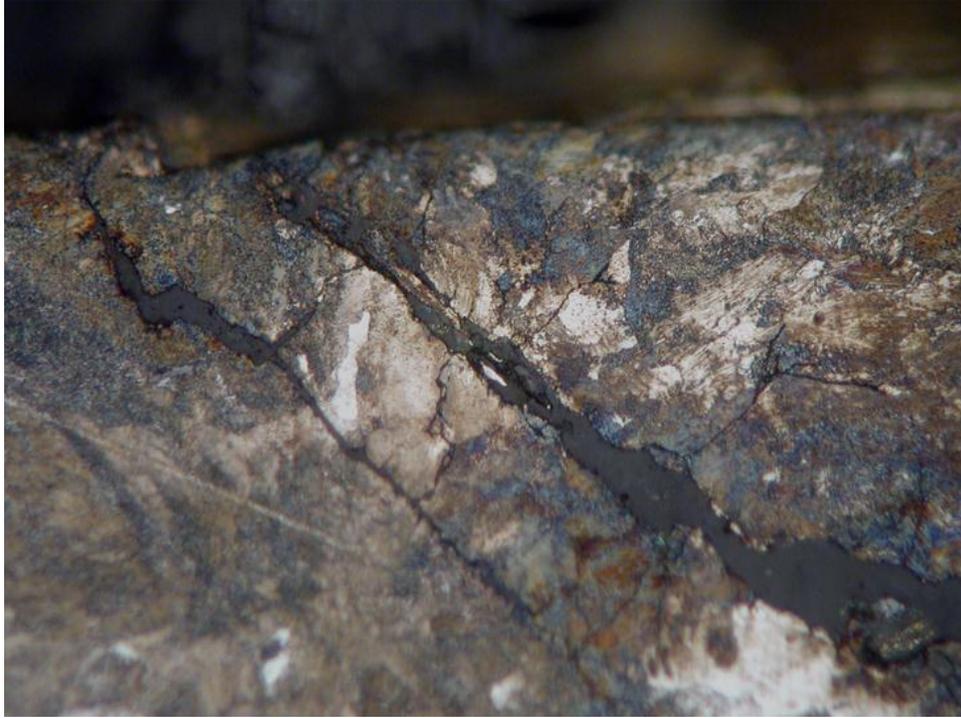
Figure 4.5: RCF-1-01-PRE microstructure of crack

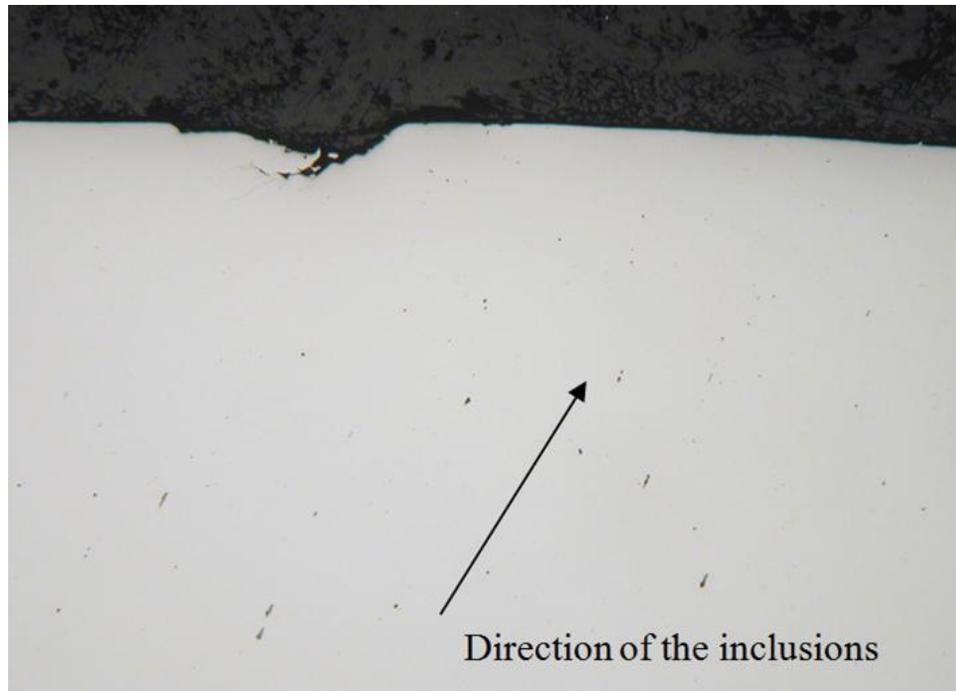
Figure 4.6: RCF-5-03-PRE inclusion direction

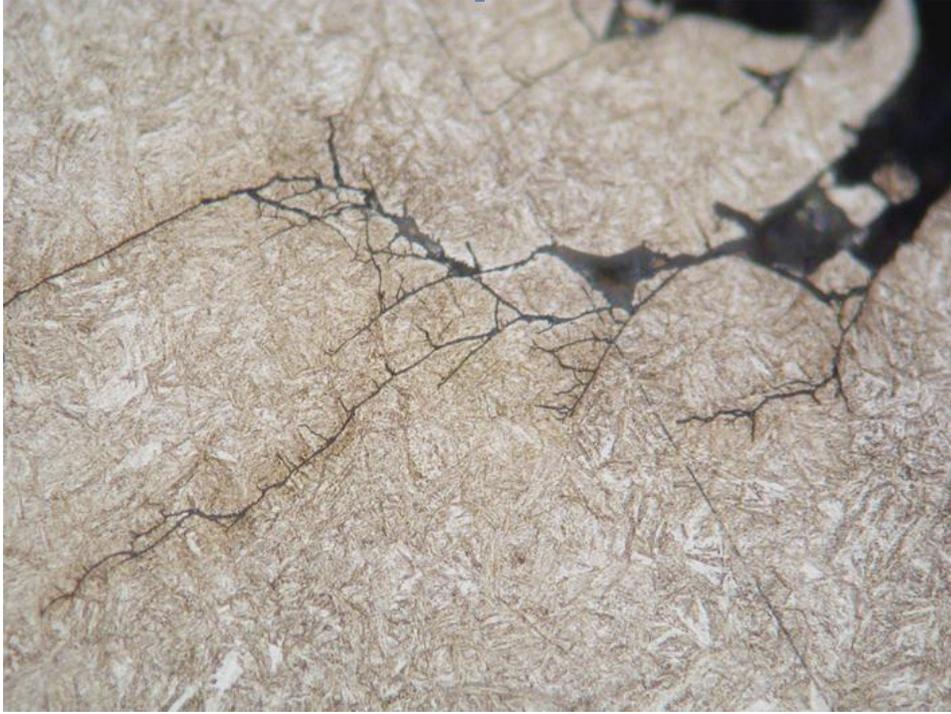
Figure 4.7: RCF-5-03-PRE Crack and Microstructure

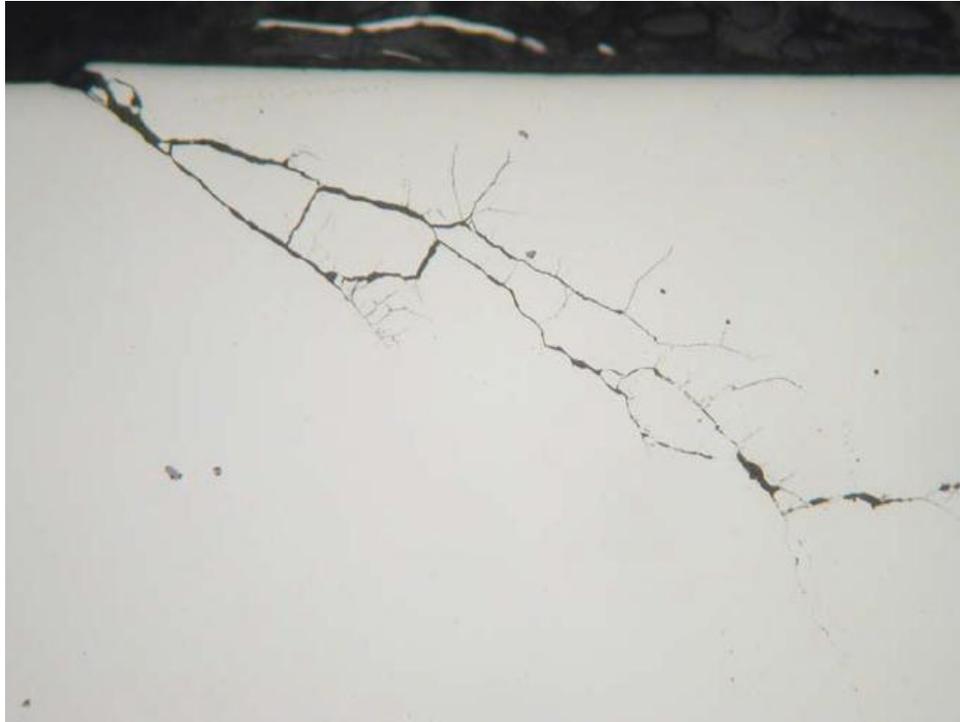
Figure 5.1: RCF-3-04, crack location. Unetched (201X)

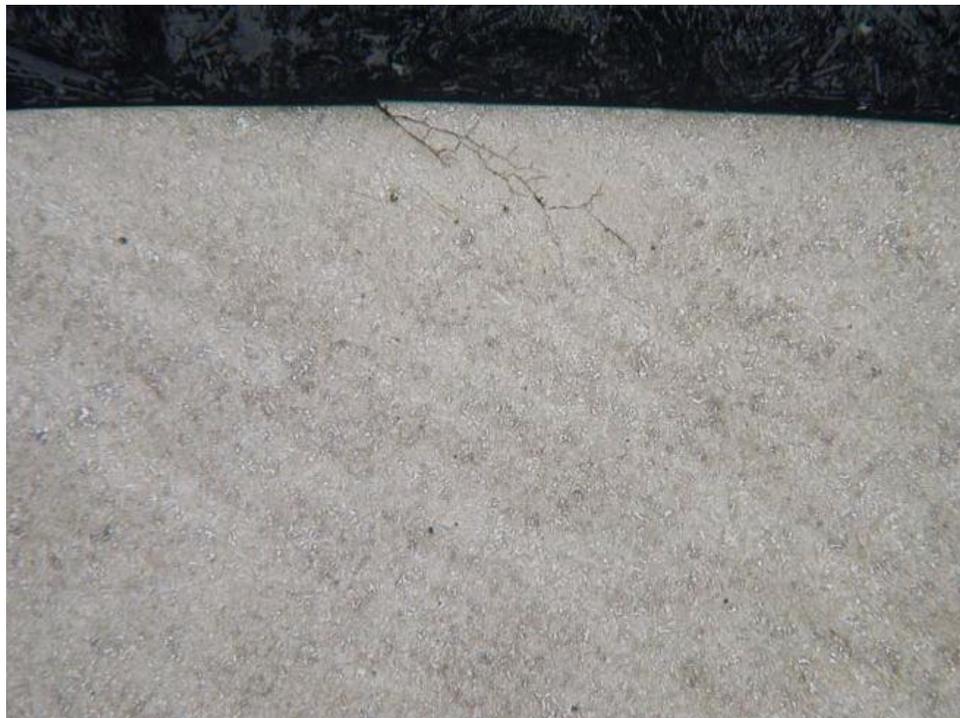
Figure 5.2: RCF-3-04, Microstructure. 2% Nital (50X)

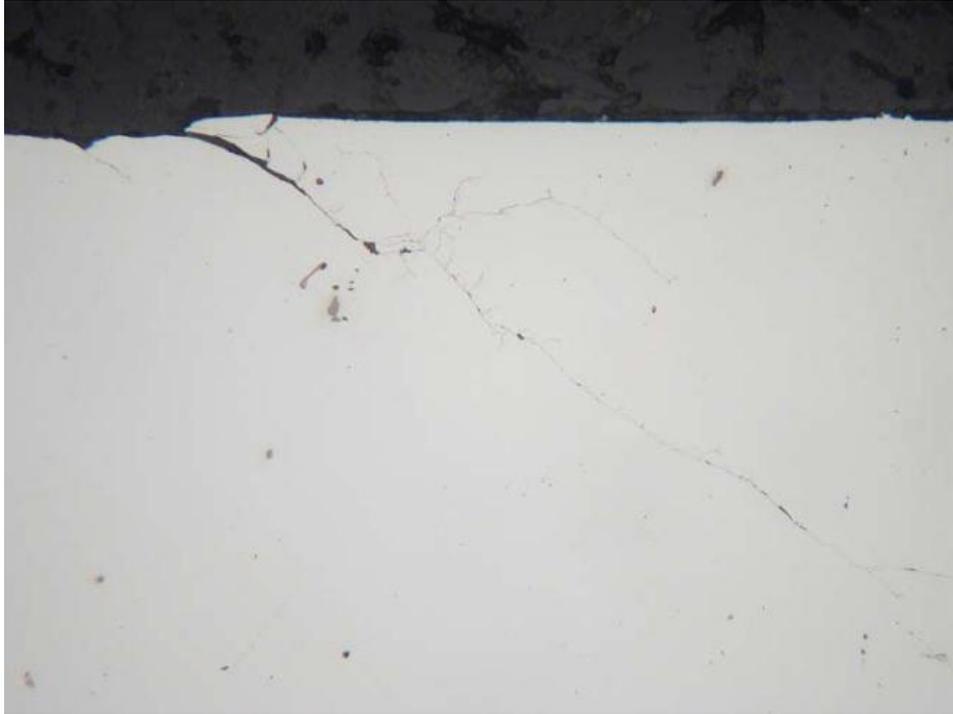
Figure 5.3: RCF-1-07, Crack location. Unetched (201X)

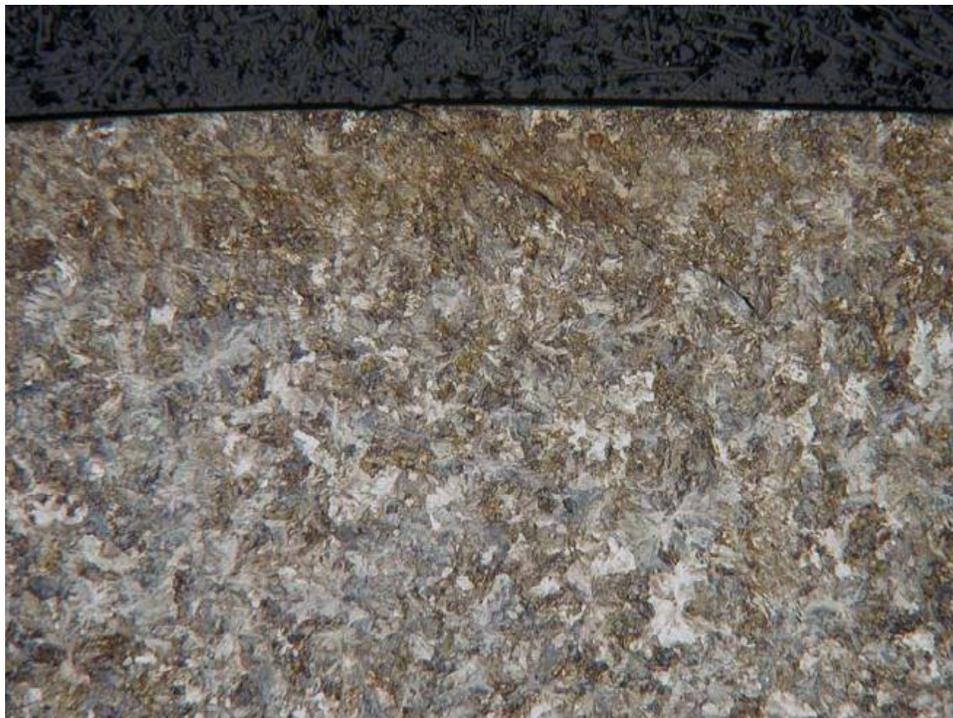
Figure 5.4: RCF-1-07, Microstructure. 2% Nital (50X)

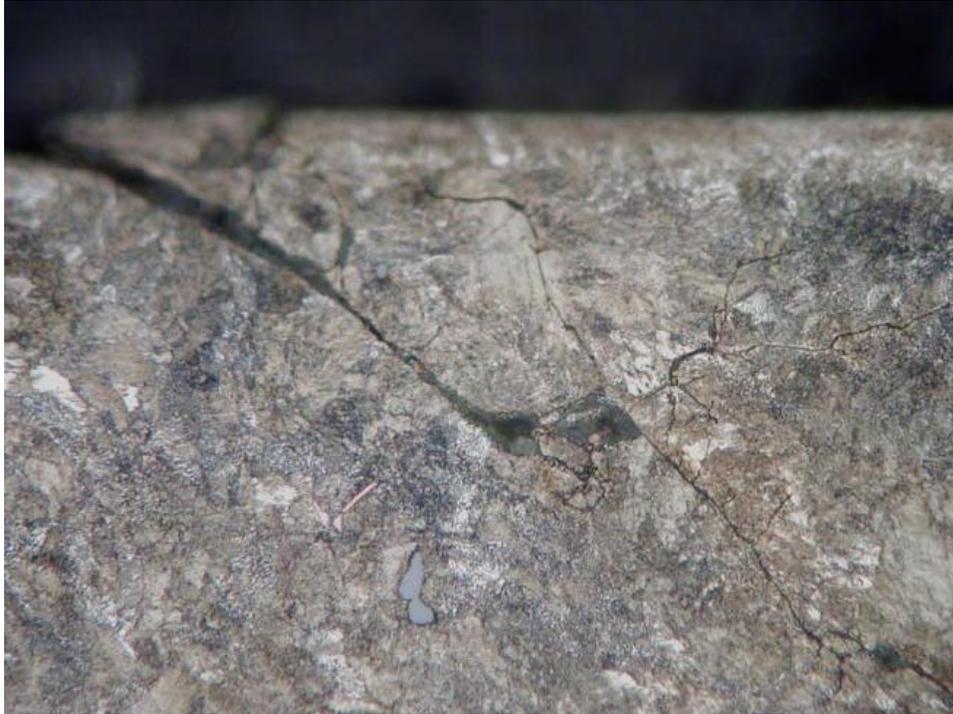
Figure 5.5: RCF-1-07, Transgranular crack. 2% Nital (494X)

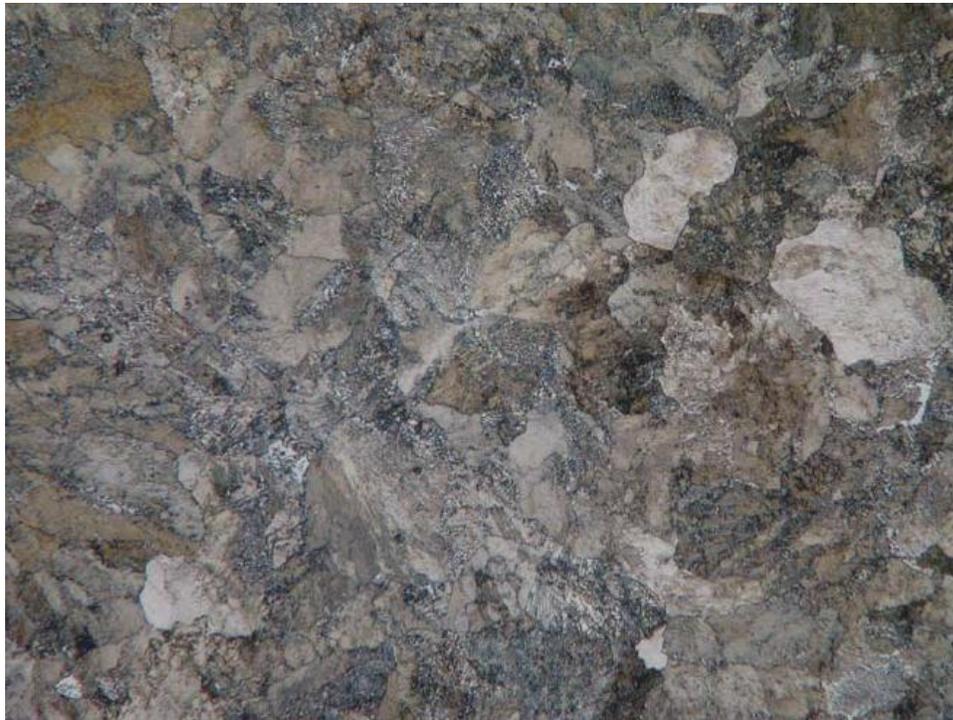
Figure 5.6: RCF-1-07, Fine lamellar pearlite with small amounts of ferrite. (494X)

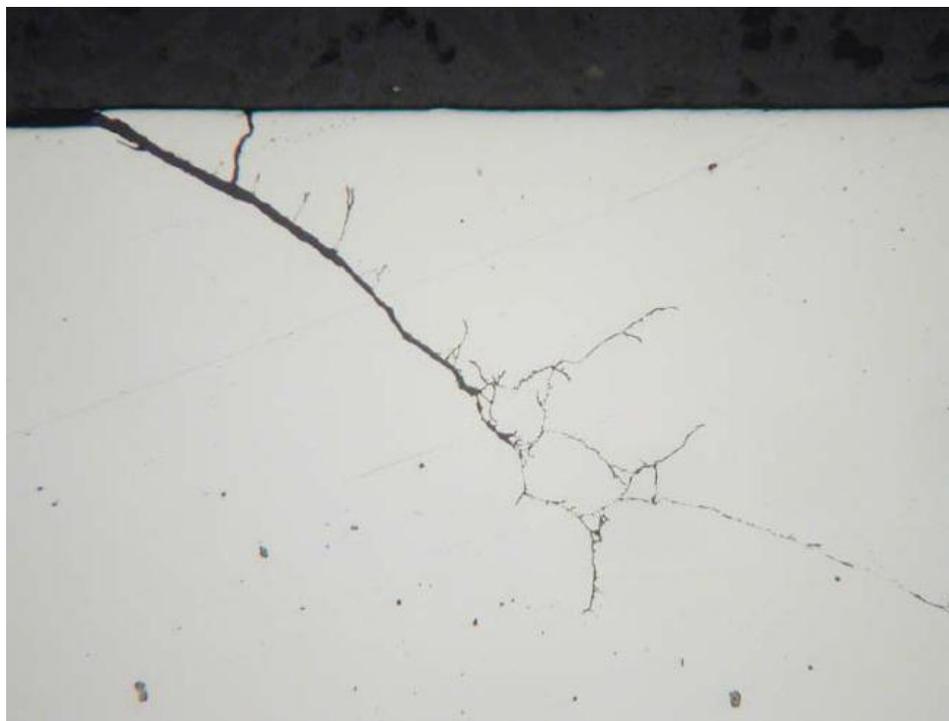
Figure 5.7: RCF-4-12, Crack location. Unetched (201X)

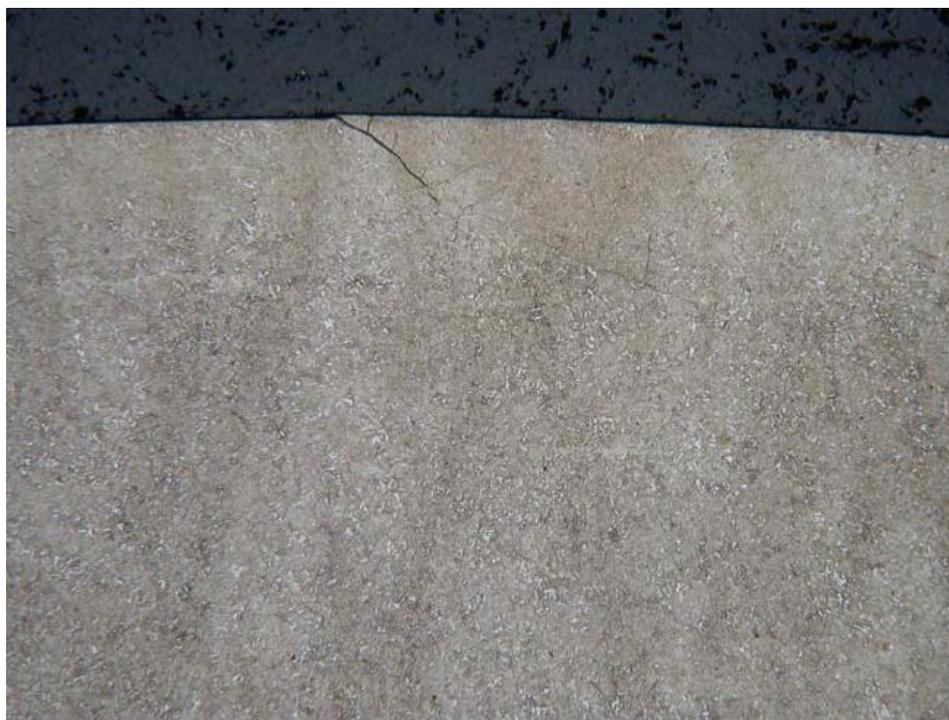
Figure 5.8: RCF-4-12, Microstructure. 2% Nital (50X)

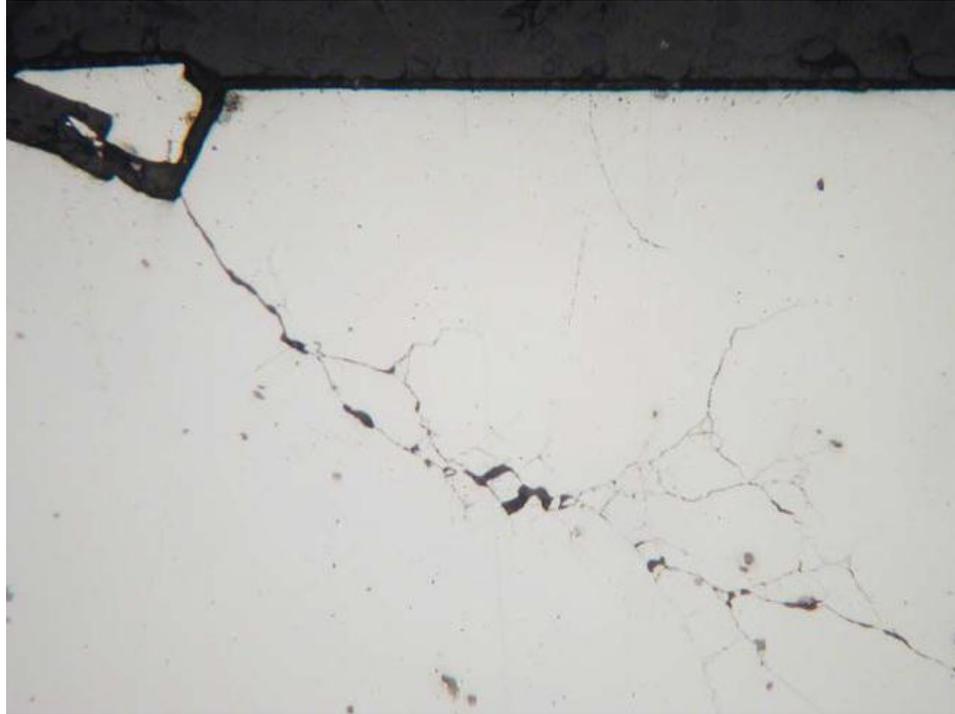
Figure 5.9: RCF-1-14, Crack location. Unetched (201X)

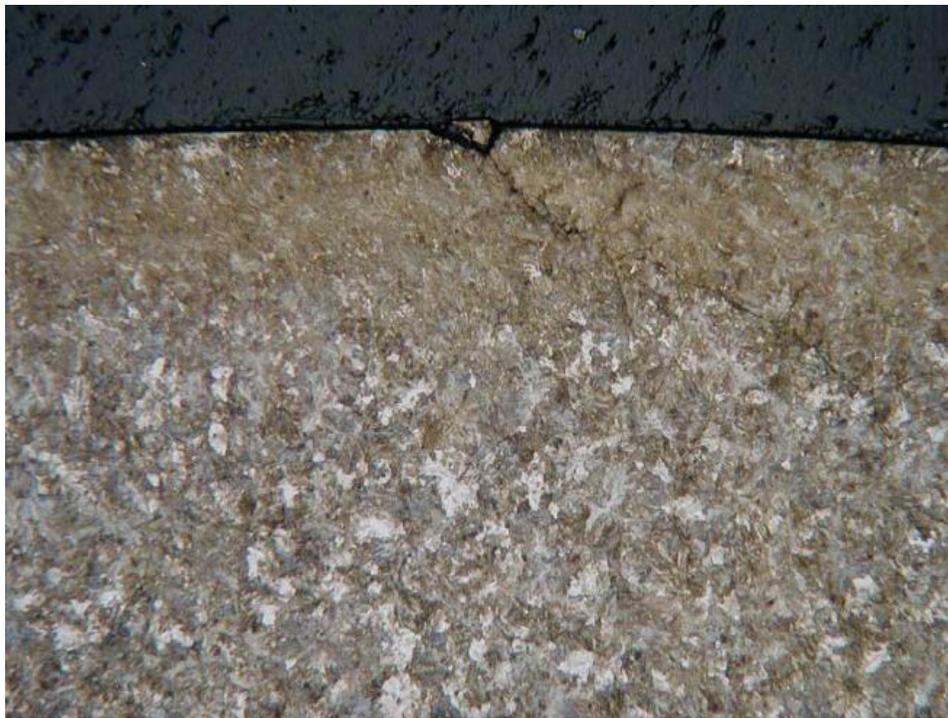
Figure 5.10: RCF-1-14, Microstructure. 2% Nital (50X)

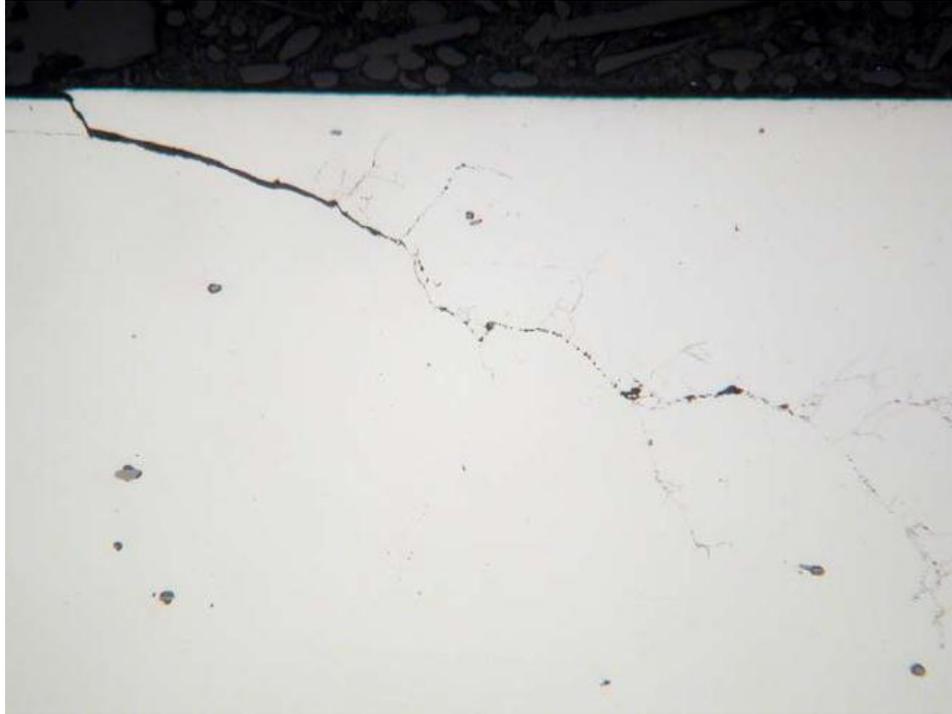
Figure 5.11: RCF-2-01, Crack location. Unetched (201X)

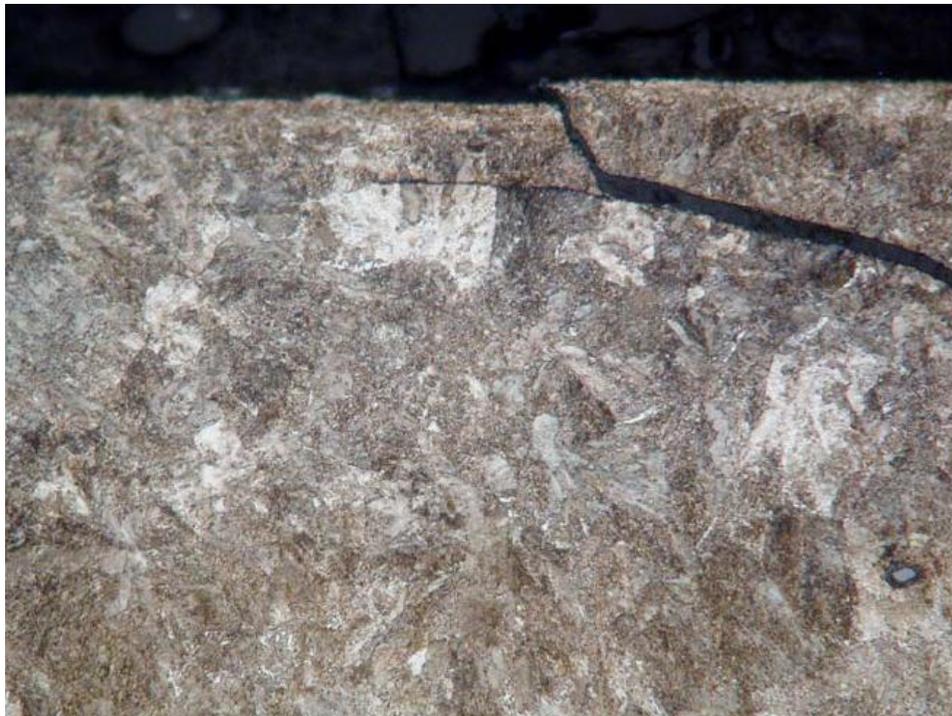
Figure 5.12: RCF-2-01, Near surface microstructure. 2% Nital (494X)

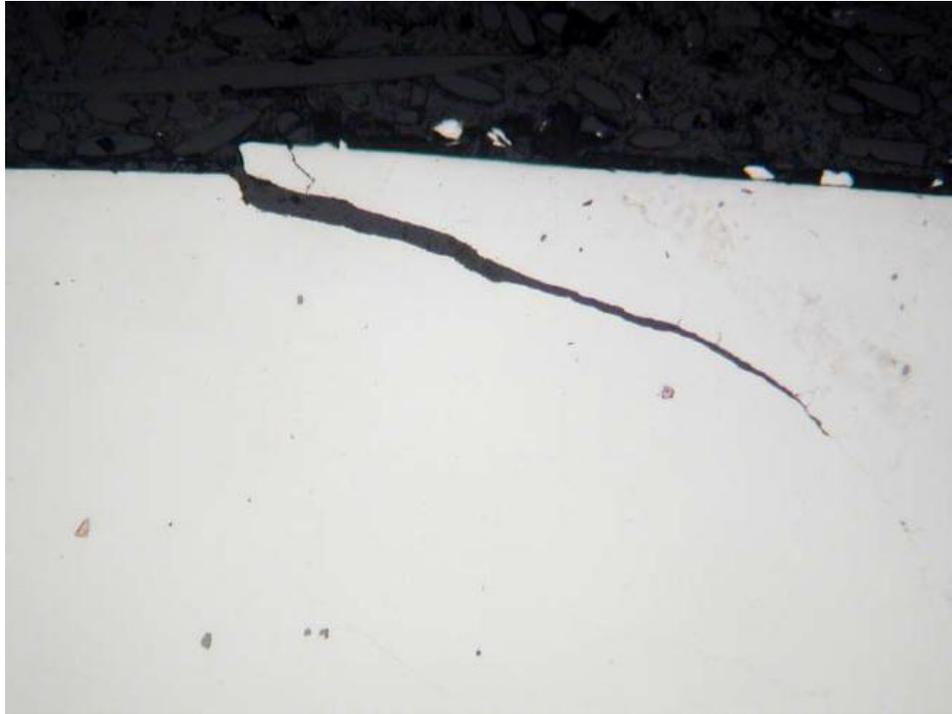
Figure 5.13: RCF-2-05, Crack location. Unetched (201X)

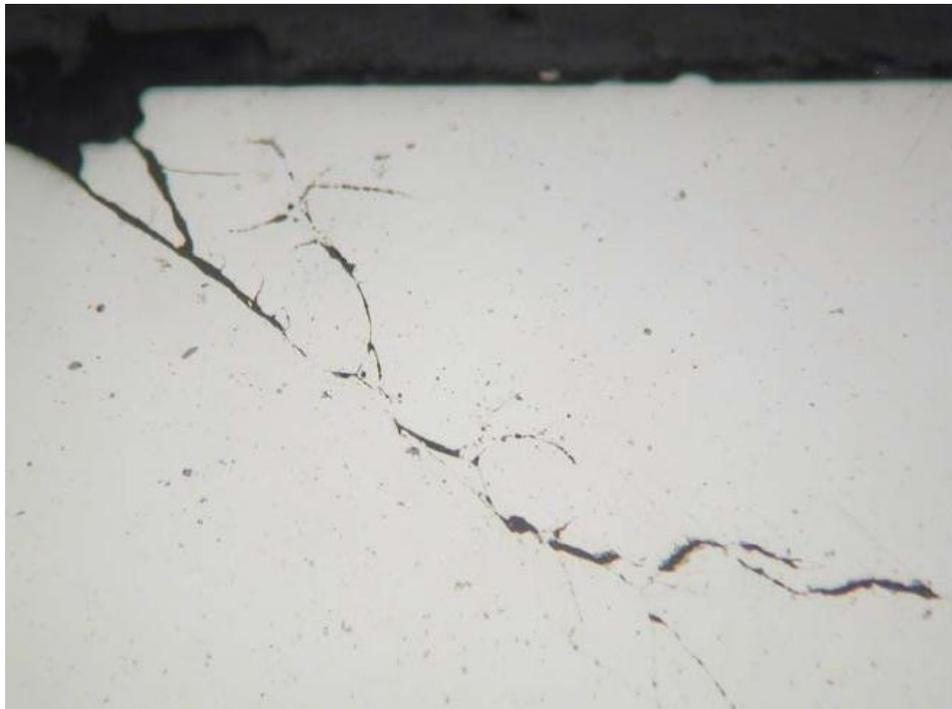
Figure 5.14: RCF-5-02, Crack location. Unetched (201X)

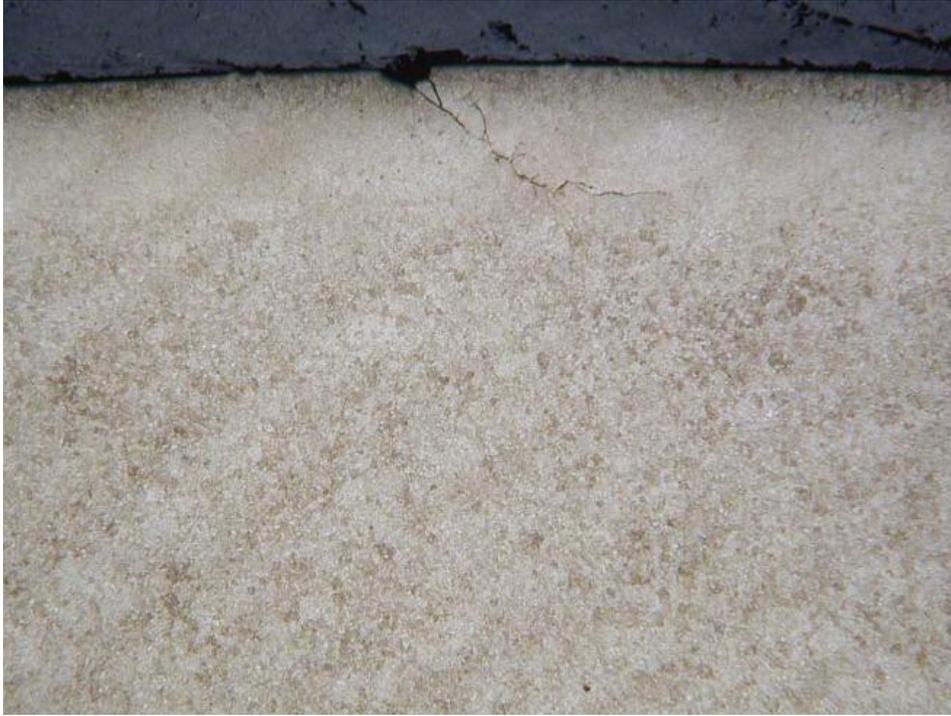
Figure 5.15: RCF-5-02, Microstructure. 2% Nital (50X)

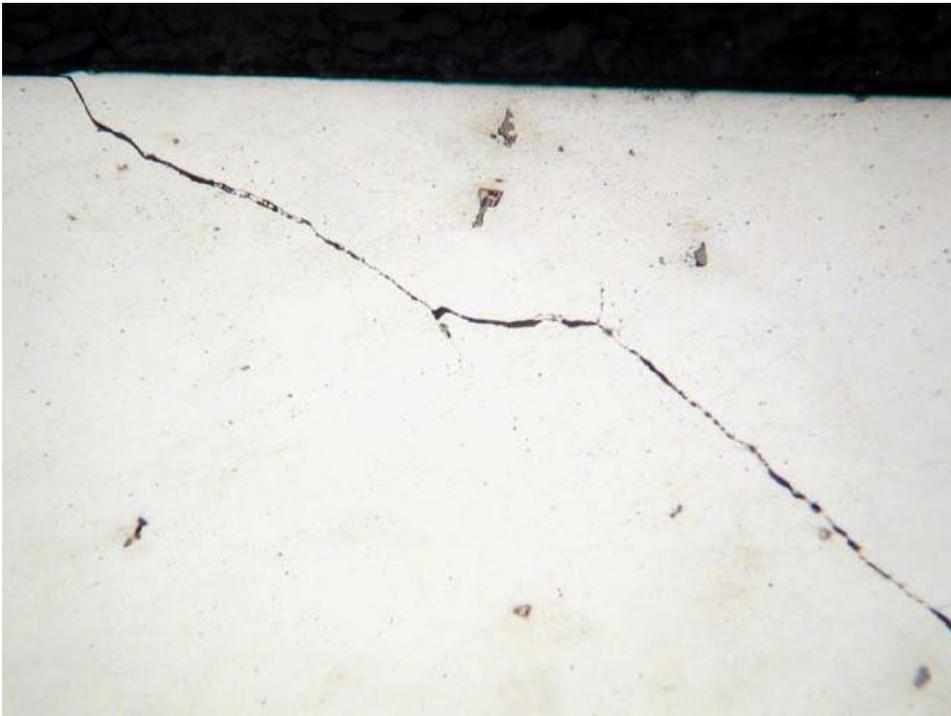
Figure 5.16: RCF-2-07, Crack location. Unetched (201X)

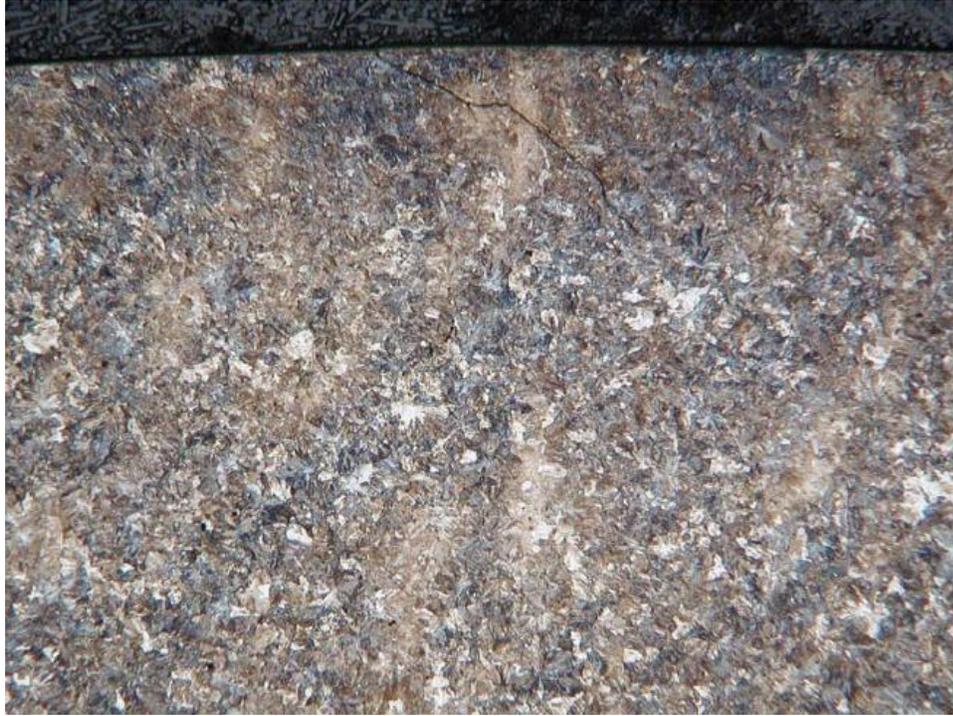
Figure 5.17: RCF-2-07, Microstructure. 2% Nital (50X)

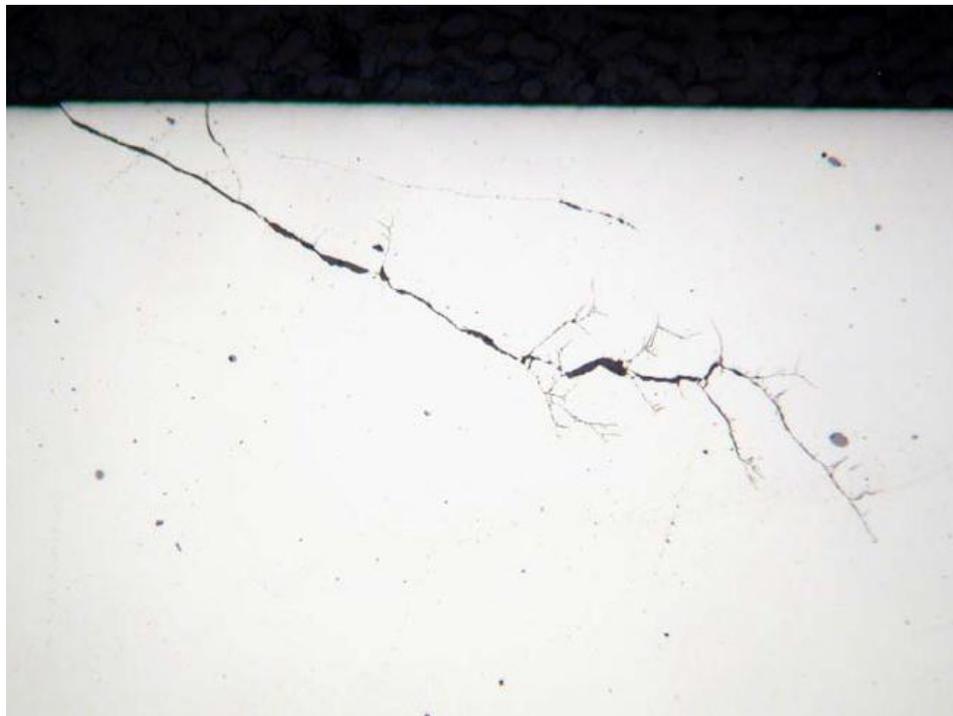
Figure 5.18: RCF-5-09, Crack Location Unetched (201X)

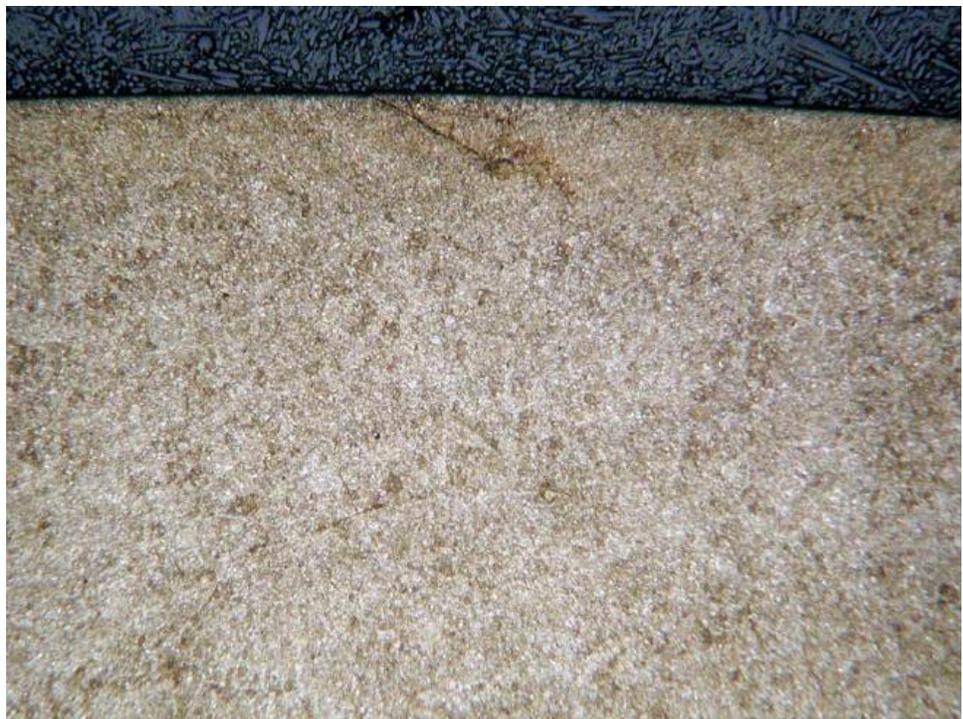
Figure 5.19: RCF-5-09, Microstructure. 2% Nital (50X)

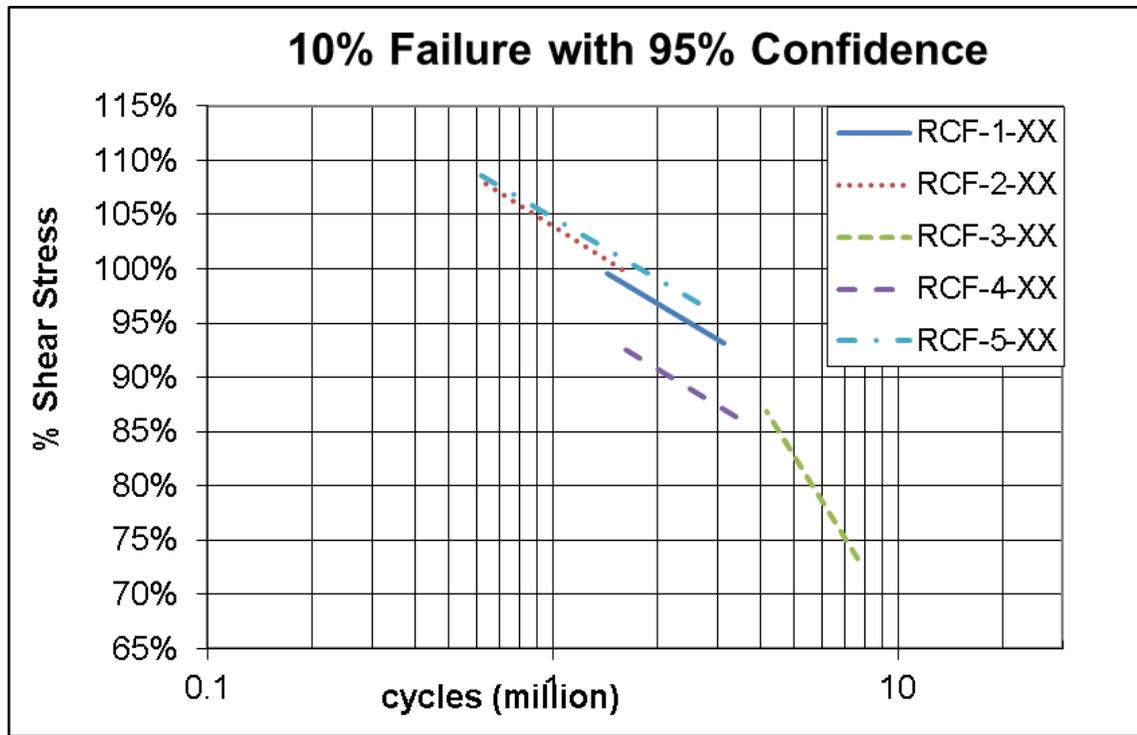
Figure 5.20: S-N Curve of 10% Failure with 95% Confidence

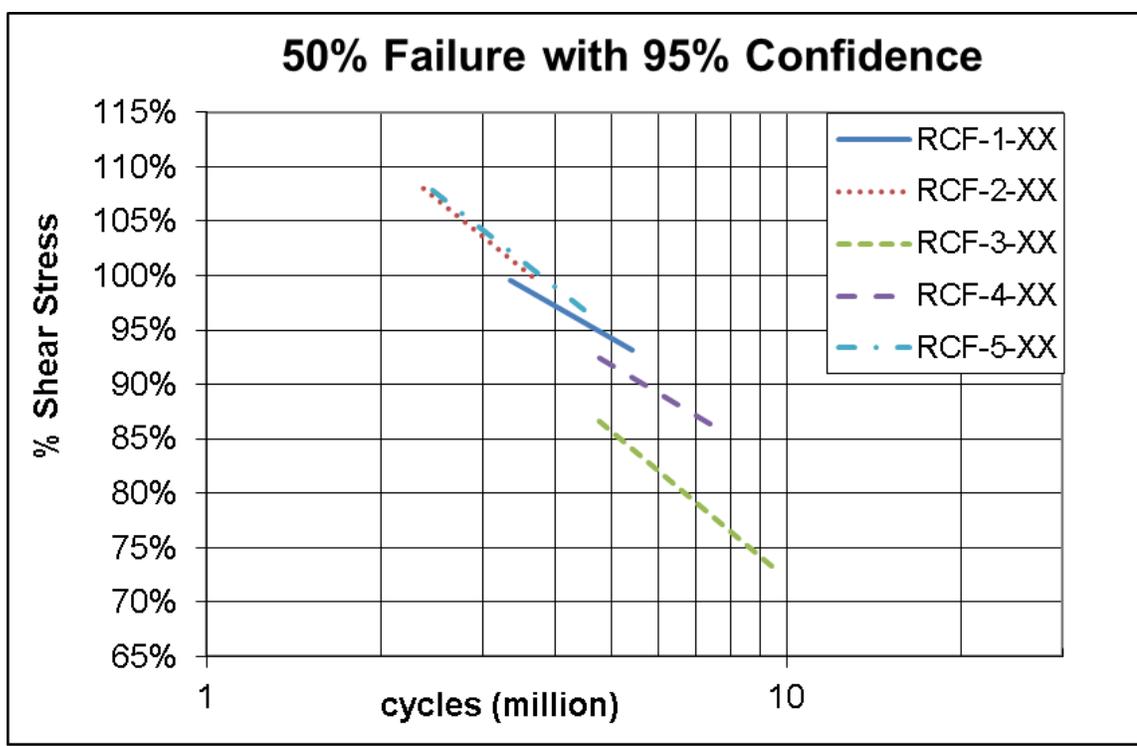
Figure 5.21: S-N Curve of 50% Failure with 95% Confidence

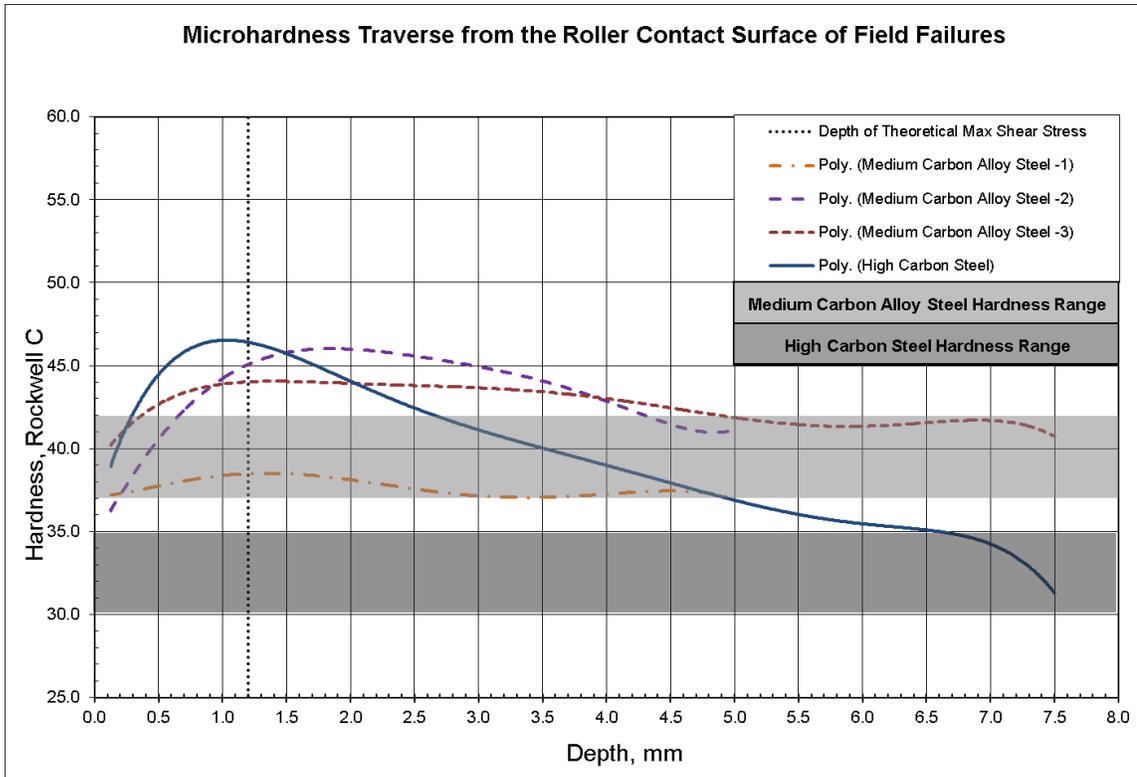
Figure 5.22: Subsurface hardness specific application material

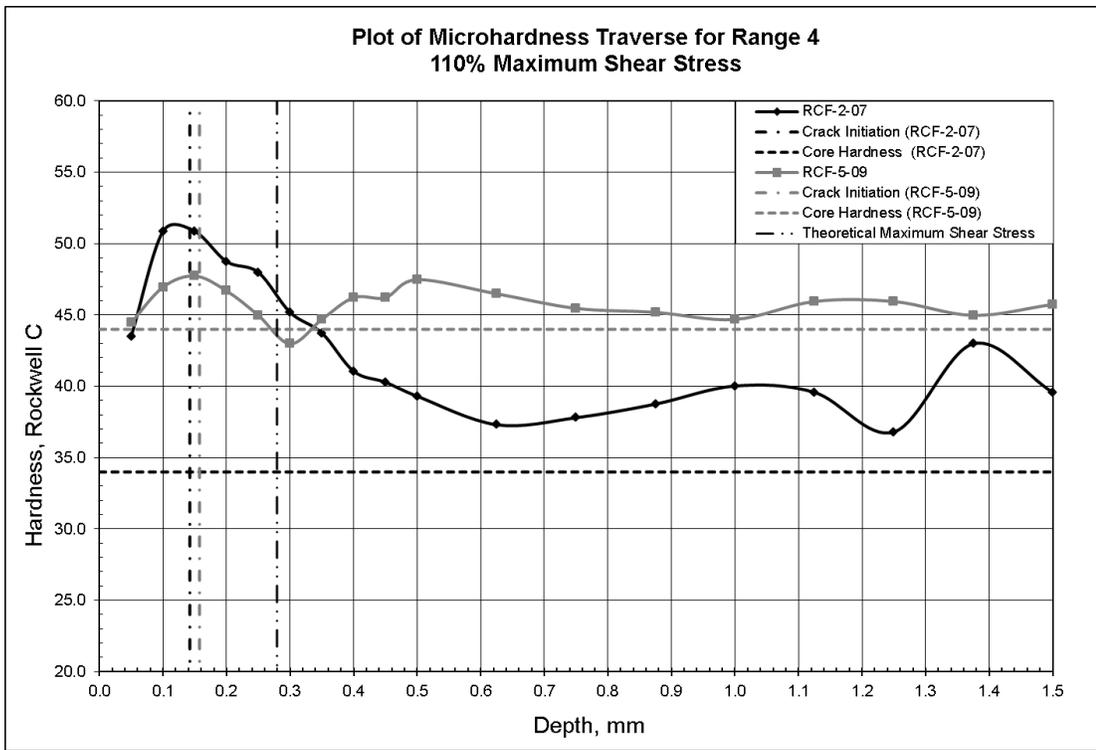
Figure 5.27: Range 4 shear stress level 110% micro hardness

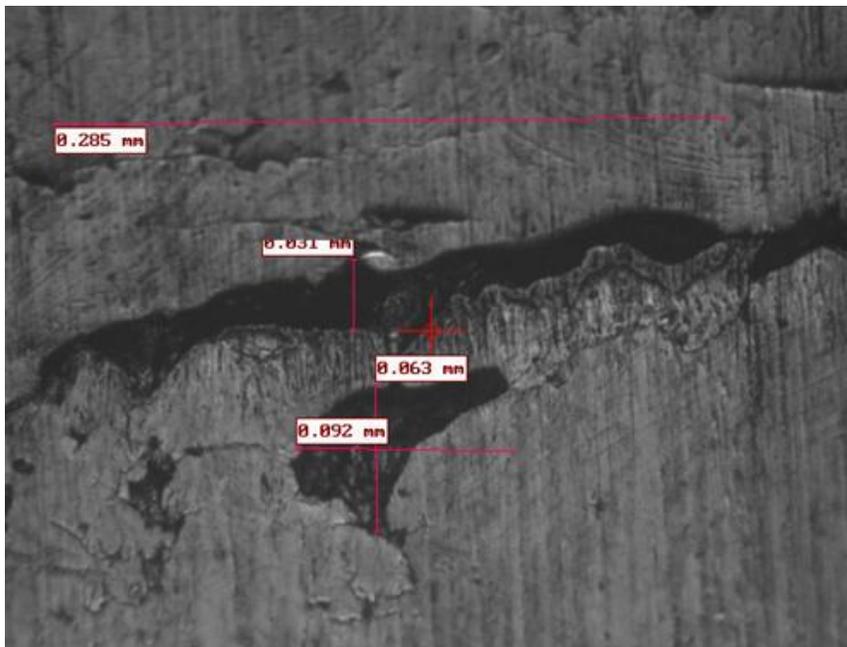
Figure 0.1: RCF-1-06, 30.8% Increased Contact Width, crack 2.1mm
