Rolling Contact Fatigue of Low Hardness Steel for Slewing Ring Application

A Thesis Submitted in
Partial Fulfillment of the
Requirements for Degree of

Master of Science

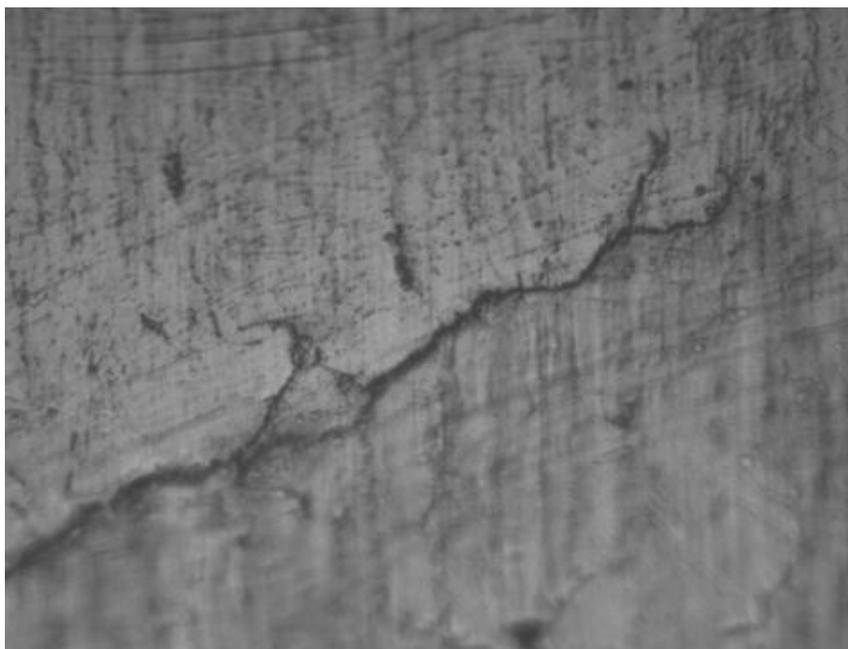
Figure 0.2: RCF-1-06, Crack Tip

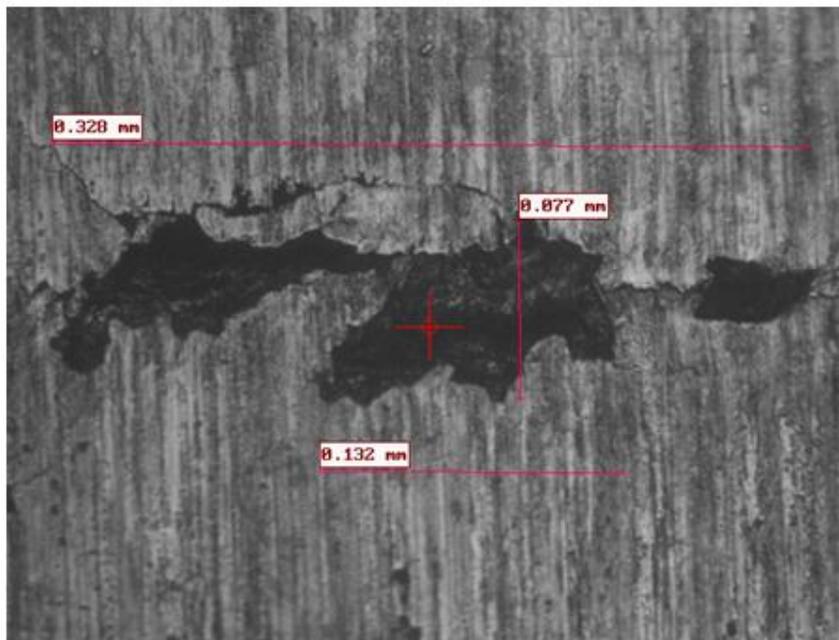
Figure 0.3: RCF-1-07, 30% Increased Contact Width, crack 1.24mm

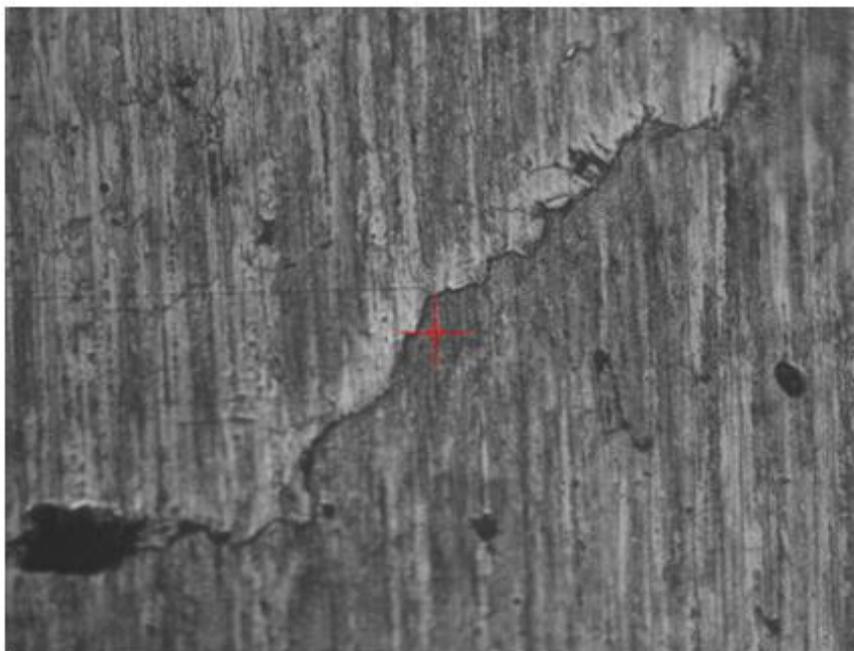
Figure 0.4: RCF-1-07, Crack Tip

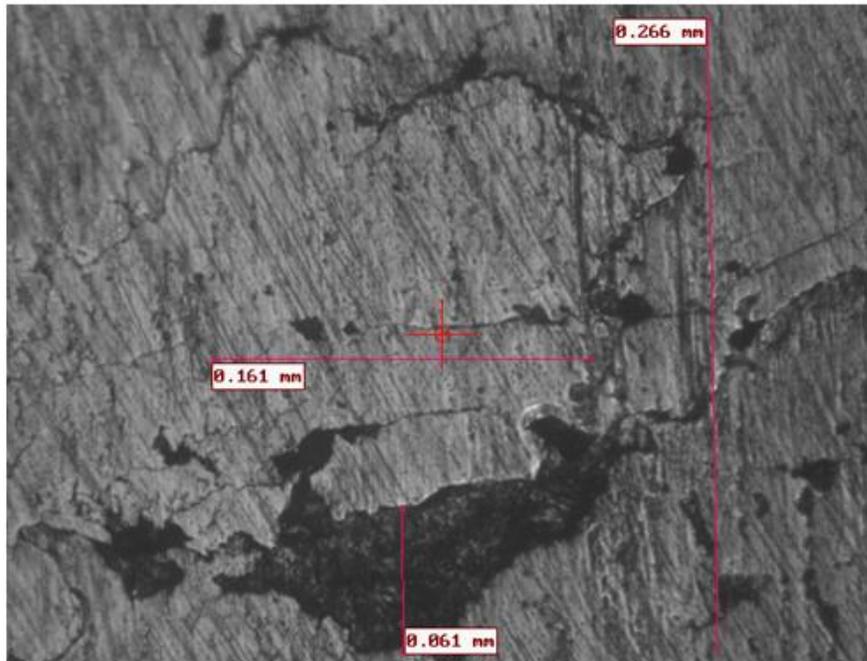
Figure 0.5: RCF-1-08, 24.3% Increased Contact Width, crack 1.7mm

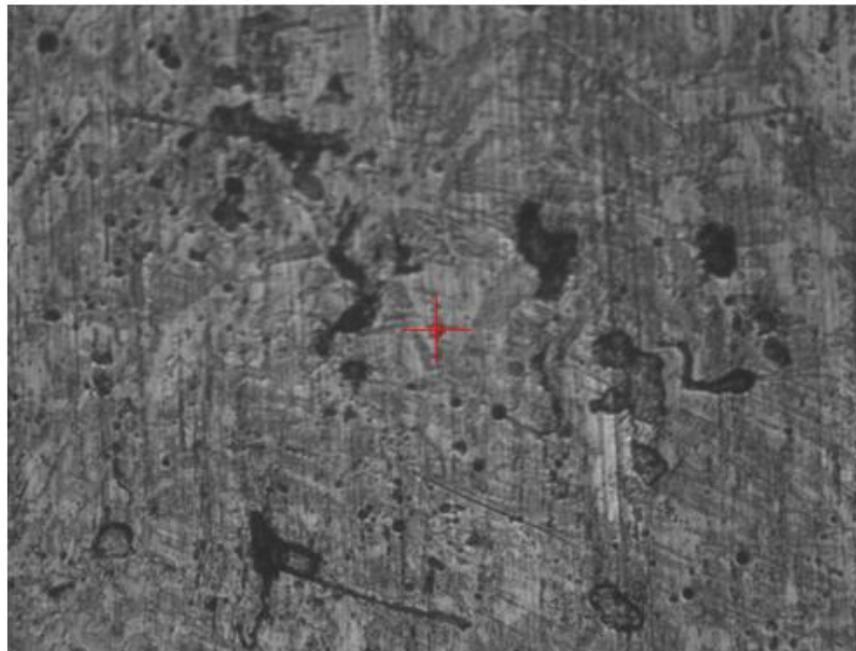
Figure 0.6: RCF-1-08, Surface Condition

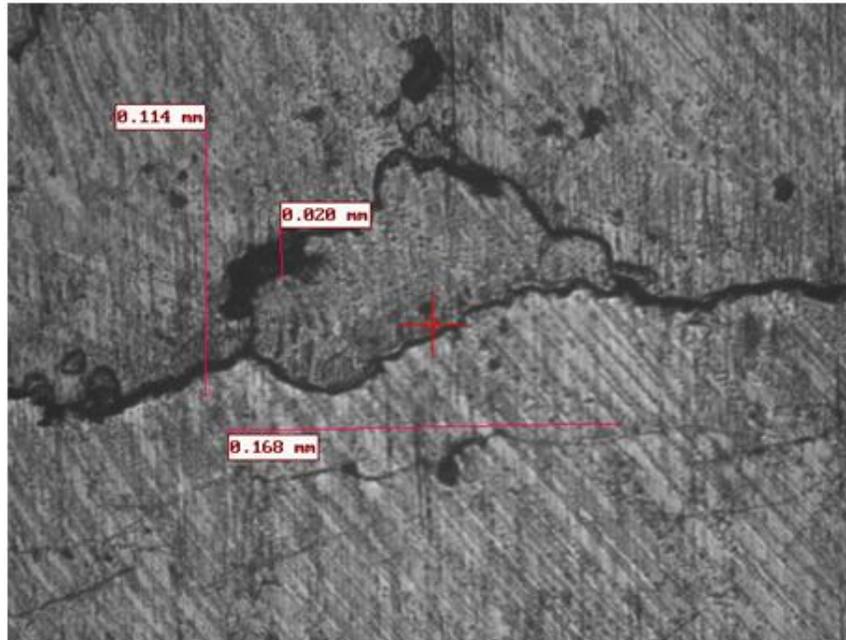
Figure 0.7: RCF-1-09, 27.5% Increased Contact Width, crack 2.4mm

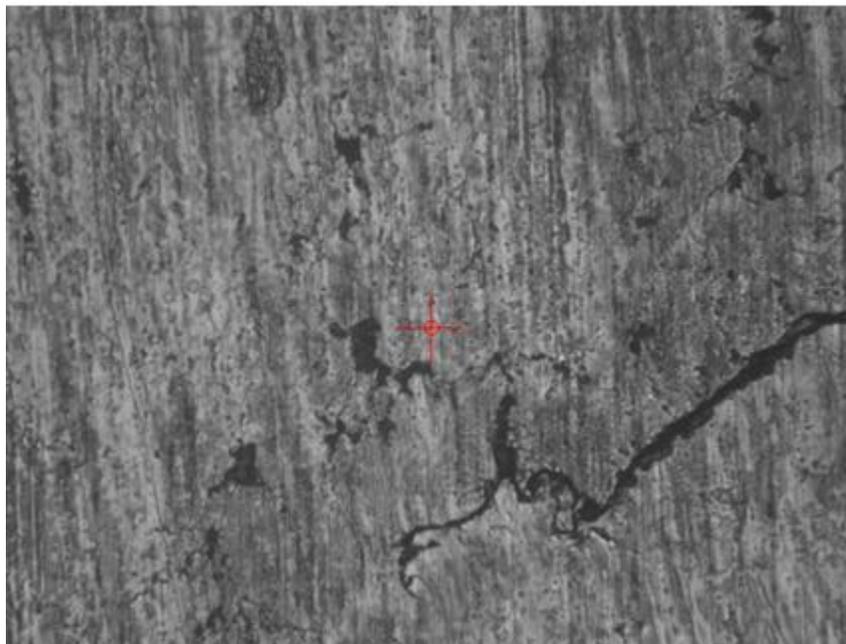
Figure 0.8: RCF-1-09, Crack Tip

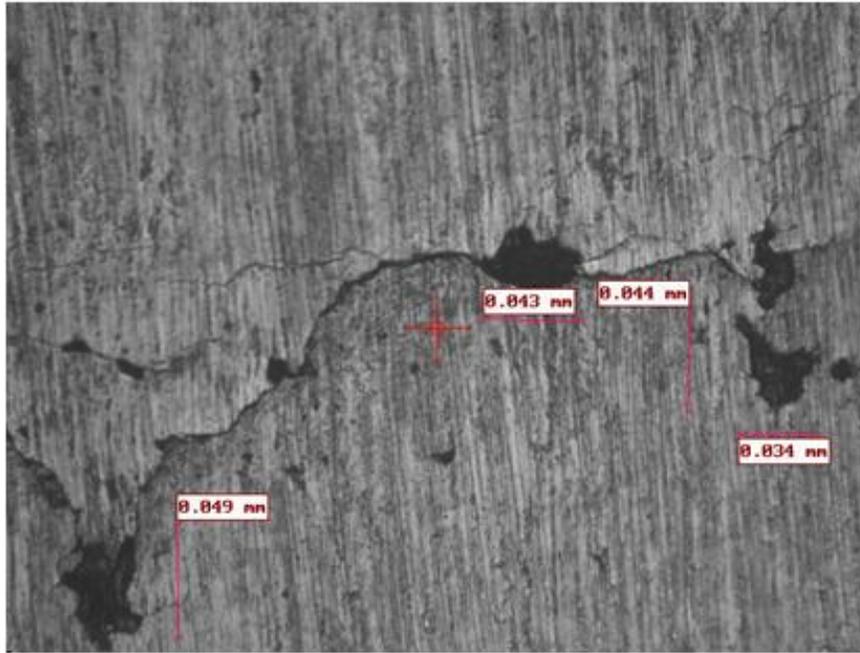
Figure 0.9: RCF-1-10, 28.8% Increased Contact Width, crack 1.3mm

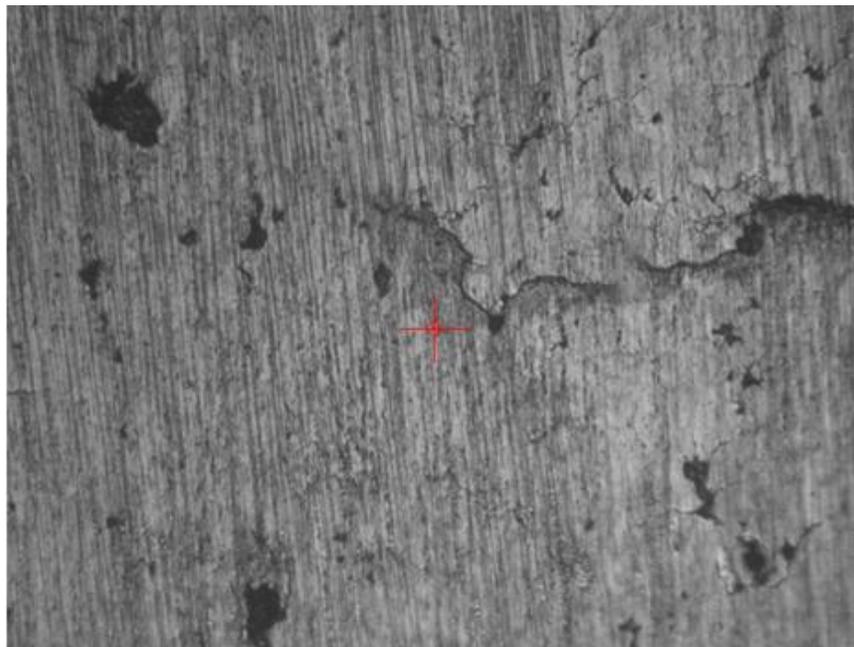
Figure 0.10: RCF-1-10, Crack Tip

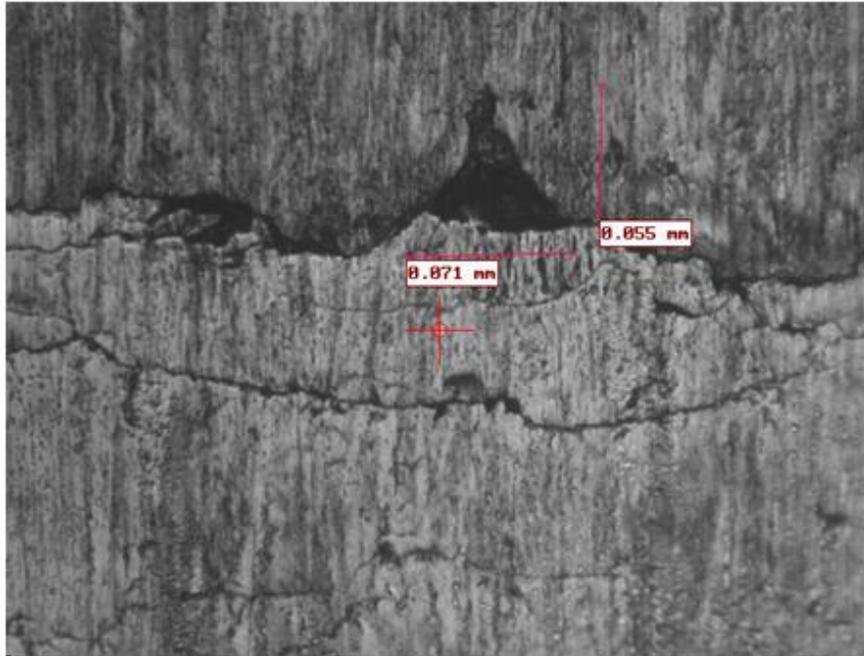
Figure 0.11: RCF-1-11, 33.7% Increased Contact Width, crack 1.64mm

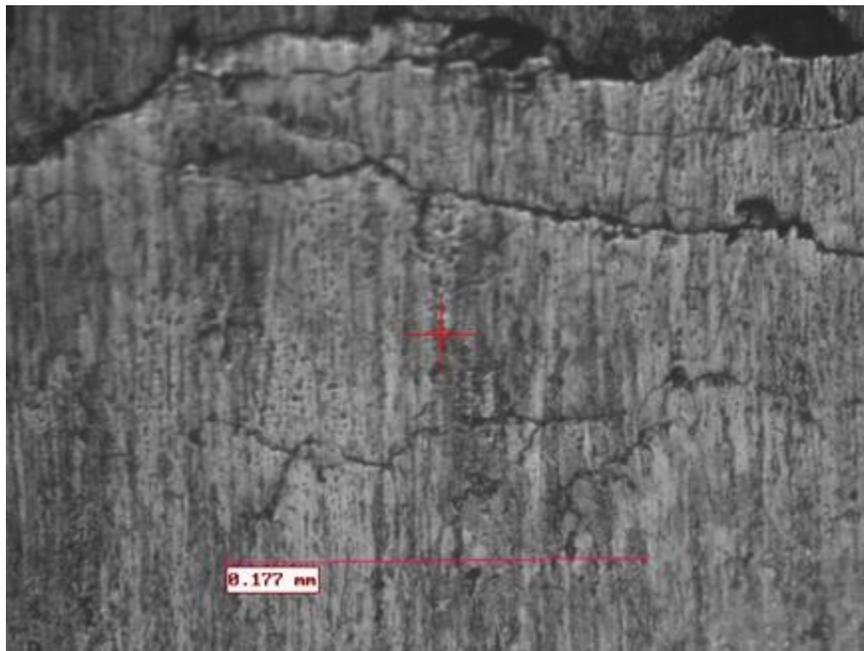
Figure 0.12: RCF-1-11, Crack Tip

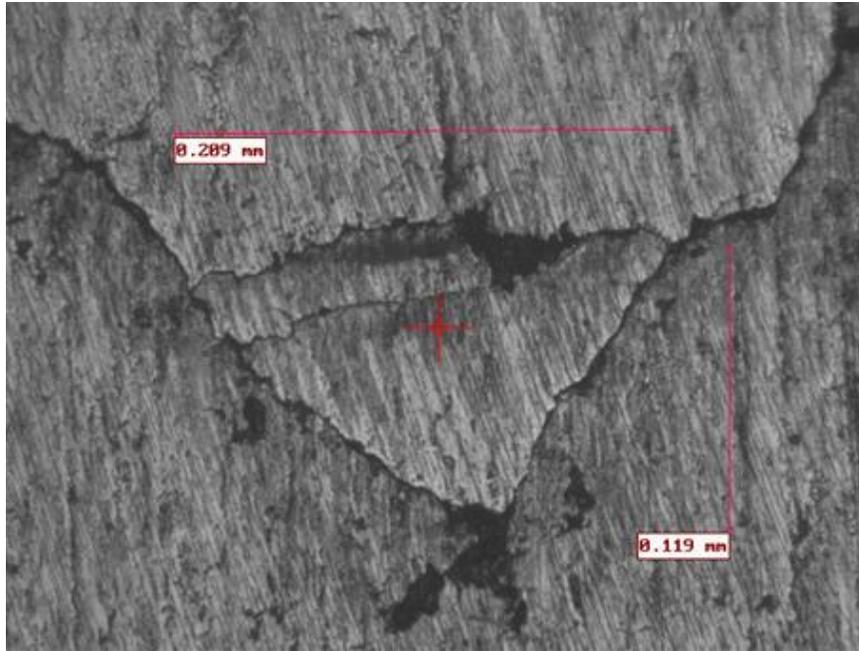
Figure 0.13: RCF-1-12, 40.0% Increased Contact Width, crack 1.5mm

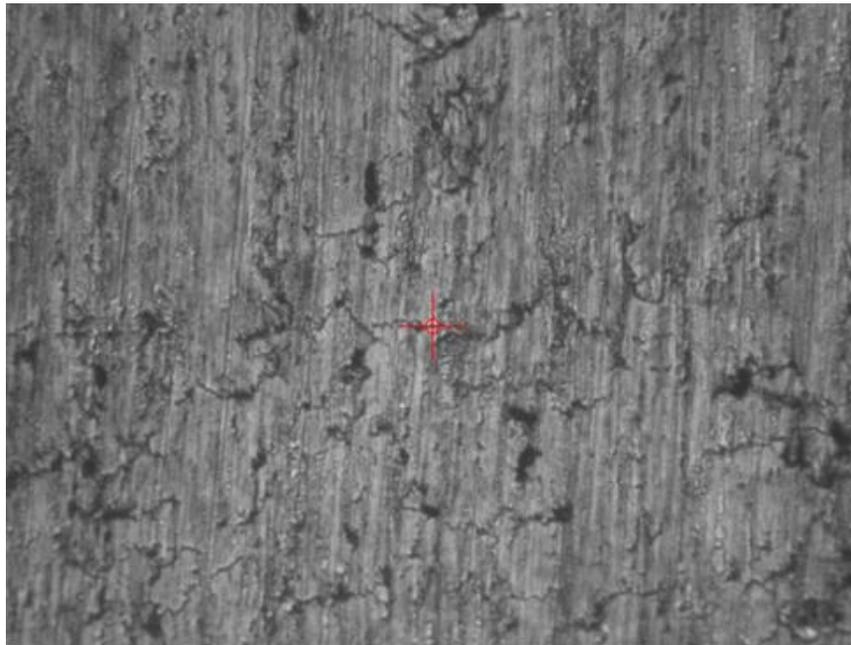
Figure 0.141: RCF-1-12, Surface Condition

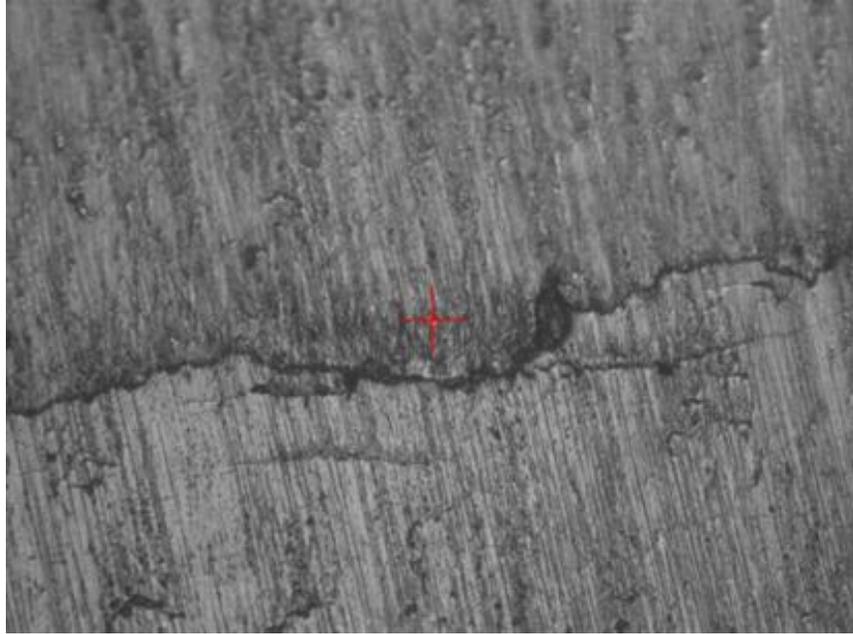
Figure 0.15: RCF-1-13, 42.0% Increased Contact Width, crack 1.7mm

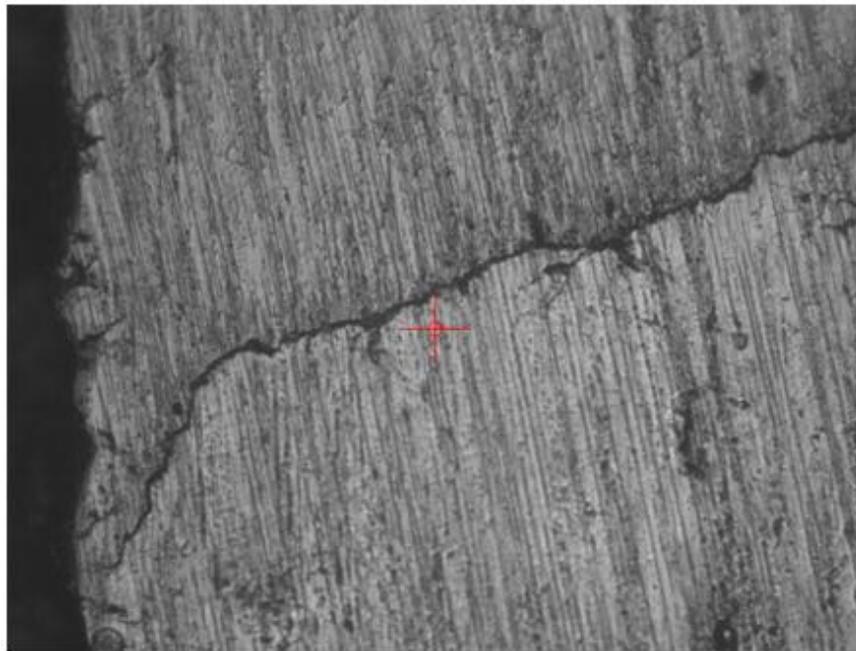
Figure 0.16: RCF-1-13, Crack Tip at Edge of Rolling Surface

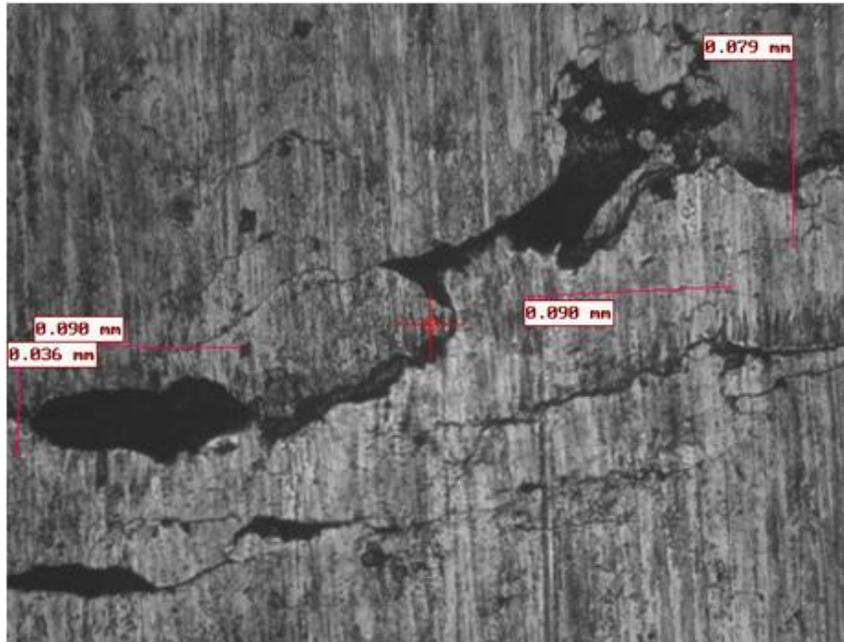
Figure 0.17: RCF-1-14, 37.8% Increased Contact Width, crack 3mm

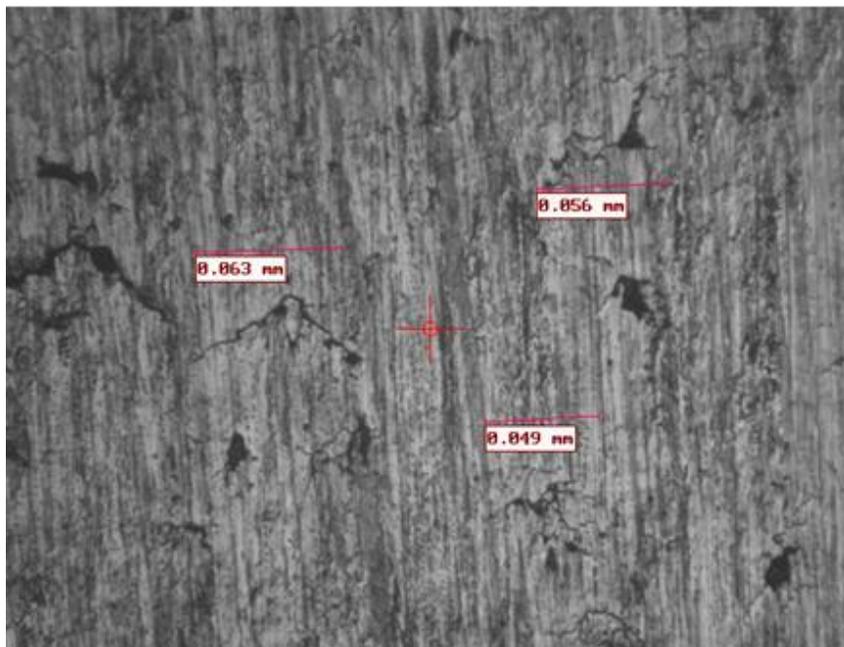
Figure 0.18: RCF-1-14, Surface Condition

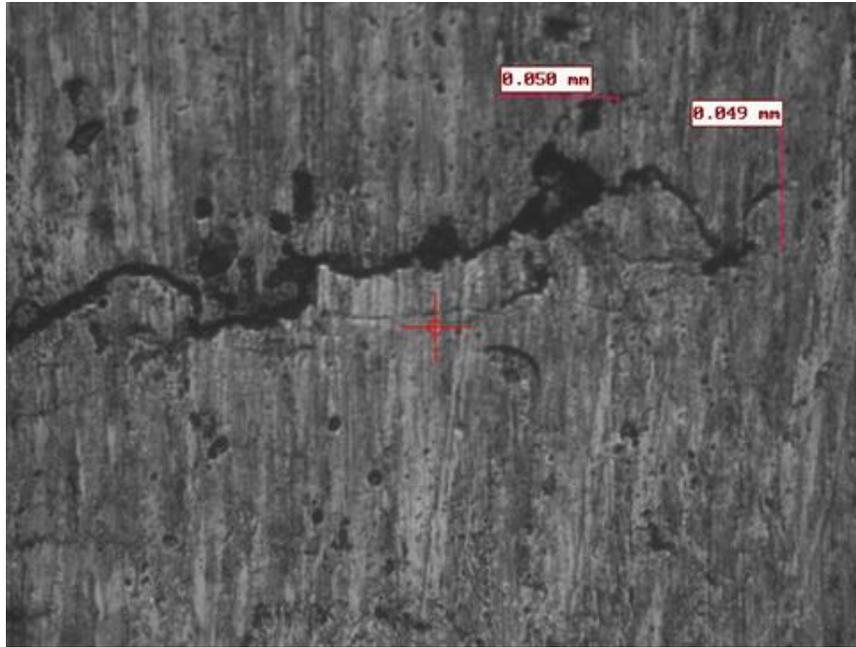
Figure 0.19: RCF-1-15, 38.5% Increased Contact Width, crack 1.3mm

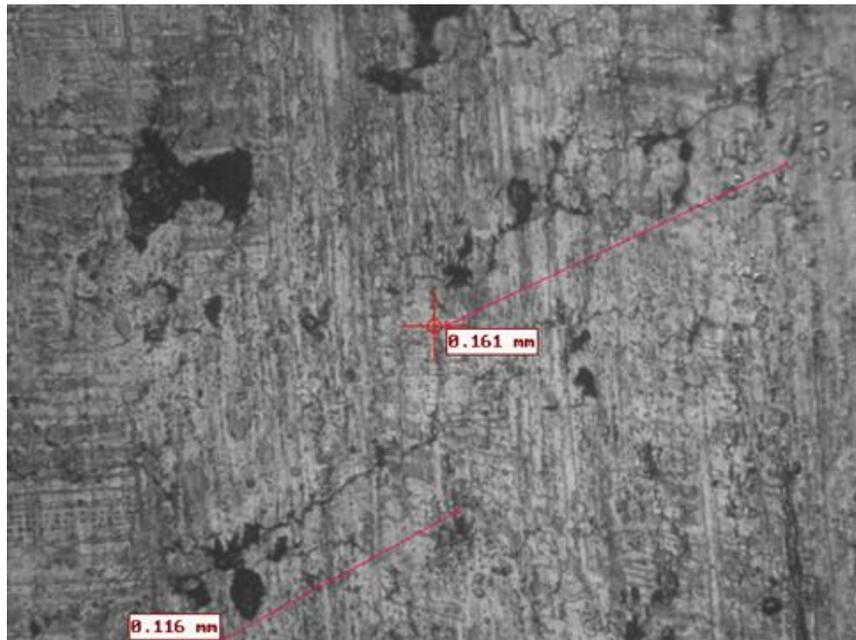
Figure 0.20: RCF-1-15, Surface Condition

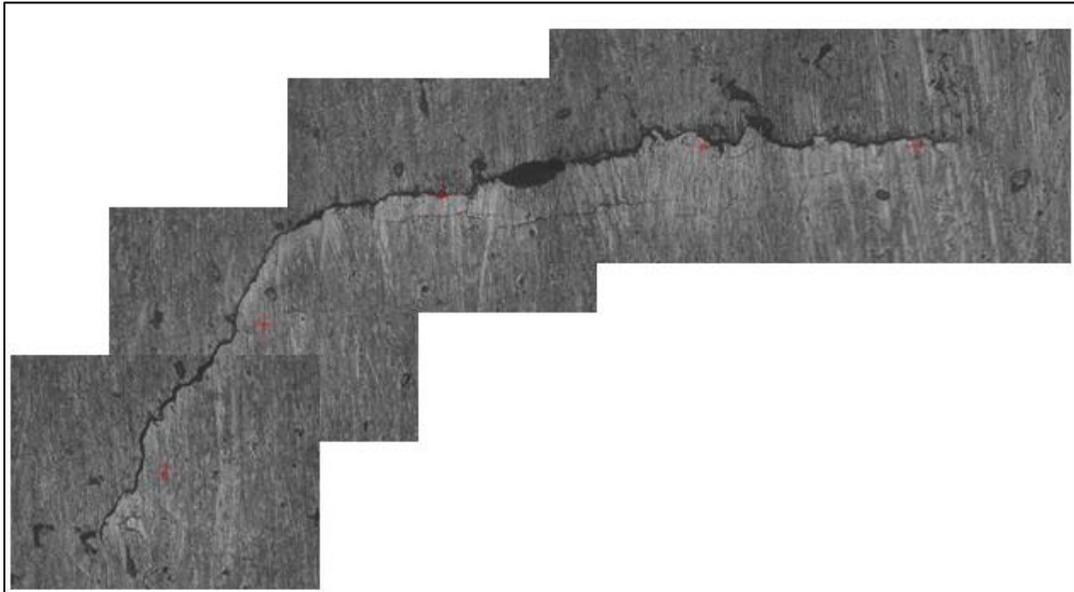
Figure 0.2: RCF-2-02, 9.8% Increased Contact Width, crack 2.15mm

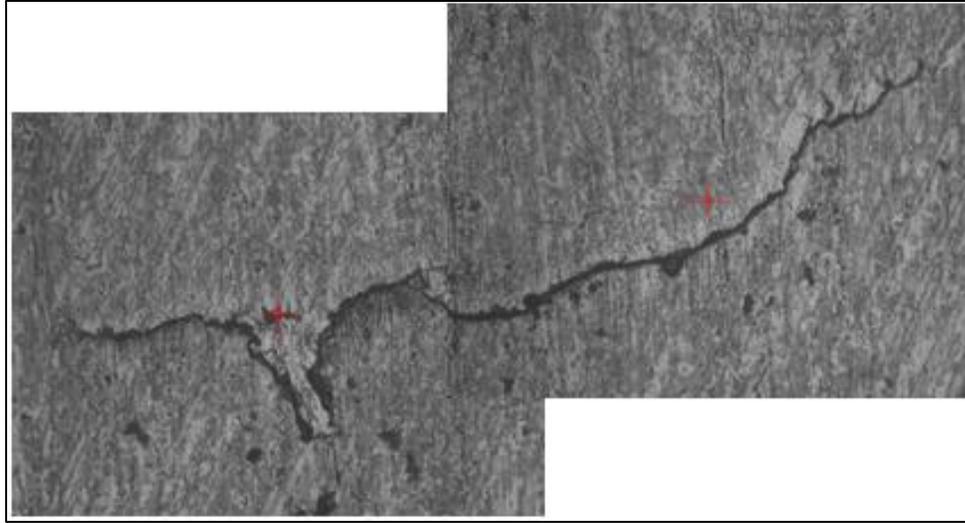
Figure 0.3: RCF-2-03, 11.8% Increased Contact Width, crack 1.2mm

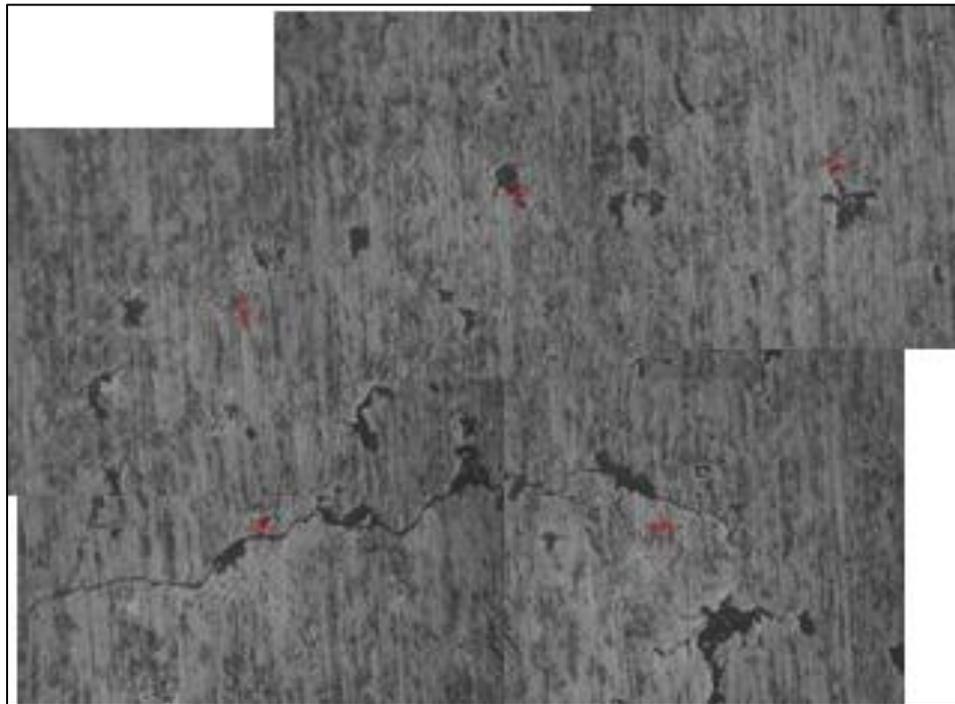
Figure 0.4: RCF-2-04, 11.8% Increased Contact Width, crack unknown

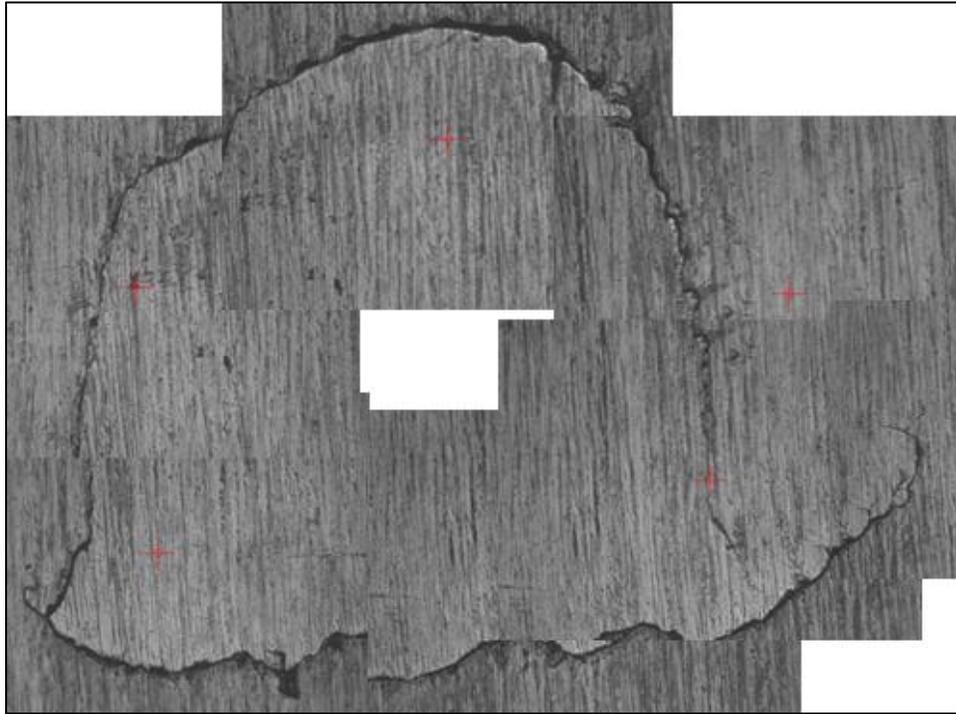
Figure 0.1: RCF-3-04, 9.4% Increased Contact Width, crack 1.9mm

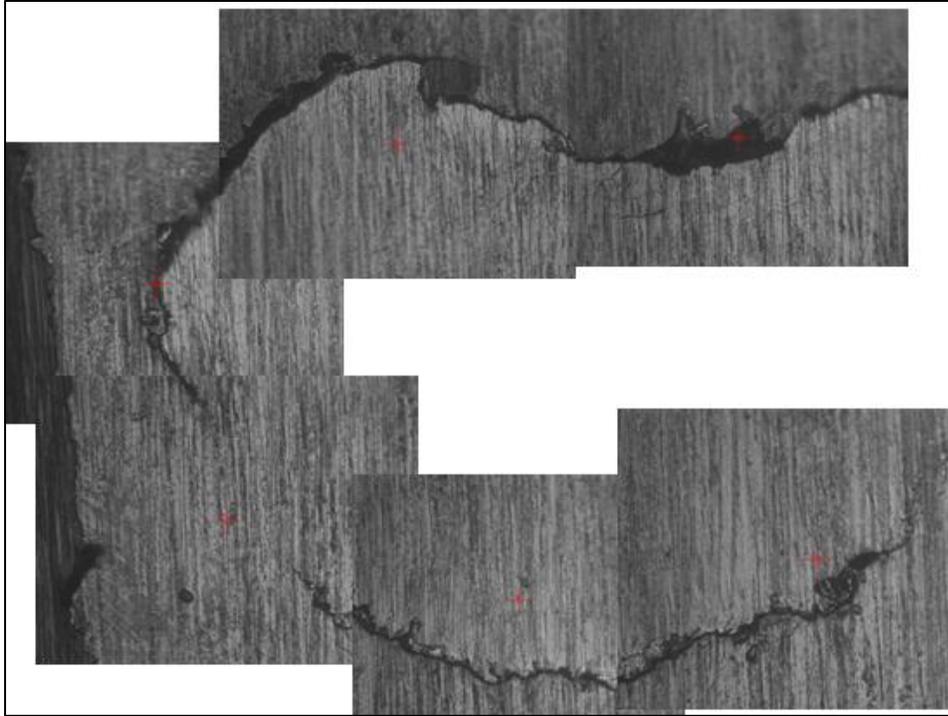
Figure 0.3: RCF-3-06, 7.3% Increased Contact Width, crack 1mm

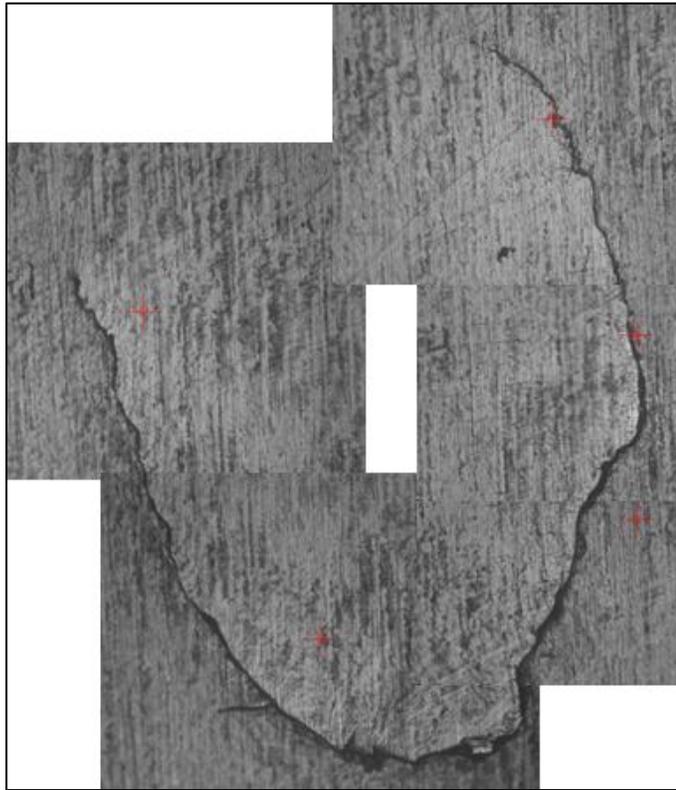
Figure 0.4: RCF-4-06, 12.2% Increased Contact Width, crack 0.9x1.2mm

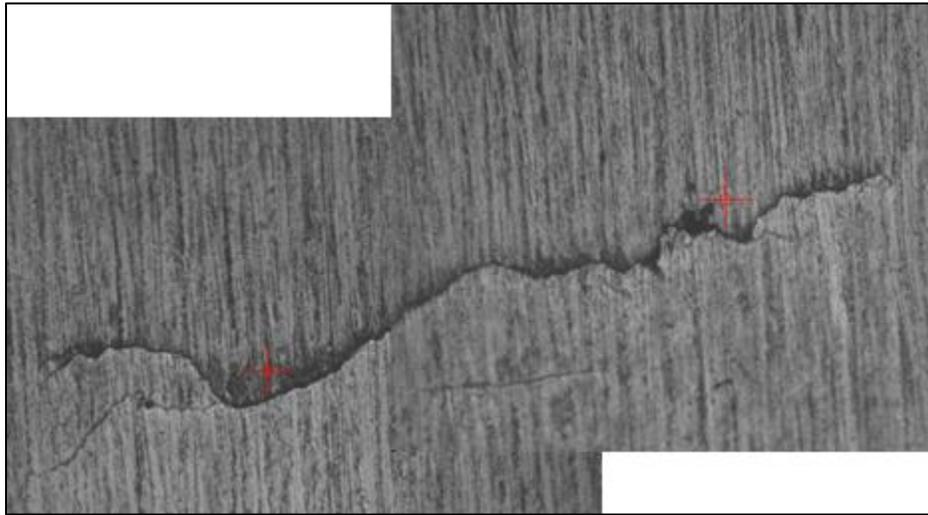
Figure 0.6: RCF-4-08, 7.8% Increased Contact Width, crack 1mm

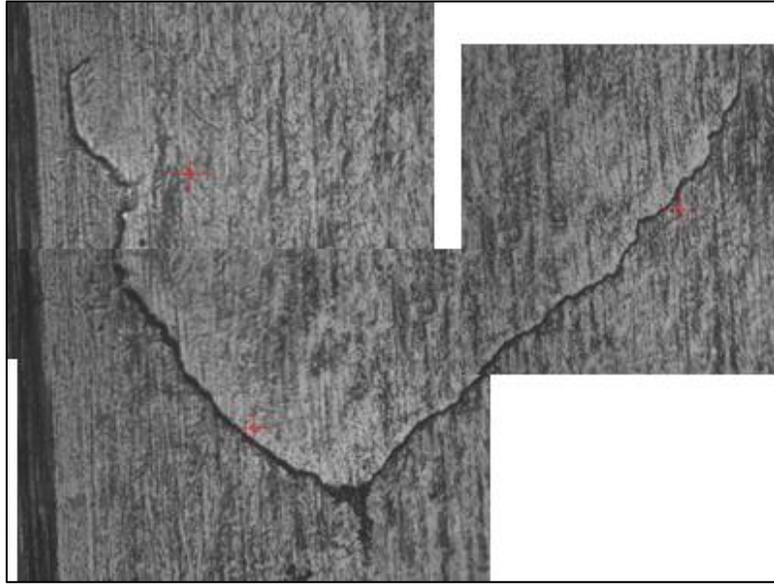
Figure 0.9: RCF-4-14, 14.9% Increased Contact Width, crack 1x0.6mm

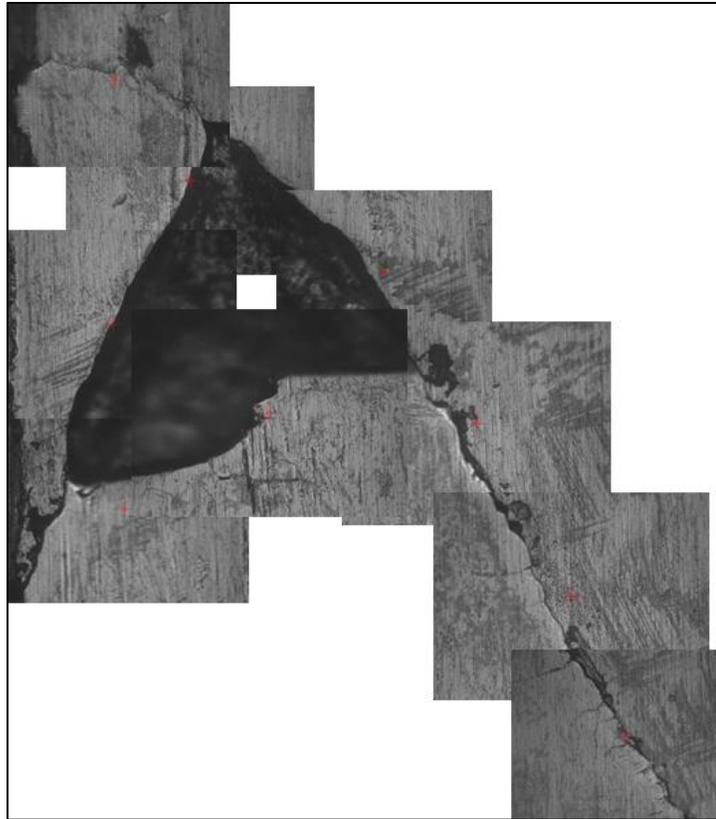
Figure 0.11: RCF-4-16, 7.8% Increased Contact Width

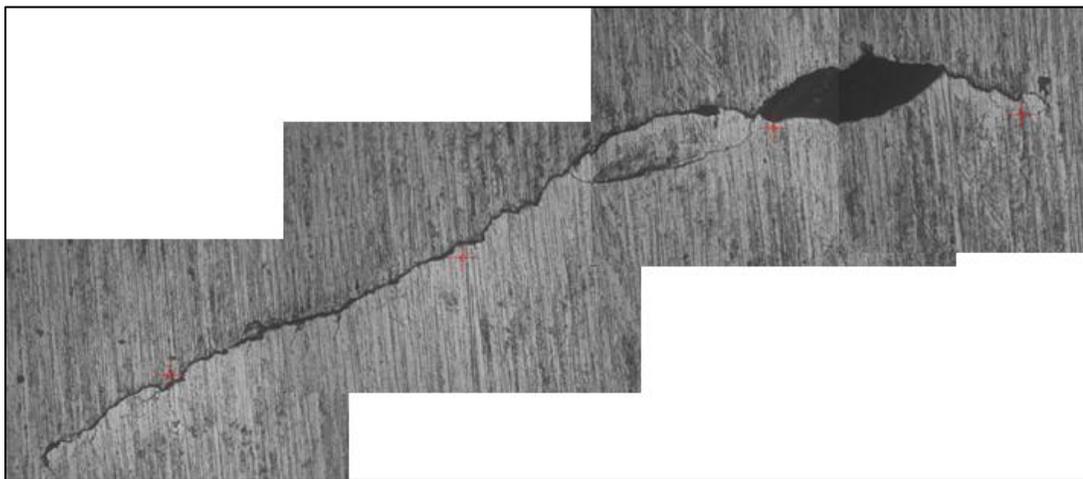
Figure 0.12: RCF-4-18, 12.5% Increased Contact Width, crack 2.1mm

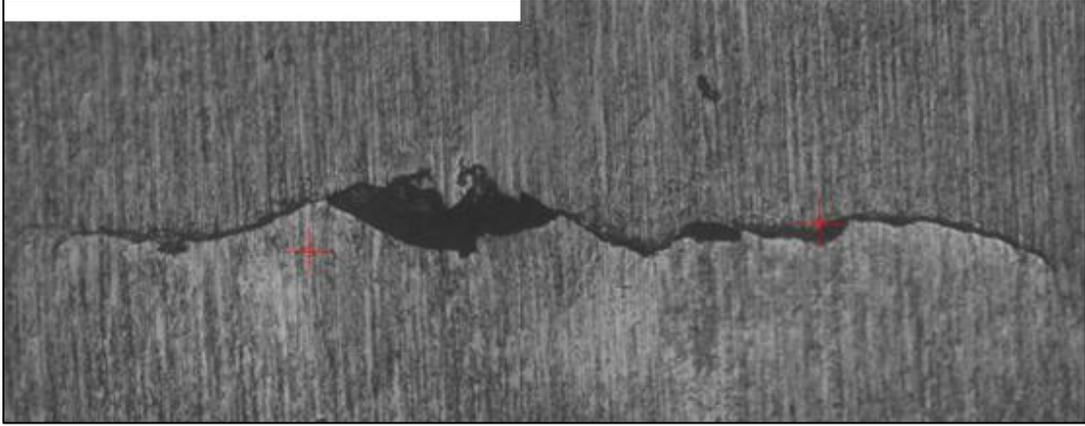
Figure 0.13: RCF-4-19, 10.2% Increased Contact Width, crack 1.2mm

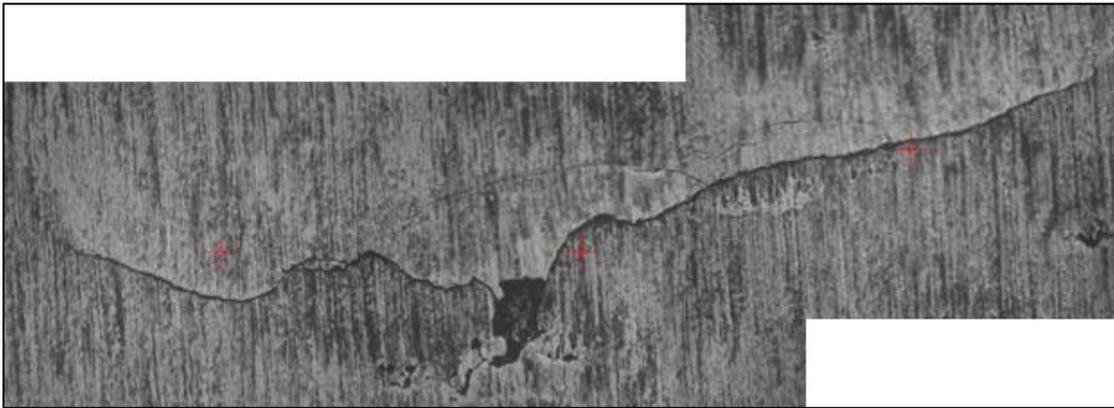
Figure 0.14: RCF-4-21, 13.9% Increased Contact Width, crack 1.7mm

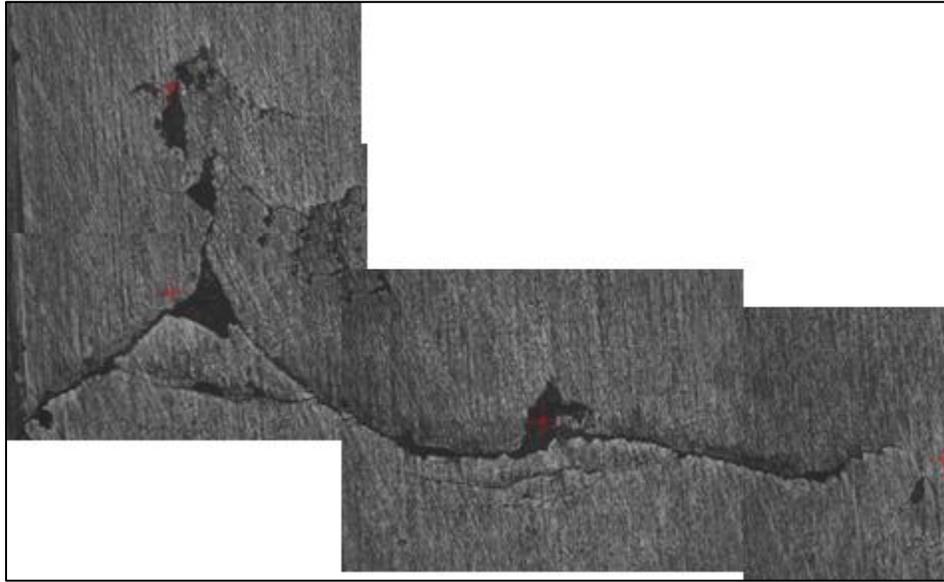
Figure 0.1: RCF-5-01, 17.6% Increased Contact Width, crack 1.5mm

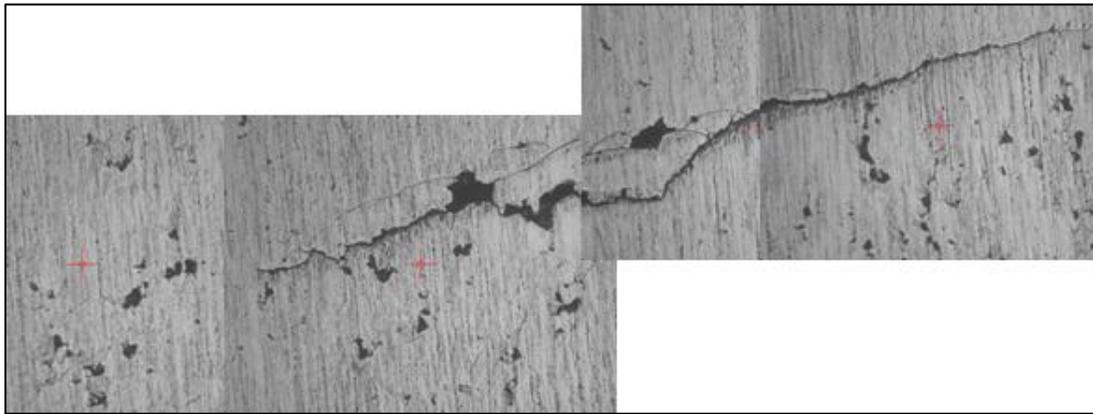
Figure 0.2: RCF-5-02, 5.1% Increased Contact Width

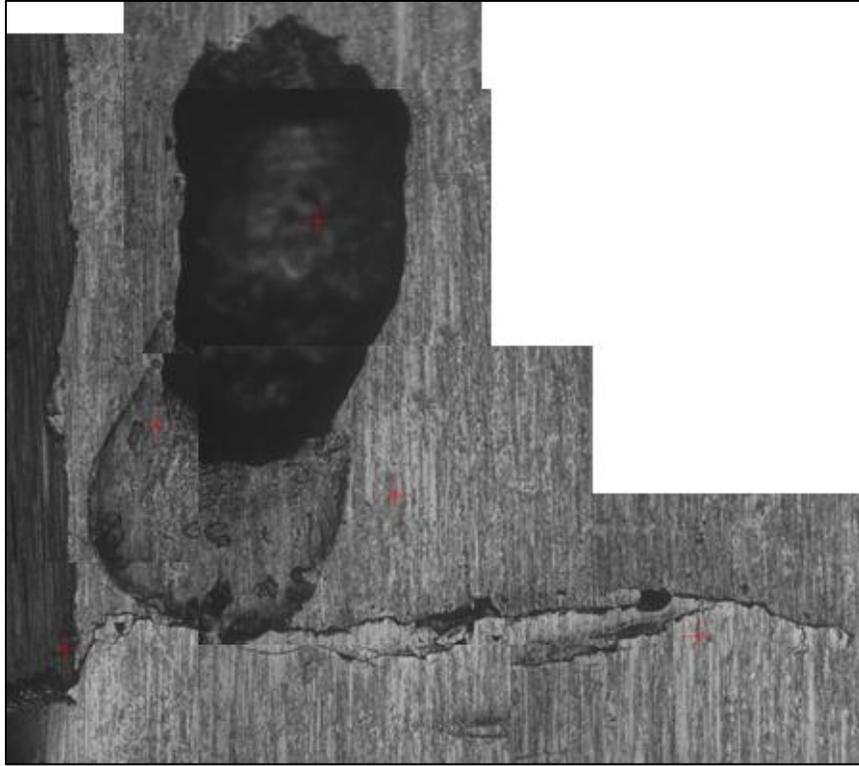
Figure 0.3: RCF-5-04, 4.9% Increased Contact Width, Crack 1.6mm

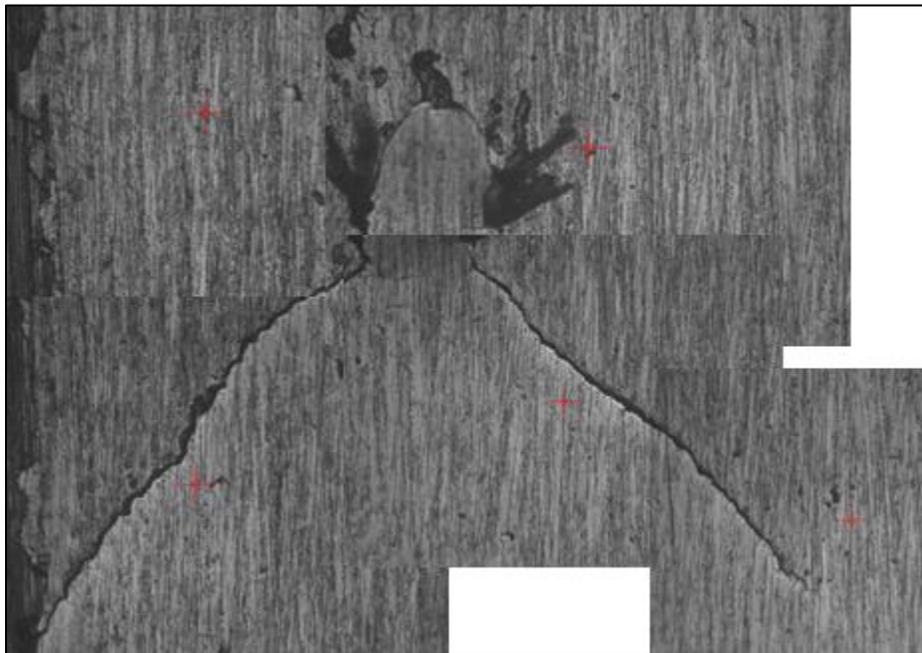
Figure 0.4: RCF-5-05, 3.5% Increased Contact Width, Crack 1.2mm

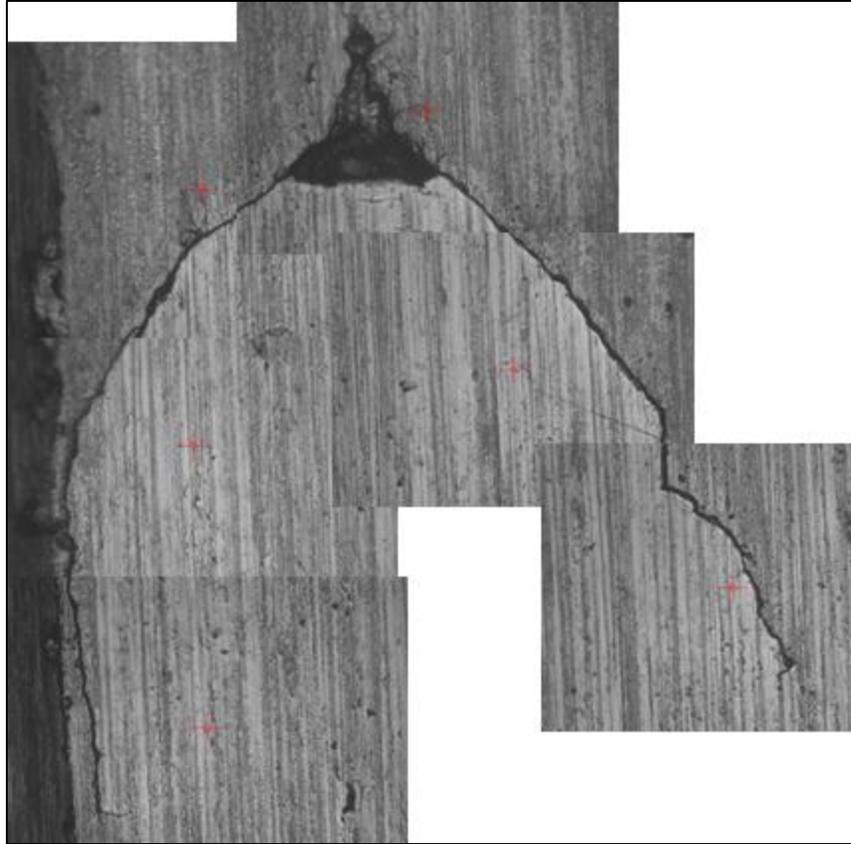
Figure 0.9: RCF-5-11, 4.1% Increased Contact Width

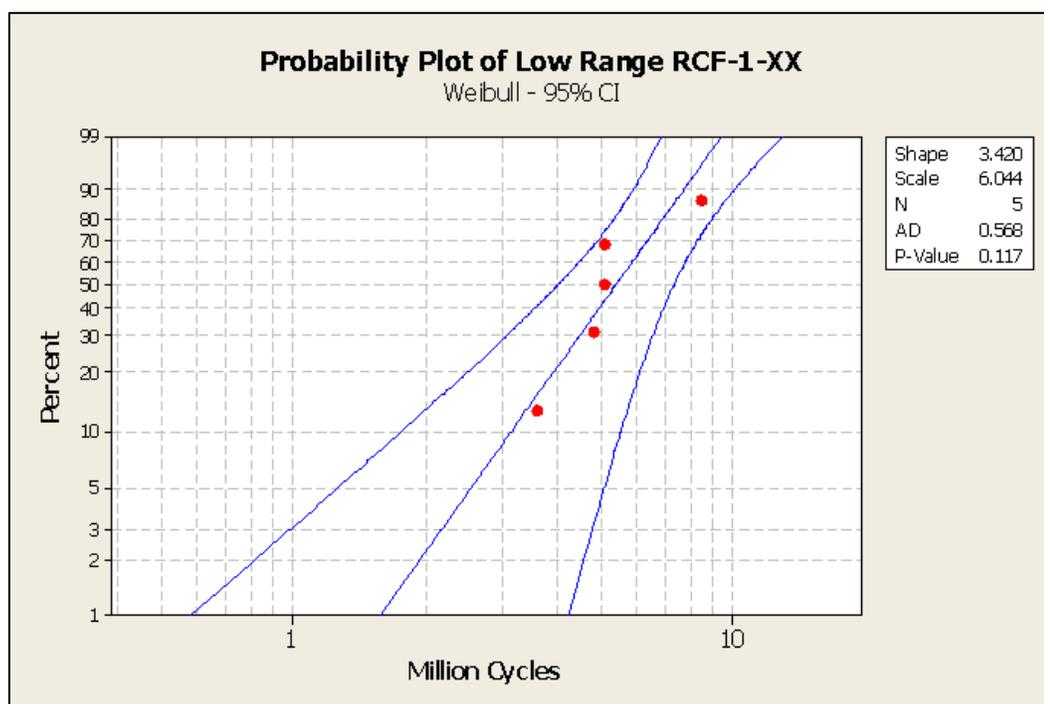
Figure 0.1: RCF-1-XX, Low Range, Weibull Plot
