Residual Tensile Strength and Bond Properties of GFRP Bars after Exposure to Elevated Temperatures

Article

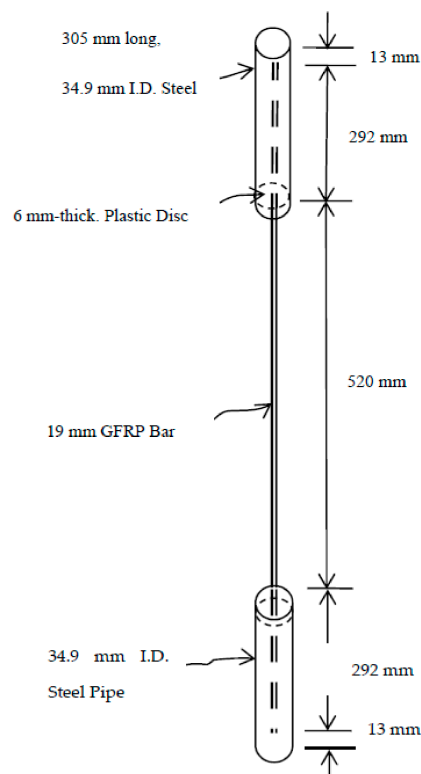
Figure 1. Tensile Test Specimen.

The tensile testing procedures were based on ASTM D7205 [31] and Castro and Carino [32] test procedures. Each specimen consisted of a 19-mm-diameter GFRP reinforcing bar with both ends embedded to a depth of 286 mm in a 305-mm-long, 38-mm-diameter (1½-inch) steel tube filled with a high-strength mixture of expansive cement, sand, and water. The choice of specimen length was to ensure that the rupture of the specimen occurred within the free length of the bar while considering the constraints of the testing equipment. Figures 1 and 2 show details of the tension test specimens.

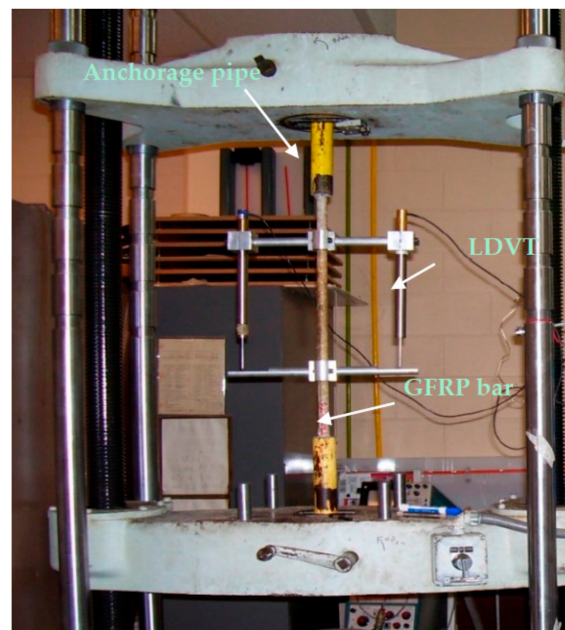
Figure 2. Tensile Test set up.

To determine the tensile strength of the GFRP reinforcing bar at ambient temperature, one set of tensile test specimens (T-A) was placed in a universal testing machine at ambient temperature and loaded incrementally until the specimen ruptured. The universal tension-compression test machine was a screw-driven Tinius Olsen machine. To determine the stress-strain behavior of the bar material,

two linear variable differential transformers (LVDT) were attached to the bar such as to measure the extension of the bar within the middle third of its free length, and the center-to-center distance between attaching arms (gage length) was recorded. The specimen was then loaded at a rate of about 8.9 kN/min until the bar ruptured. To prevent damage to the LVDTs, the devices were removed prior to the rupture of the rebar so the strain at rupture of the rebar in the specimens was not measured, and only partial displacement data were obtained for the tension specimens.

A heating tape was wrapped around the free length of the other TS specimens after placement of the bar in the test machine. Two thermocouples were attached to the bar surface under the heating tape. The free length of the bar was further wrapped with a ceramic insulation material. The specimen was loaded to 80.0 kN or 42% of the average rupture load obtained from the tests performed at ambient temperature. This load level was meant to represent the applied service load at the time of fire. The target service load was applied and held constant before heating the specimen to the desired temperature (within its free length). The heat was supplied to the specimens using custom-built equipment that consisted of a temperature controller and heating tapes capable of supplying a heat flux of 20.16 kW/m² and a maximum temperature of 760 °C. The temperature at the surface of the reinforcing bar was measured at 5-min intervals during the heating. After the attainment of the desired temperature, the heat was turned off and the specimen was unloaded and removed from the tensile testing machine and allowed to cool down to ambient temperature in the laboratory for at least 24 h. Then, the specimens were placed back into the testing machine, the LVDT's were attached, and the specimens were loaded until the bar ruptured.

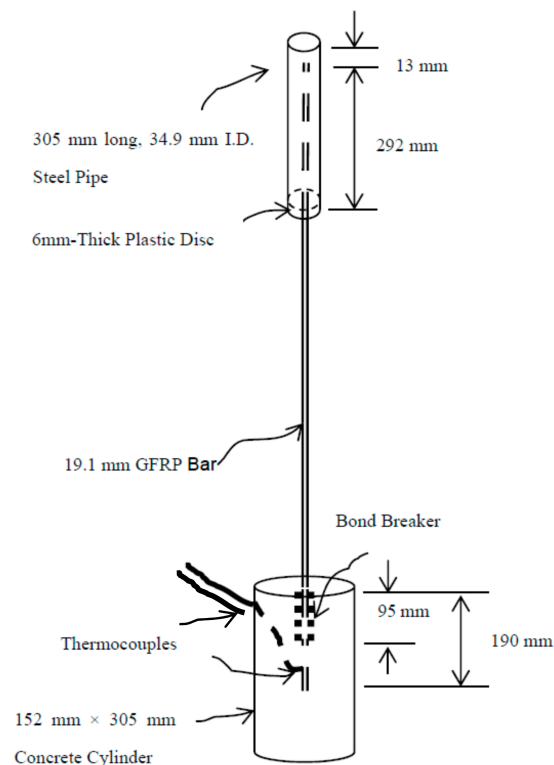
Figure 3. Bond Test Specimen.

Details of the bond test specimens were based on the ASTM D7913 [33] and similar setups used in earlier experiments by others [1,6,7,18], which is in accordance with test procedure. The specimen consisted of a 19-mm GFRP bar with one end embedded to a depth of 95-mm—or five times the bar diameter—at the center of a 152-mm diameter by 305-mm high concrete cylinder. Consistent with earlier experiments [1,7], the actual embedded length of 95-mm started beyond a 95-mm bond breaker created by wrapping the FRP bar with electrical tape (Figure 3). This was to minimize the effect of confining stresses due to the test setup. The opposite end of the bar was identical to the ends used on the tensile test specimen (Figure 3).

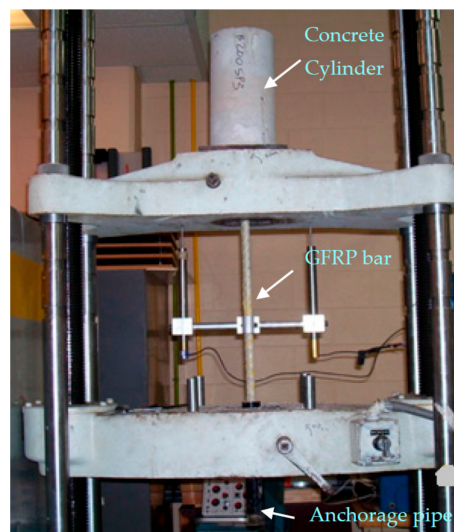
Figure 4. Bond Test set up.

To perform the bond tests, the specimens were placed in the universal testing machine with the concrete cylinder bearing on the top cross-head of the machine and the gripping end of the specimen in the grips in the lower cross-head (Figure 4). LVDTs were attached to the reinforcing bar with purpose-built brackets. The “B-A” specimens were loaded incrementally at ambient temperature until bar pull-out or any other form of specimen failure occurred. Failure was deemed to have occurred when the load reading from the tensile testing machine started to drop. During the loading process, the corresponding slip was measured by LVDTs. The bond force-slip relationship and the force at pull-out were recorded, and the bond strength at ambient temperature was determined.

After cooling naturally in the laboratory for at least 24 h, the specimens were placed in the tensile testing equipment as shown in Figure 4. Loading was then applied until bar pull-out occurred. The force-slip relationship and the force at pull-out were recorded.

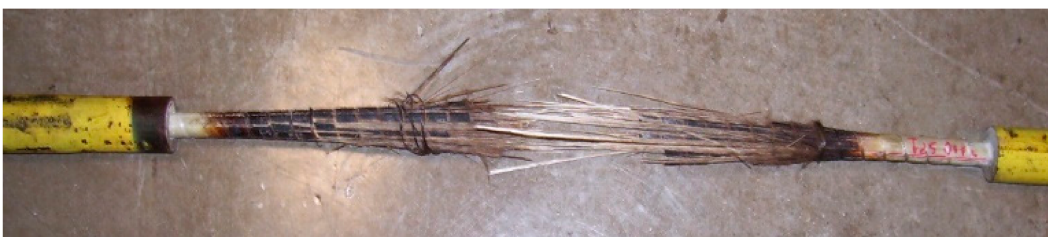
Figure 5. Tensile test specimens after failure: (a) T-A, (b) T-200, (c) T-400.

Figure 5a shows a photograph of a T-A specimen after failure. The failure of the T-200 specimens was characterized by large longitudinal cracks in the rebar and the breaking away of the outer layer of the bar (Figure 5b). This contrasts with the failure characteristics observed in the T-A and T-100 specimens, in which the fibers appeared to explode away from the bar. Failure of the T-400 specimens was less explosive than that observed in the lower temperature tests, and all T-400 specimens ruptured at failure (Figure 5c). Table 2 summarizes the results from the tensile strength tests.

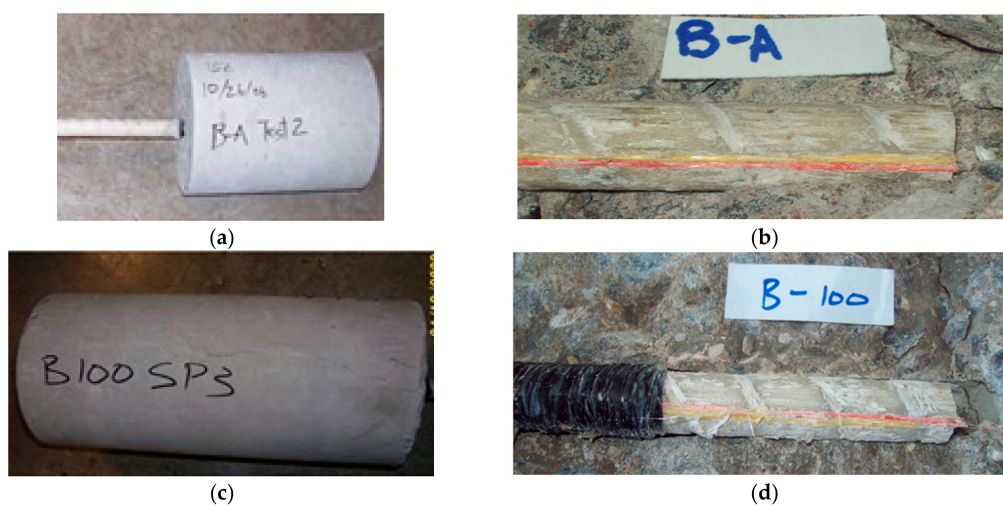
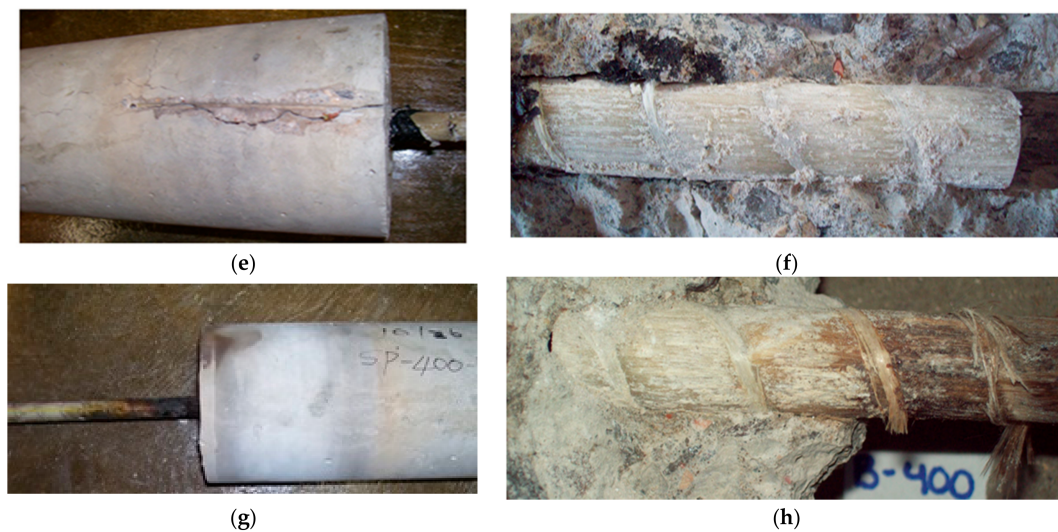
Figure 6. The bond specimens after bond failure. (a) Side view of B-A specimen after bond failure; (b) B-A specimen showing embedded portion of bar after failure of specimen; (c) side view of B-100 specimen after bond failure; (d) B-100 specimen showing embedded portion of bar after failure of specimen; (e) side view of B-200 specimen after bond failure; (f) B-200 specimen showing embedded portion of bar after failure of specimen; (g) side view of B-400 specimen after bond failure; (h) B-400 specimen showing embedded portion of bar after failure of specimen.

Each of the B-A specimens (bond specimens that were not exposed to elevated temperature) failed by pull-out of the rebar from the concrete cylinder and no cracking of the concrete was observed (Figure 6a). Some resin and glass fibers were observed on the concrete (Figure 6b).

After the heating, tapes were removed from the B-100 specimens; small random cracks, forming a web-like pattern, were observed on the concrete surface that had direct contact with the heating tape. Failure of all three of the B-100 specimens was by pull-out of the rebar from the concrete. However, unlike the unheated specimens, failure of the B-100 specimens was associated with cracks that radiated from the rebar to the surface of the concrete cylinder (Figure 6c). Additionally, when the concrete was broken after pull-out failure had occurred, significant damage to the bar surface was apparent and resin (Figure 6d) and glass residue was observed on the concrete.

In all cases, failure of the B-200 specimens occurred by pull-out of the rebar from the concrete cylinder. Failure involved cracks (smaller than those in the B-100 specimens) radiating from the rebar location to the surface of the concrete cylinder (Figure 6e). Significant damage to the bar surface was apparent, and resin and glass residue was observed on the concrete surface that was in contact with the bar (Figure 6f). However, there was more resin residue and less glass residue observed on the concrete in the B-200 specimens compared to B-100 specimens.

One of the B-400 specimens was damaged during test setup. Consequently, only two B-400 specimens were available for complete testing. There was significant discrepancy between the failure loads observed for the two specimens. However, both specimens failed by rebar pull-out and there was no evidence of any cracking in concrete (Figure 6g). Significant damage was observed on the bar surface, including charring of the upper part of the embedded portion of the bar (Figure 6h). Some resin residue was observed on the lower portion of bar, but the bar surface generally appeared to be depleted of resin.

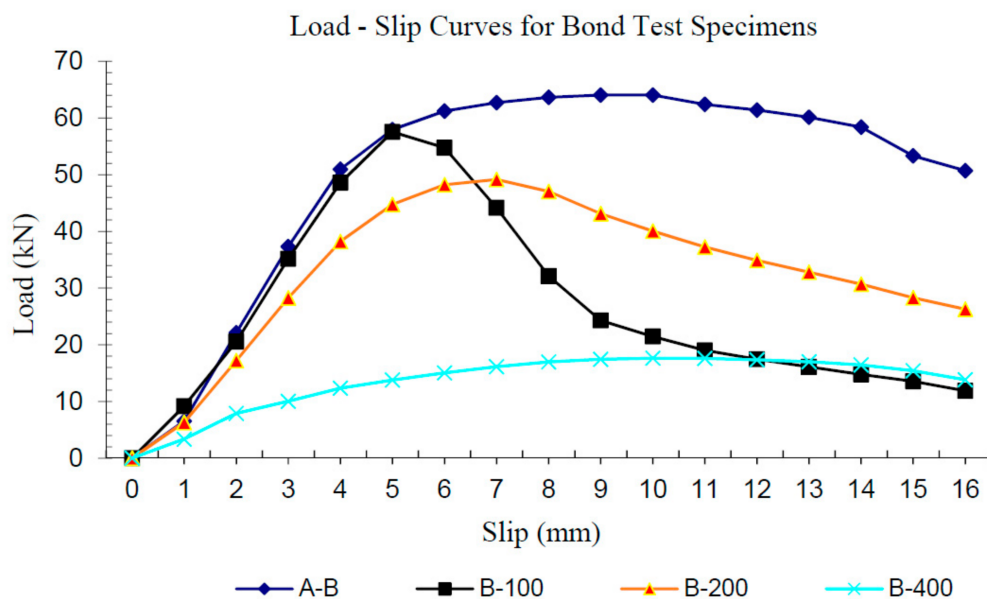
Figure 7. Comparison of mean load-slip curves for bond test specimens.

Table 3 provides a summary of the results from the bond tests and Figure 7 provides a graphical comparison of the load-slip relationships obtained from the specimens tested. A substantial reduction in the residual bond strength was observed for the specimens that were exposed to 400°C.

The load-slip response for the B-400 specimens (Figure 7) indicates that, because of the significant degradation of the resin at the surface of the bar, the “bond stiffness” and bond strength are significantly reduced. Therefore, stresses transferred to concrete are reduced, and cracking was not observed. These factors indicate that bond of FRP to concrete after the bar has been exposed to temperatures exceeding 400 °C cannot be reliable and predictable. Therefore, there could be important structural implications (i.e., structure may not be suitable for return to service) in such cases depending on estimated temperature exposure, as well as the sensitivity to bond strength in the structural configuration.

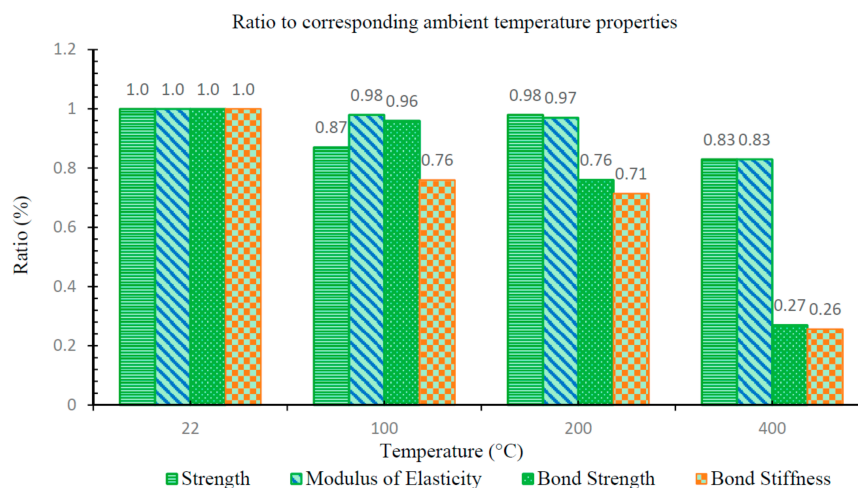
Figure 8. Ratios of residual parameters of pre-heated specimens with respect to their corresponding unheated test specimens.

Figure 8 shows relative reductions in residual tensile strength, modulus of elasticity, and bond strength of specimens that were previously exposed to elevated temperatures compared to tests performed on unheated specimens. This figure illustrates that the bond strength is the most critical parameter in assessing strength of GFRP-reinforced concrete beams that have survived fires, especially when GFRP bars were heated to temperatures of 200 °C to 400 °C before cooling. Although the bar’s residual tensile strength and modulus of elasticity also decreases with exposure to increasing temperatures, it is the residual bond stiffness and residual bond strength that exhibit drastic reductions.
