# Assessments of Concrete Internal Damage Caused By Freeze-Thaw Cycles and Mechanical Loading

**ASSESSMENTS OF CONCRETE INTERNAL DAMAGE CAUSED  
BY FREEZE-THAW CYCLES AND MECHANICAL LOADING**

Master of Science  
in Engineering

at  
The University of Wisconsin-Milwaukee

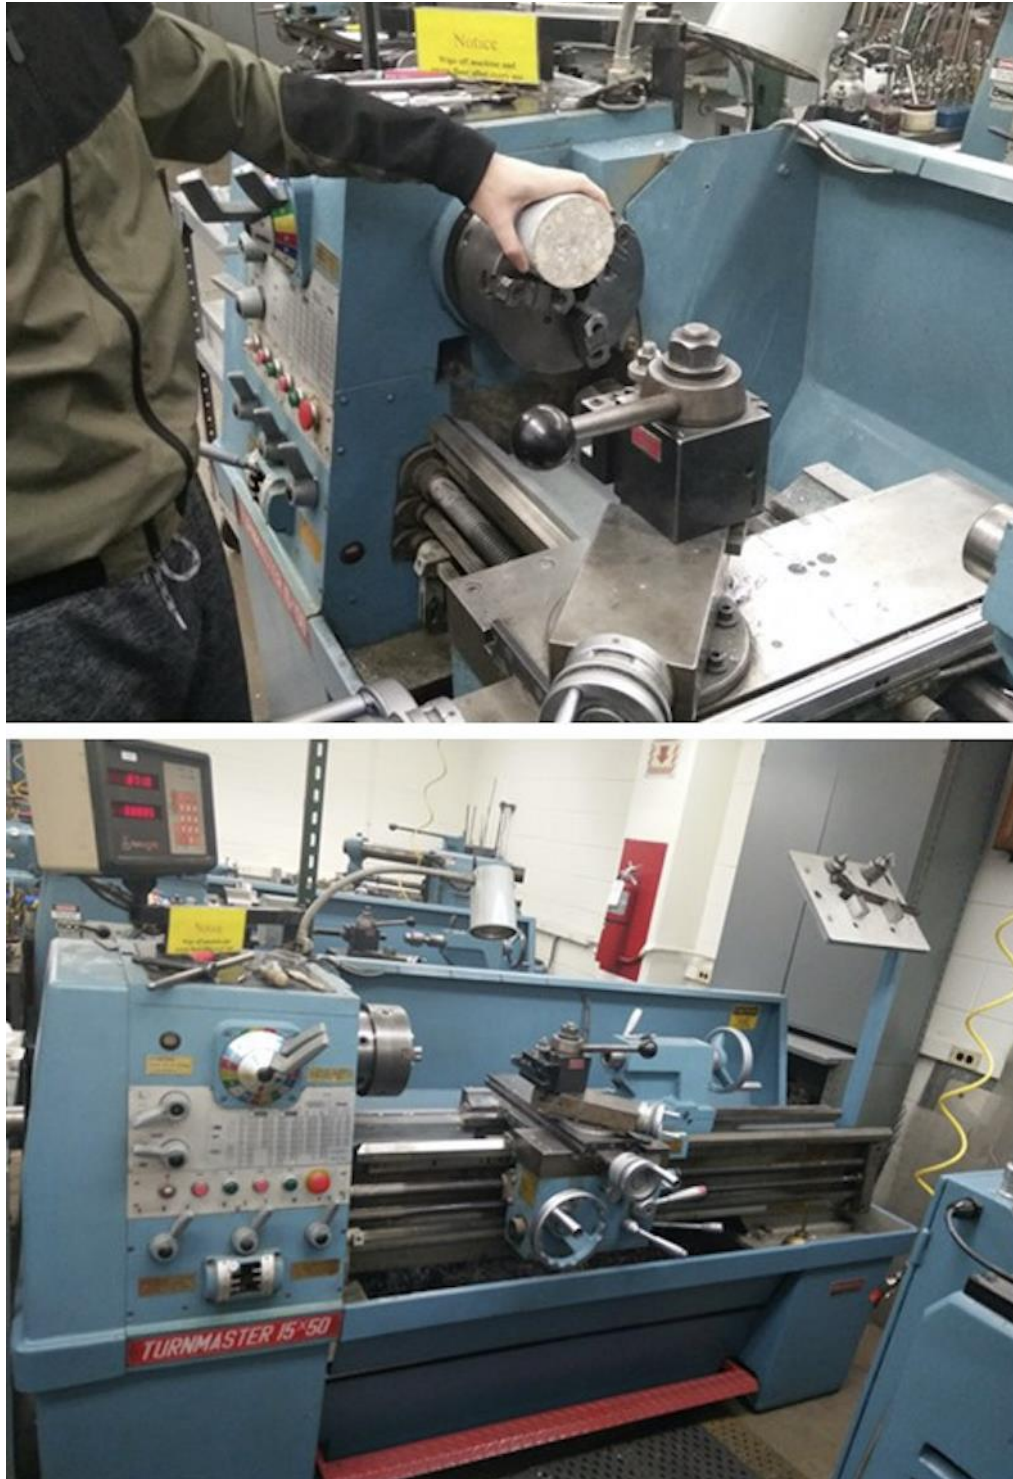
Figure 3.5: Milling sample surfaces using AMERICA TURNMASTER 1525 Engine Lathe

The surface of samples was stained with epoxy residue during the specimen preparation. As shown in the Figure 3.5, there is epoxy residues on the surface of samples. In this case, Chloride ions cannot pass through the specimens. Hence the surface of the samples surface was milled to remove the epoxy residue. A AMERICA TURNMASTER 1525 Engine Lathes with diamond drill was used for cutting epoxy off the surface of samples, as shown in Figure 3.6. It is deemed that the milling process also removed the carbonation on the disc surfaces.

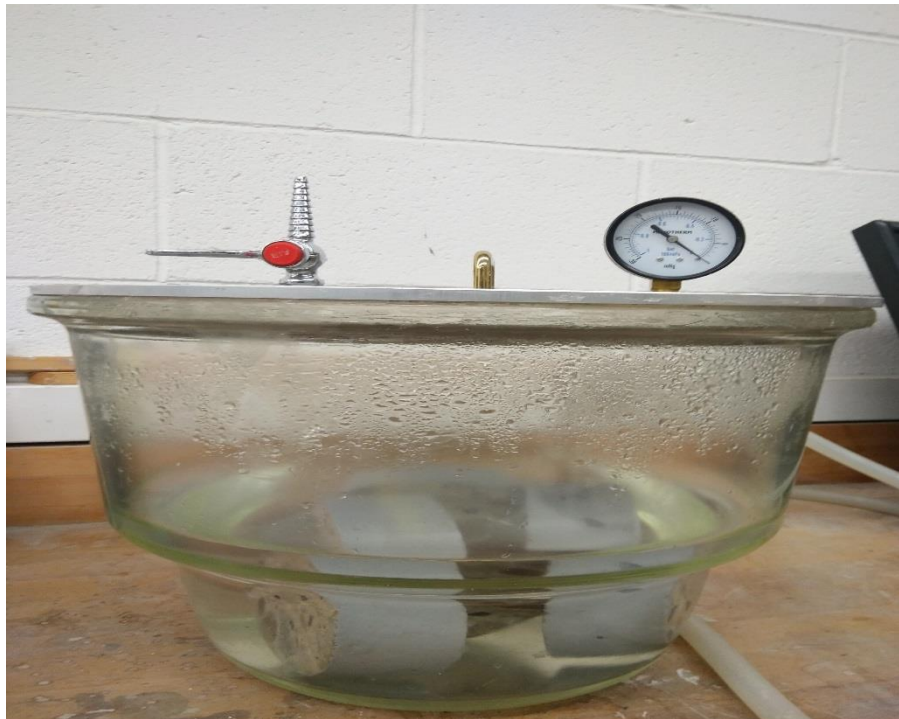
Figure 3.7: test specimens immersed in de-aerated water under atmospheric pressure.

The specimens were kept in a desiccator which was sealed for three hours, the inside pressure is below 50mm Hg (6650Pa). After this step, sufficient de-aerated water was added into the desiccator and the specimens were submerged in de-aerated water for one additional hour as shown in the Figure 3.7. During the 4-hours conditioning process, the insider pressure of desiccator was kept below 50mm Hg (6650Pa). After that, the specimens were under standard atmospheric pressure and submerged in de-aerated water for additional 18 hours as shown in the Figure 3.8.

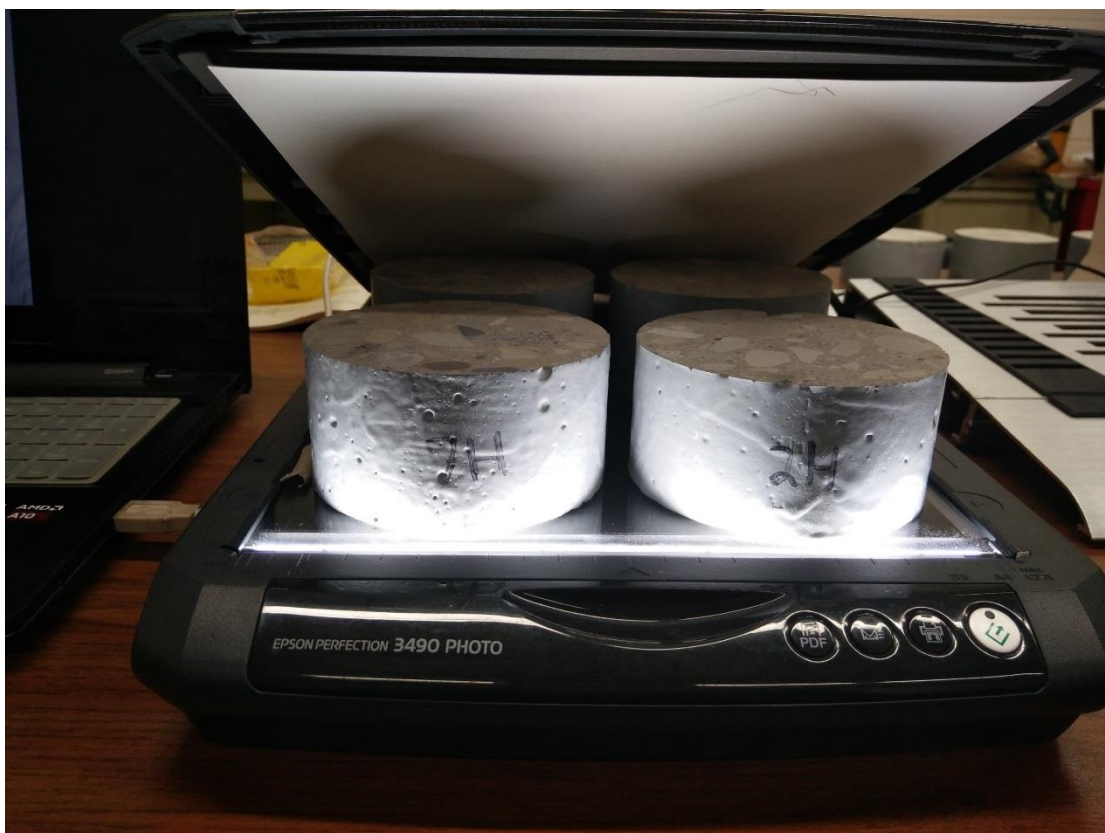
Figure 3.9: The EPSON scanner used for scanning the specimens.
