APPENDIX B

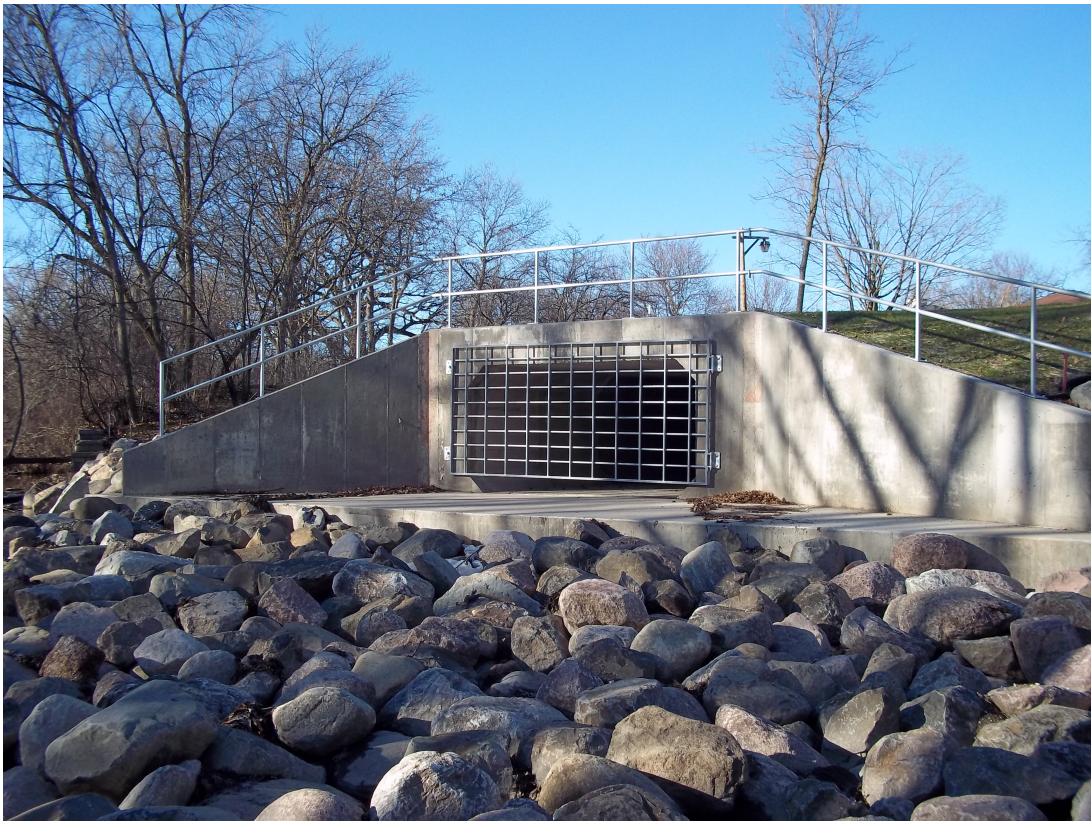
B.1.a. Terminal outfall MNWA01 post

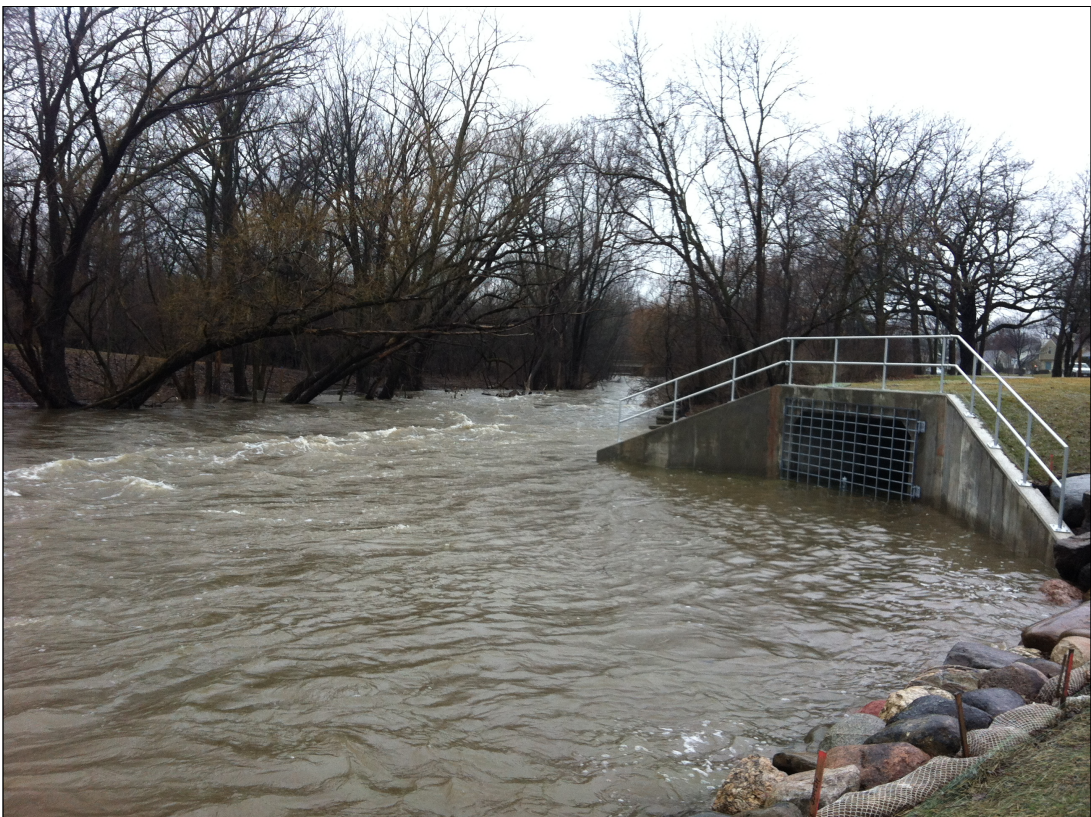
B.1.b Terminal outfall MNWA01 flooded by Menomonee River after heavy

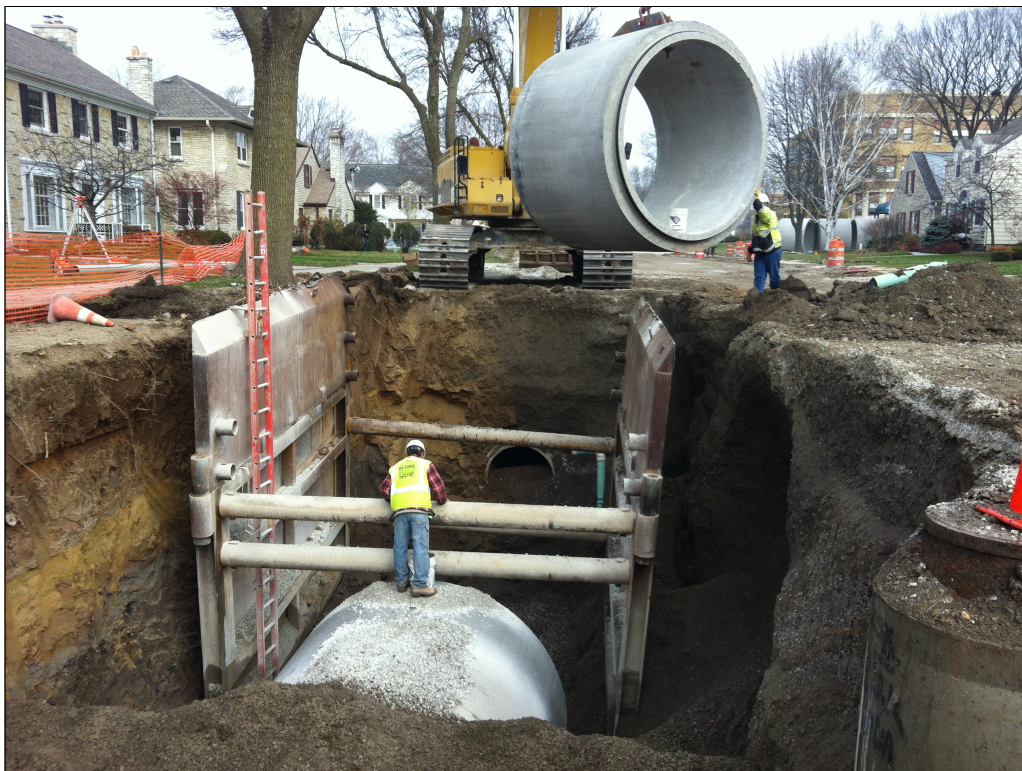
B.2.a New 12-foot diameter stormwater lines were laid along 90th Street during the Meinecke Avenue Utility Reconstruction

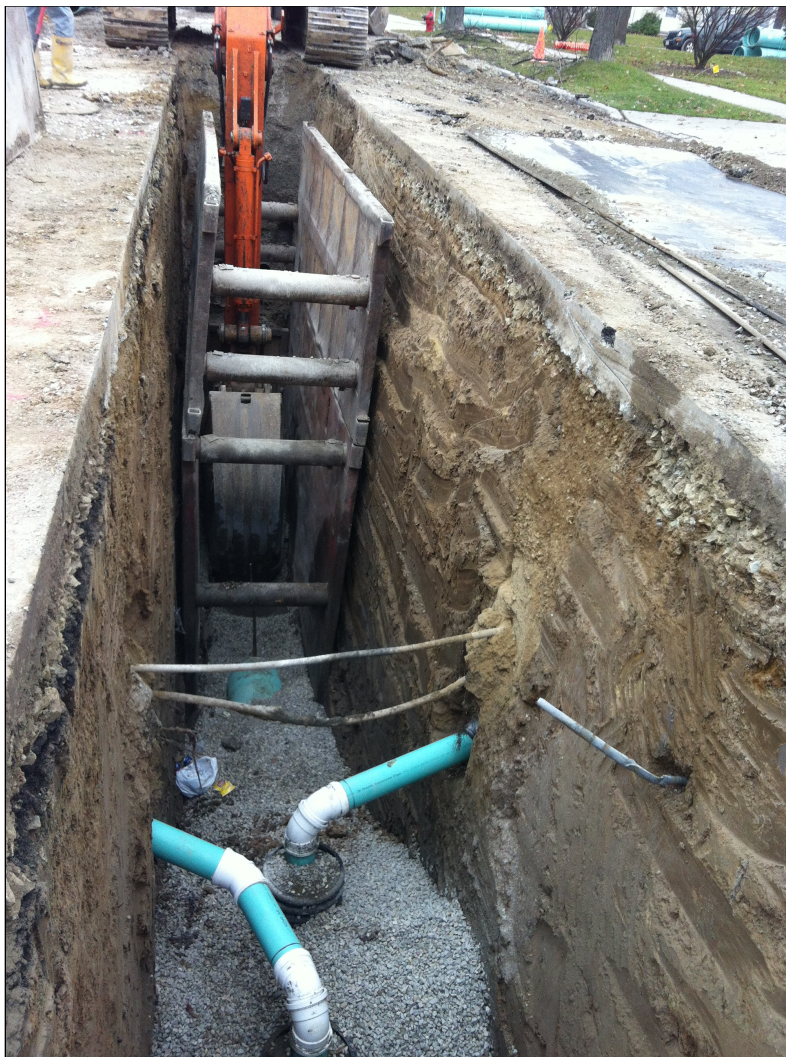
Figure B.2 Appendix B

B.2.b New sanitary pipe was laid along 90th Street. Photograph shows native clay material below the asphalt surface along the trench walls and chipped granular crushed limestone backfilling the sanitary trench. New residential lateral hook-ups are also visible.

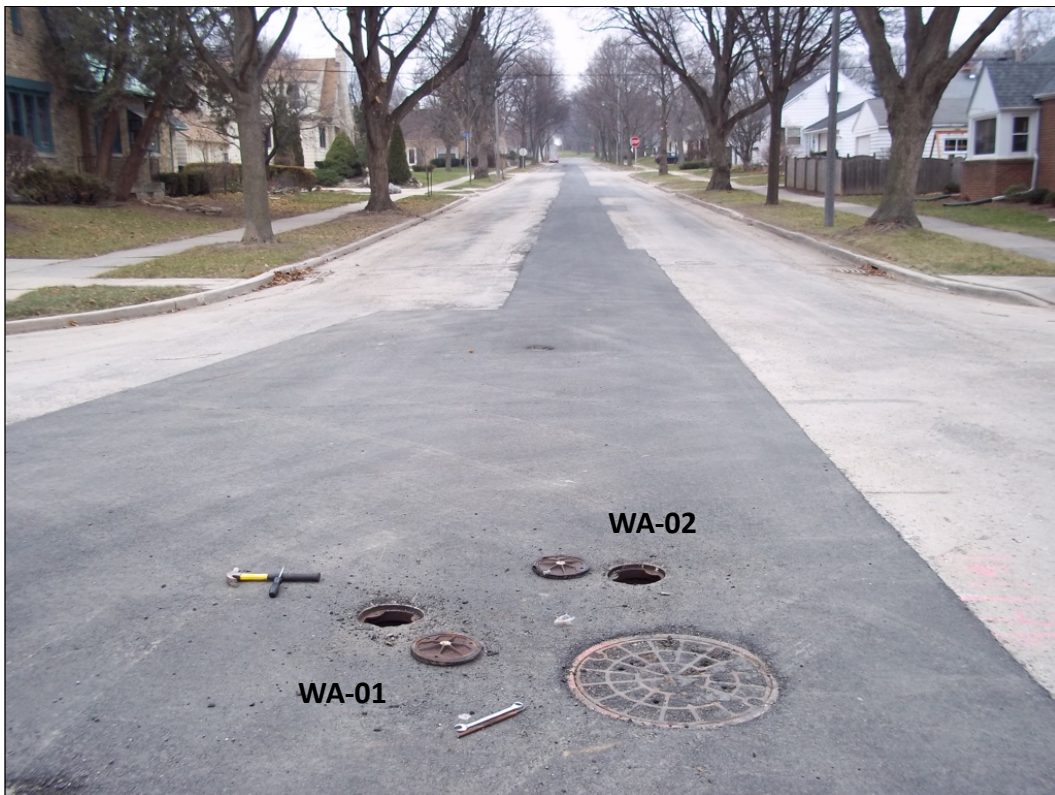
B.3.a. Monitoring wells MW-1 and MW-2 located within the intersection of Wright Street and 83rd Street facing north. A sanitary manhole is visible to the east of MW-1 and south of MW-2.

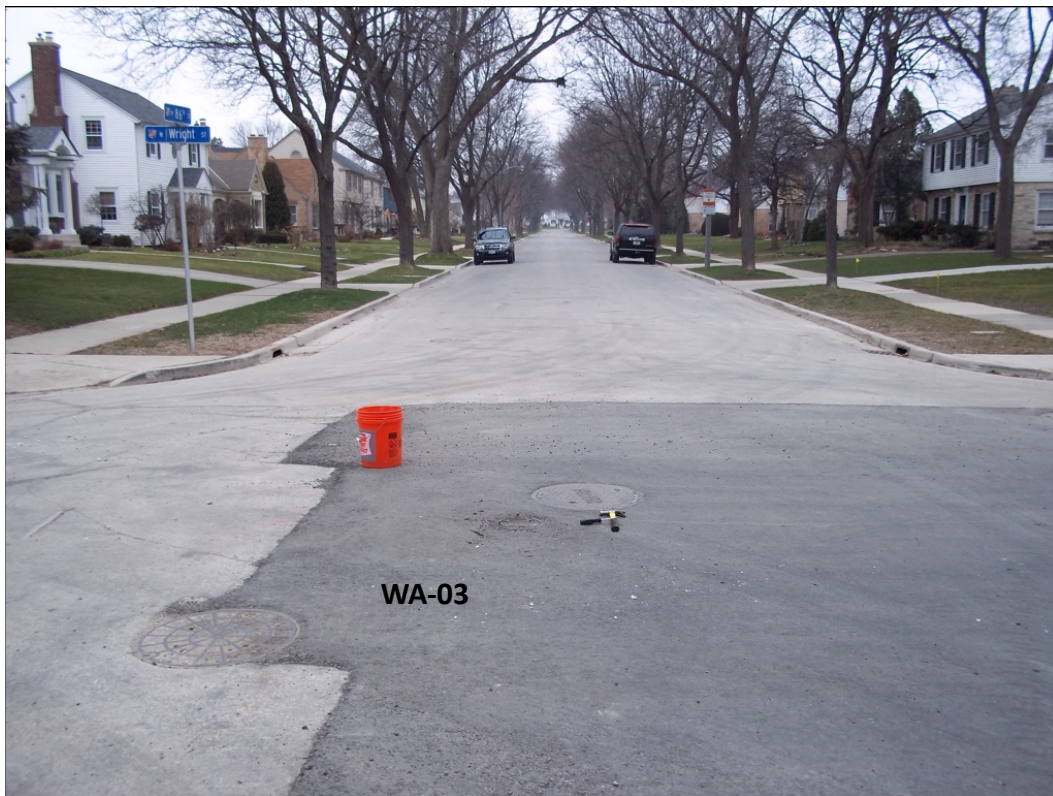
B.3.b. MW-3 is located at the intersection of Wright and 86th Street. MW-3 is located southwest of a sanitary manhole visible in the center of the photograph.
