# The Wisconsin State Building Program Research Project

Jeffrey A. Lackney

**The Wisconsin State  
Building Program  
Research Project**

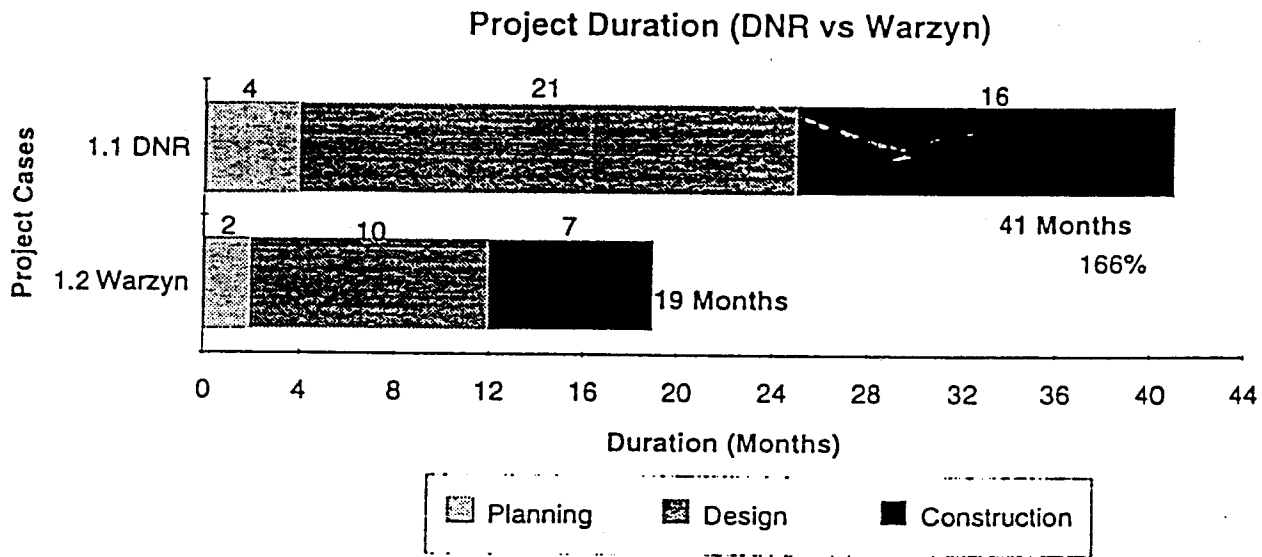
The following is a comparison of the duration of planning, design and construction activities that took place during the Facility Development Process.

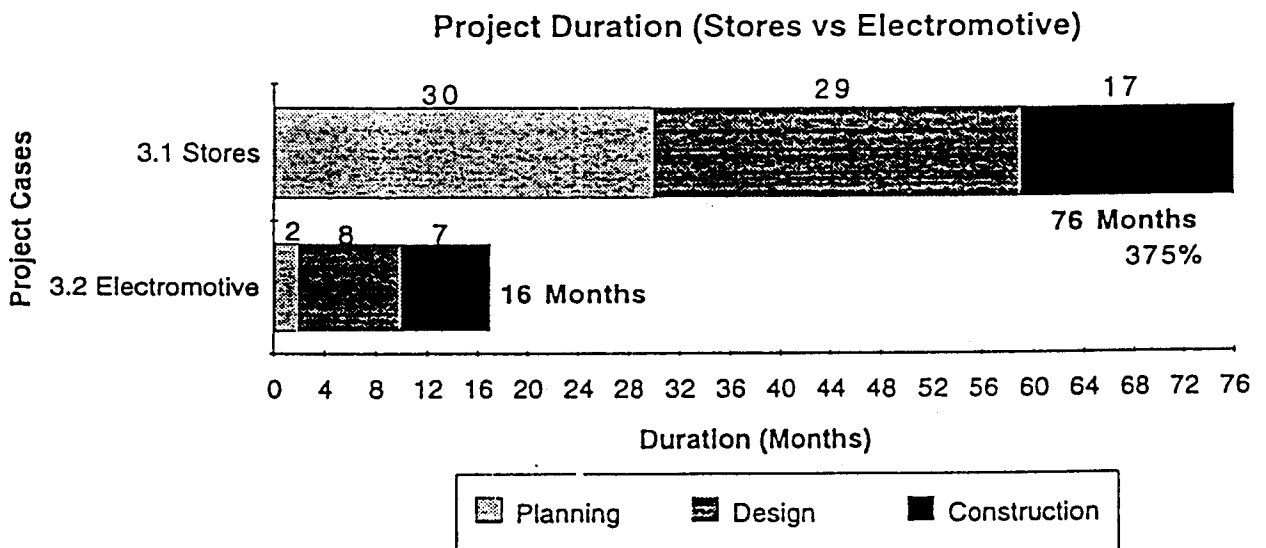
The following is a comparison of the duration of planning, design and construction activities that took place during the Facility Development Process:
