August 2020

Novel Adhesive Anchoring System Through Engineered Interface

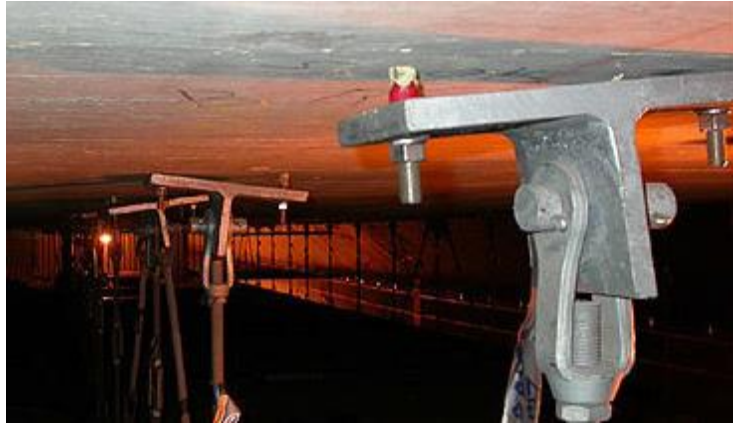
Figure 1.4. Adhesive anchors failure in a Boston Tunnel.

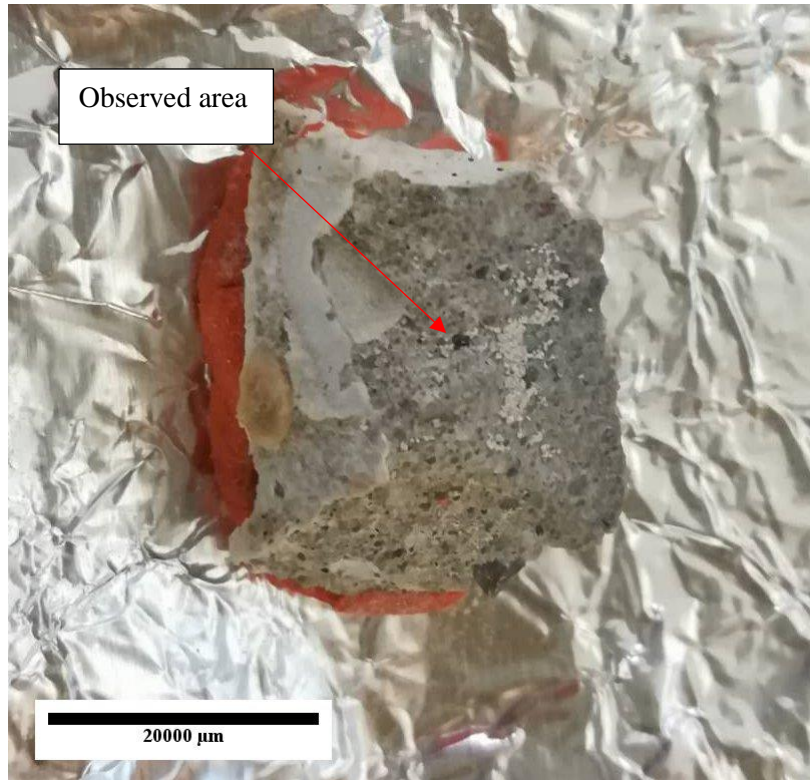
Figure 3.3. Observed area of a concrete piece peeled from a drilled hole

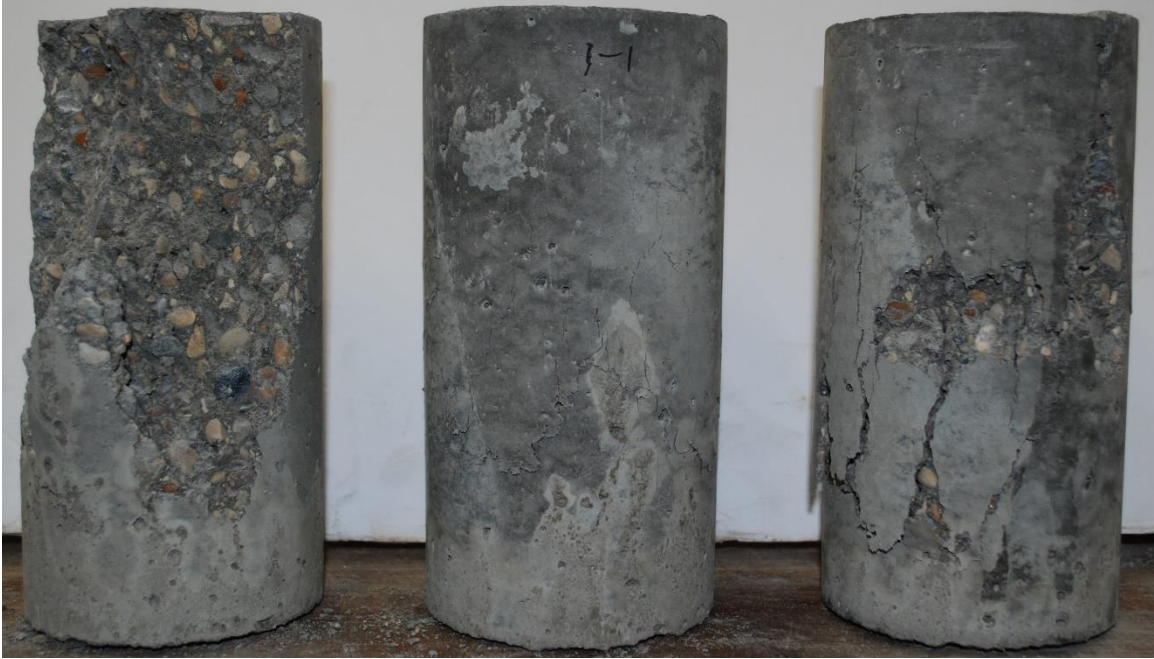
Figure I.2. Failure pattern of Cylinders 1, 2, 3 at 3 days

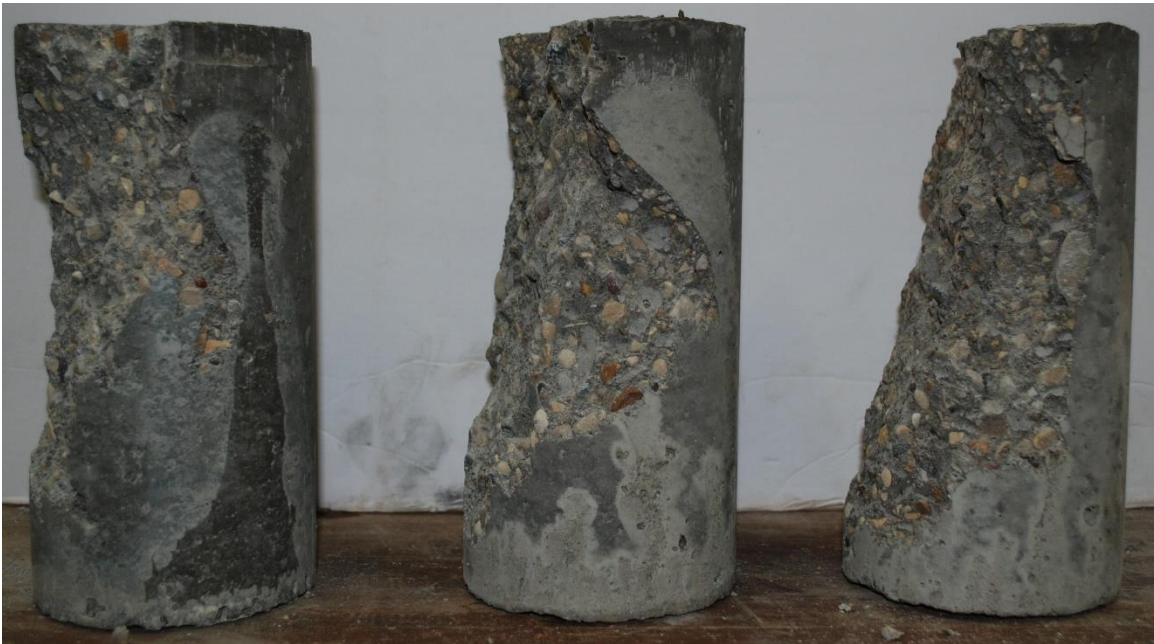
Figure I.3. Failure pattern of Cylinders 4, 5, 6 at 7 days

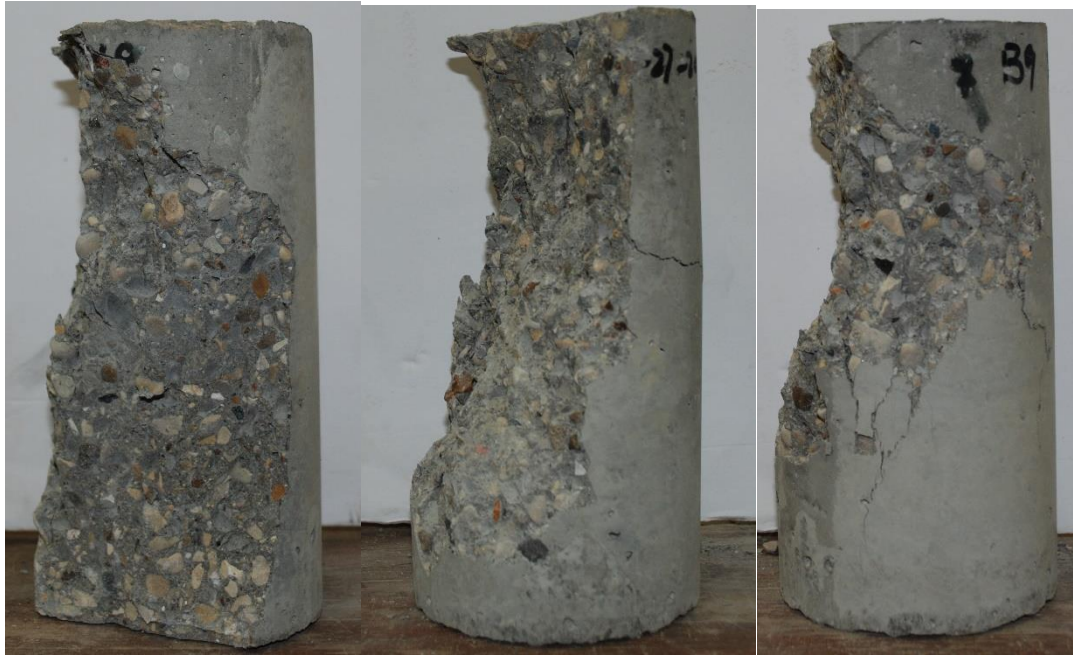
Figure I.4. Failure pattern of Cylinders 7, 8, 9 at 14 days

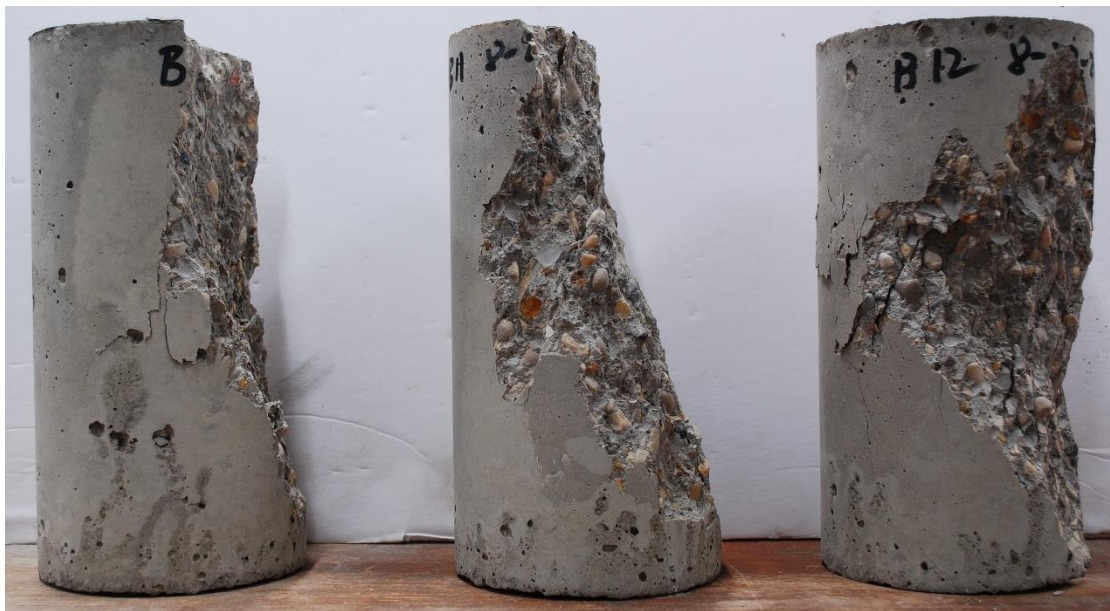
Figure I.5. Failure pattern of Cylinders 10, 11, 12 at 21 days

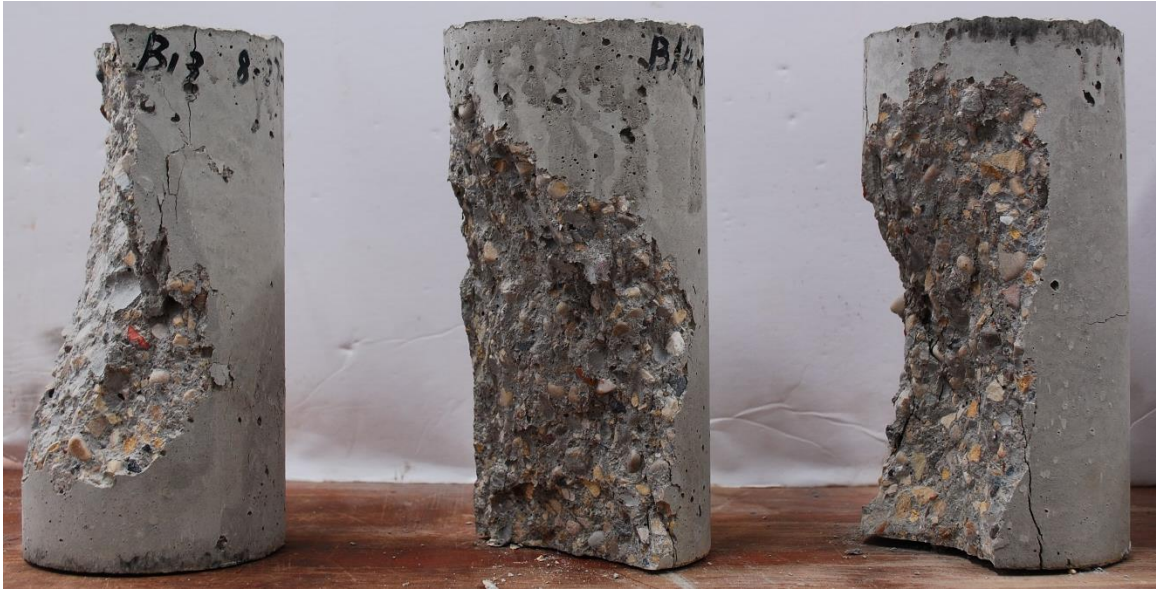
Figure I.6. Failure pattern of Cylinders 13, 14, 15 at 28 days

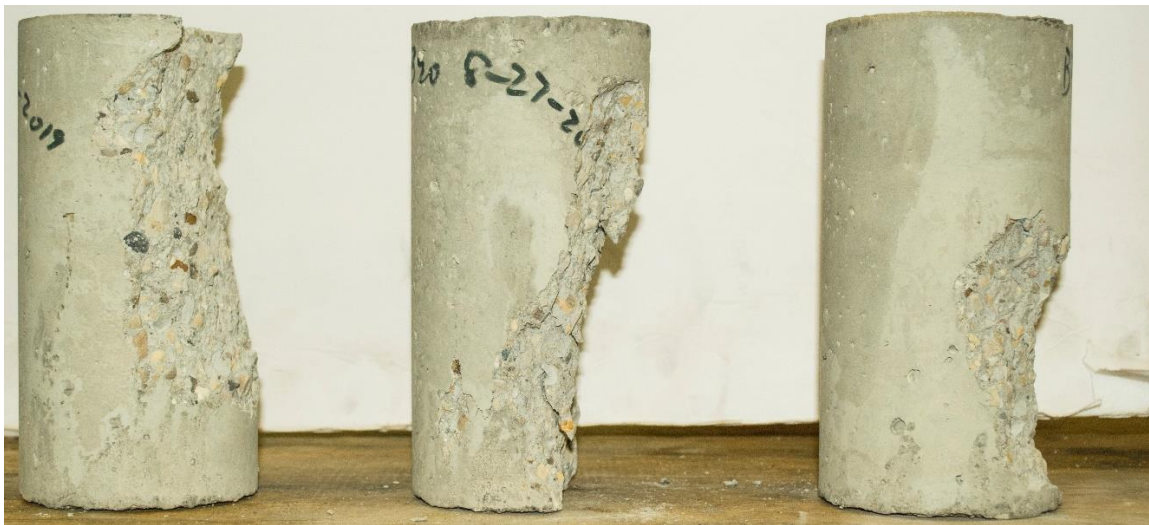
Figure I.7. Failure pattern of Cylinders 16, 17, 18 at 90 days

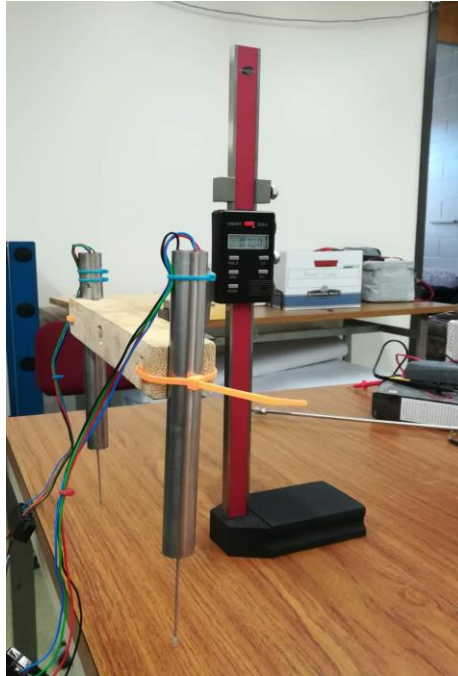
Figure II.1 Calibration equipment setup

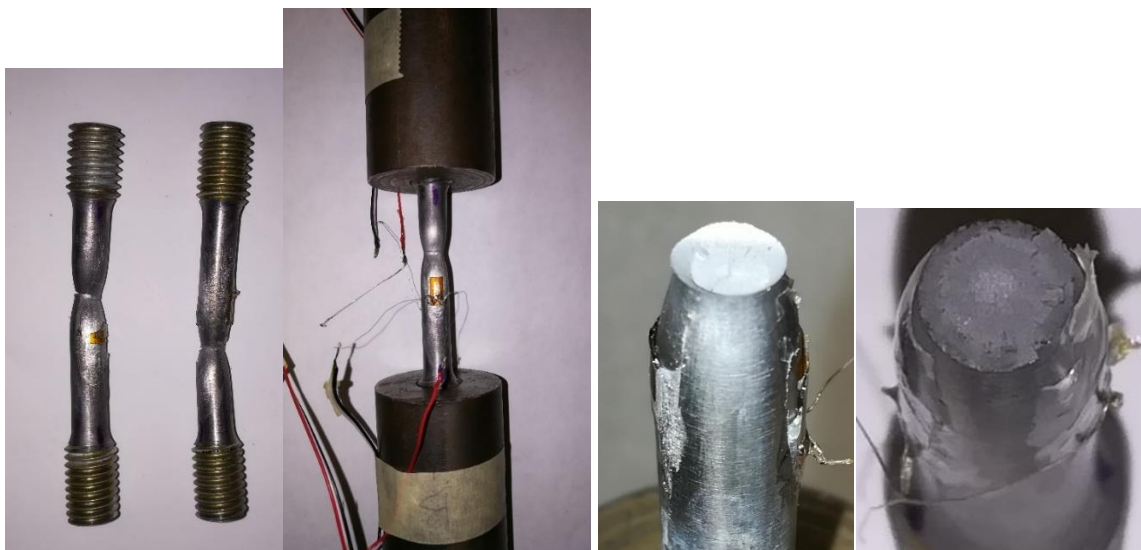
Figure II.19. Tensile fracture surface of A193 anchor rod

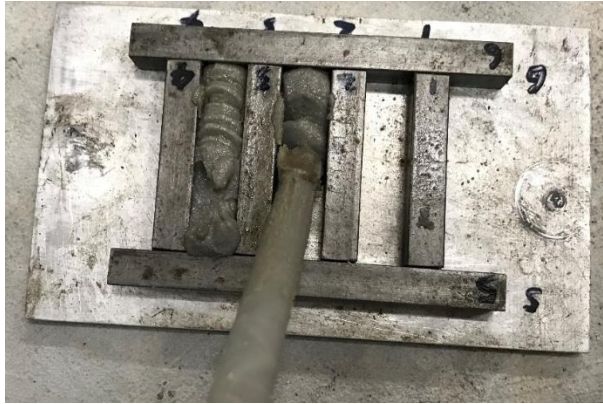
Figure III.1. Inject adhesive into prism molds

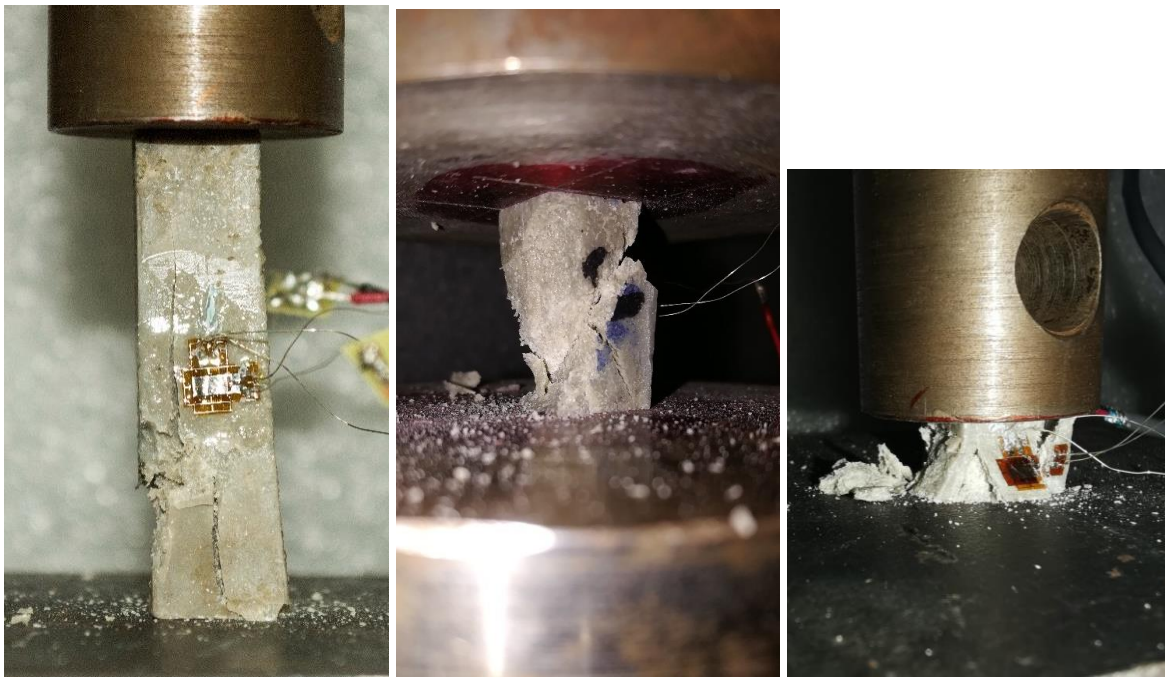
a) specimen with 1:4 ratio; b) specimen with 1:2 ratio; c) specimen with 1:1 ratio;

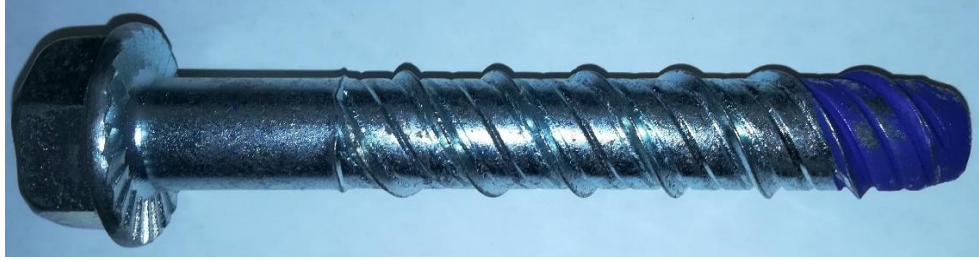
Figure IV.1. A 5/8-in. diameter, 5-in. long screw anchor

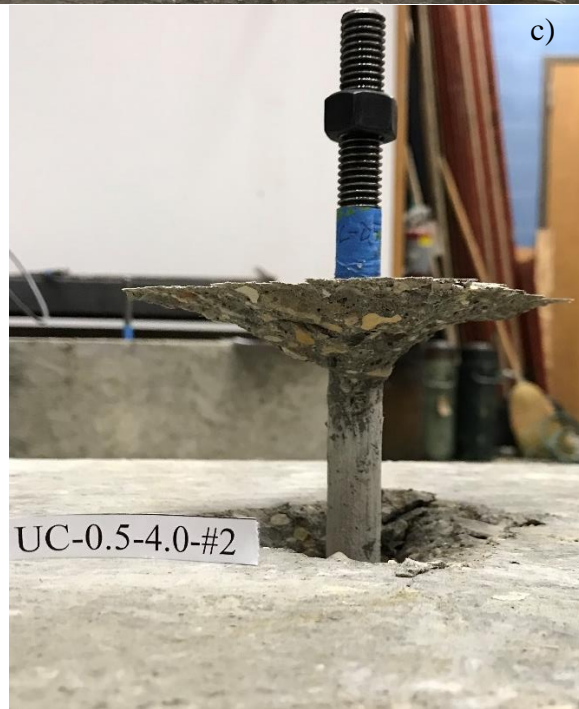
a) load-displacement behavior; b) cracked surface; c) partial cone bond failure
Figure VI.2. Observed behavior of Specimen UC-0.5-4.0-#2

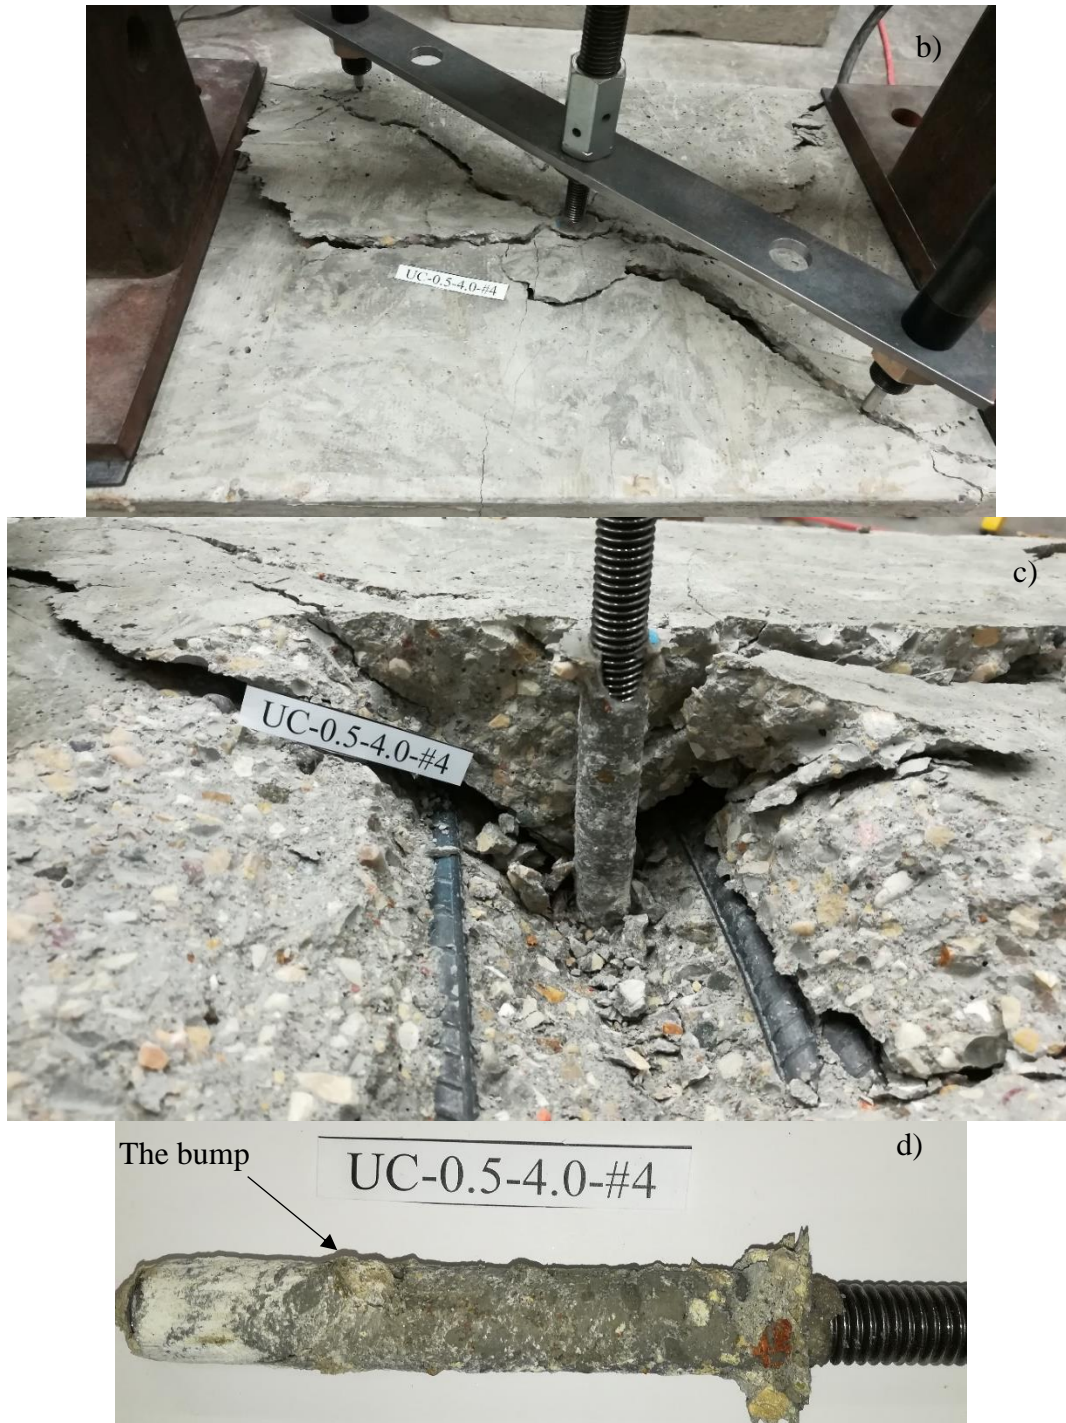
a) load-displacement behavior; b) cracked surface; c) concrete breakout cone in block; d) anchor with adhesive

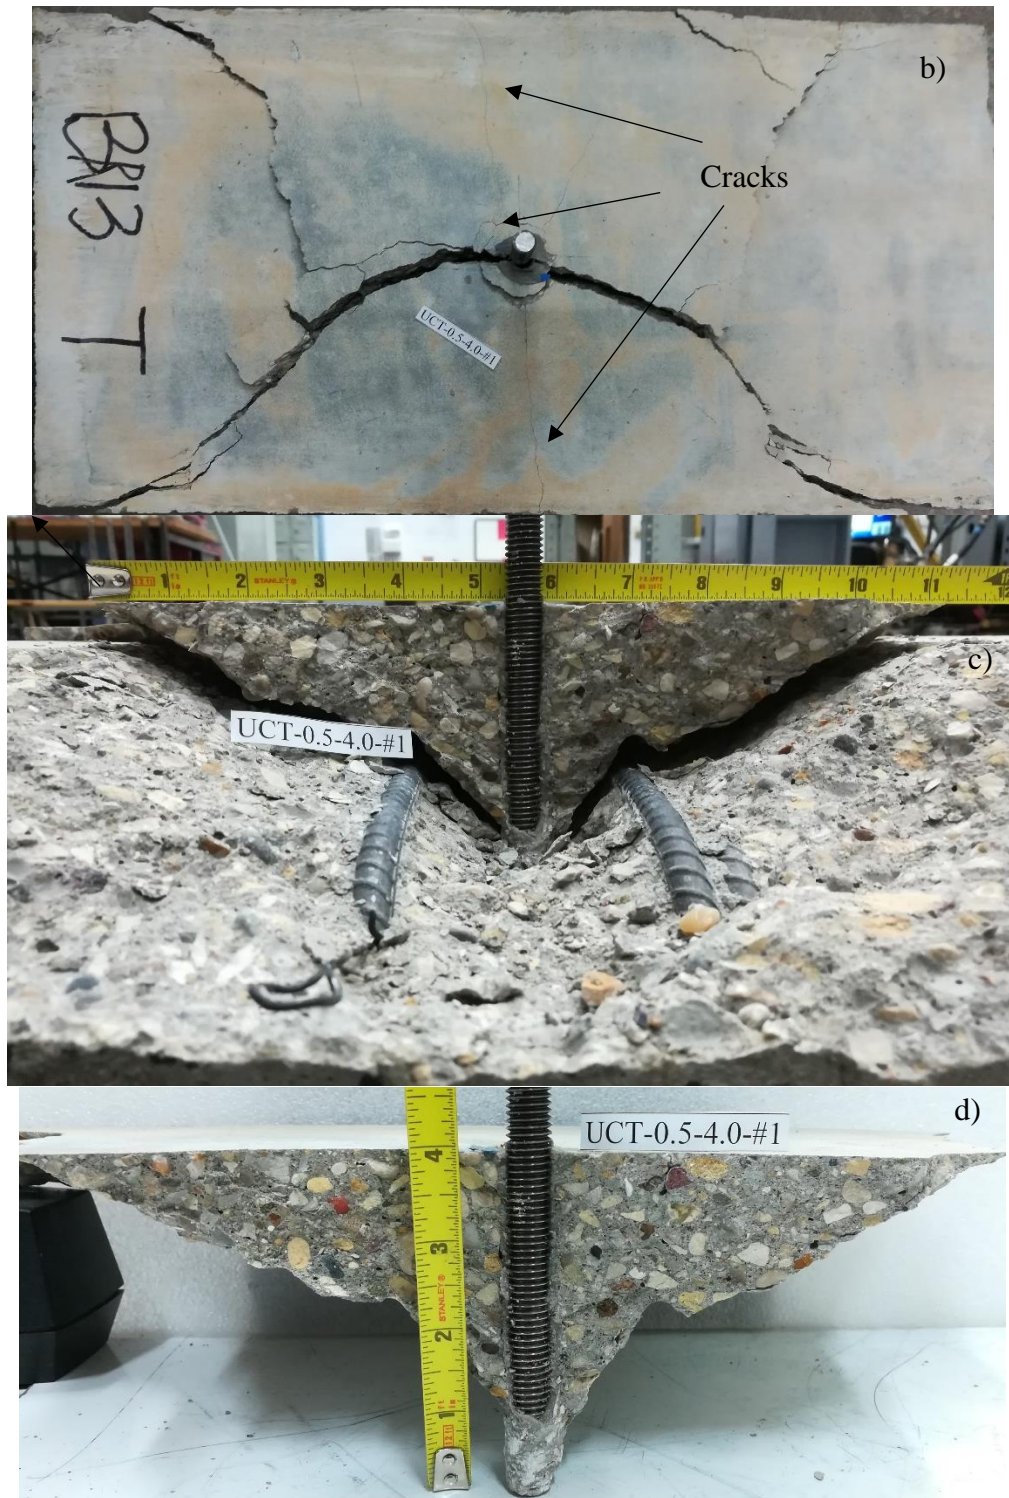
a) load-displacement behavior; b) cracked surface; c) concrete breakout cone in block; d) concrete breakout cone

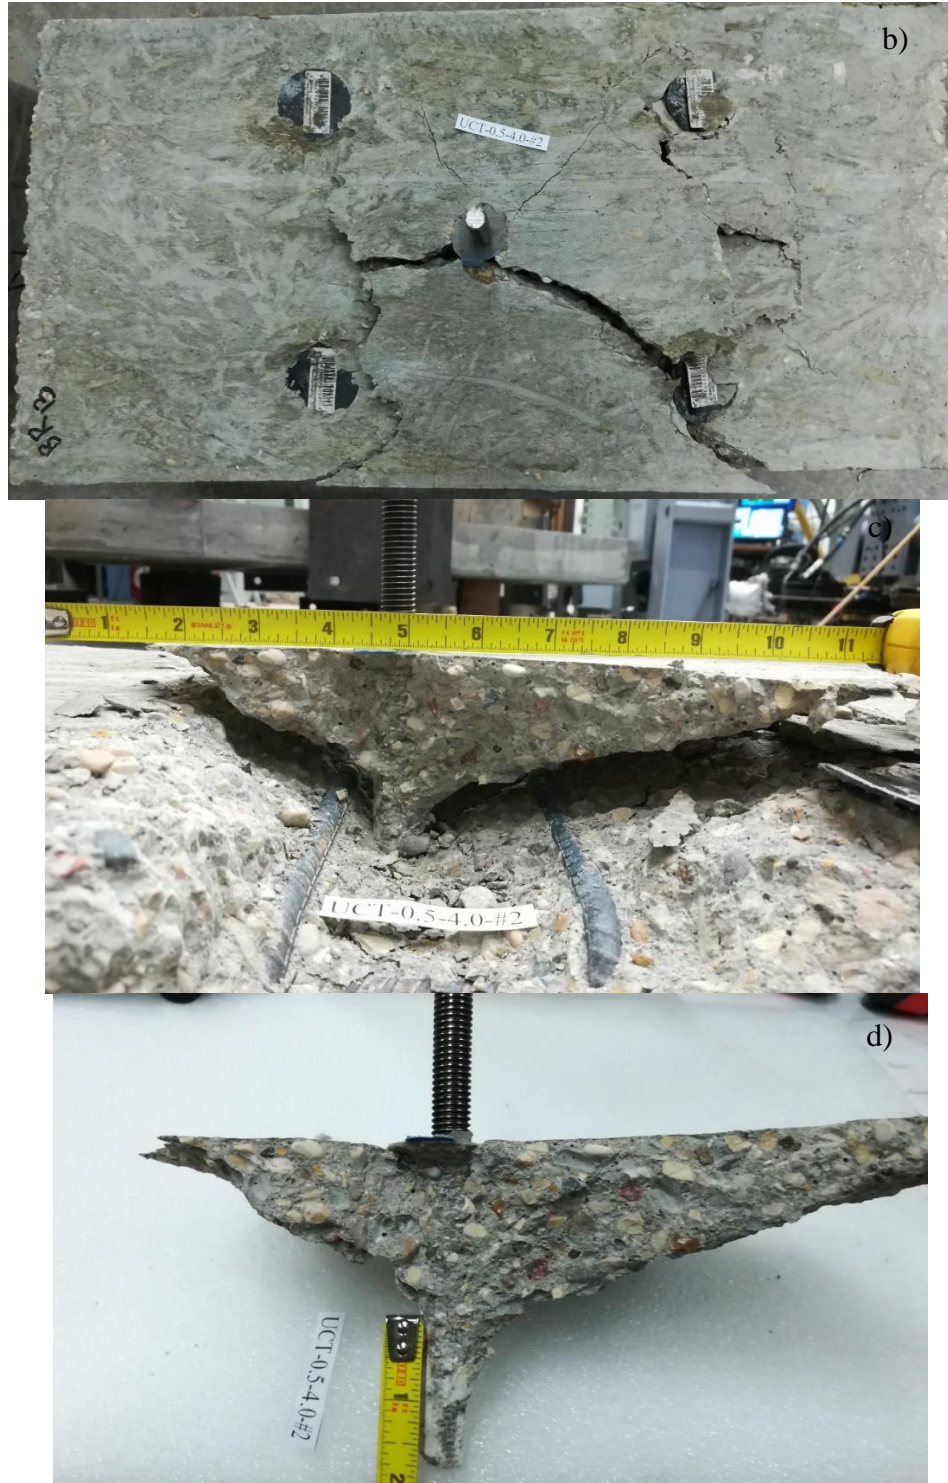
a) load-displacement behavior; b) cracked surface; c) concrete breakout cone in block; d) concrete breakout cone

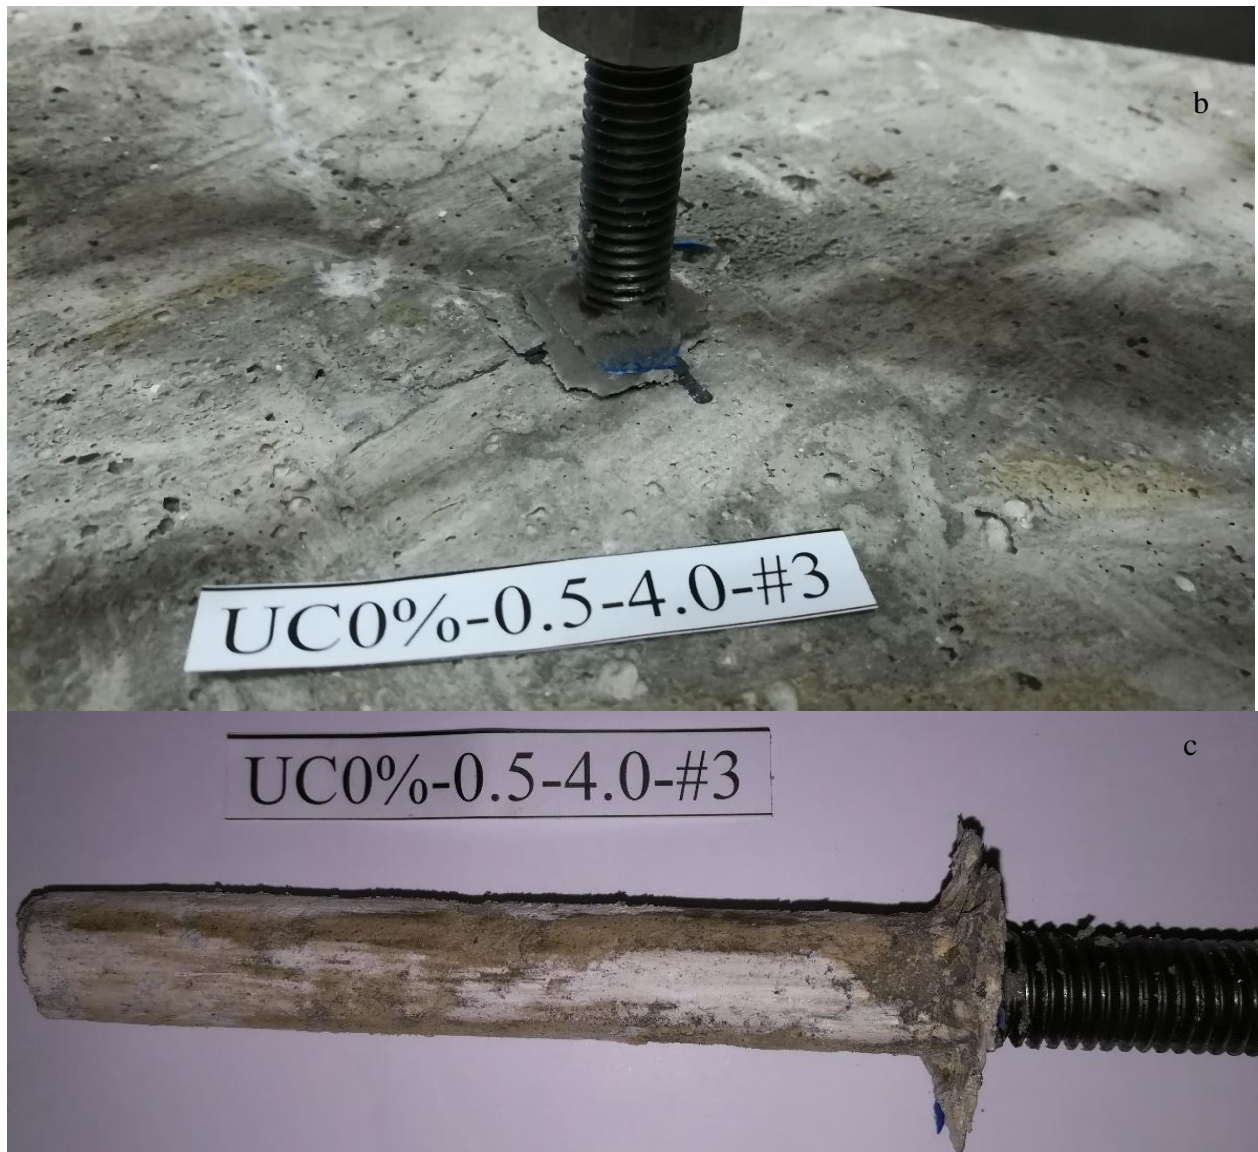
a) load-displacement behavior; b) cracked surface; c) partial cone bond failure
Figure VI.15. Observed behavior of Specimen UC0%-0.5-4.0-#3

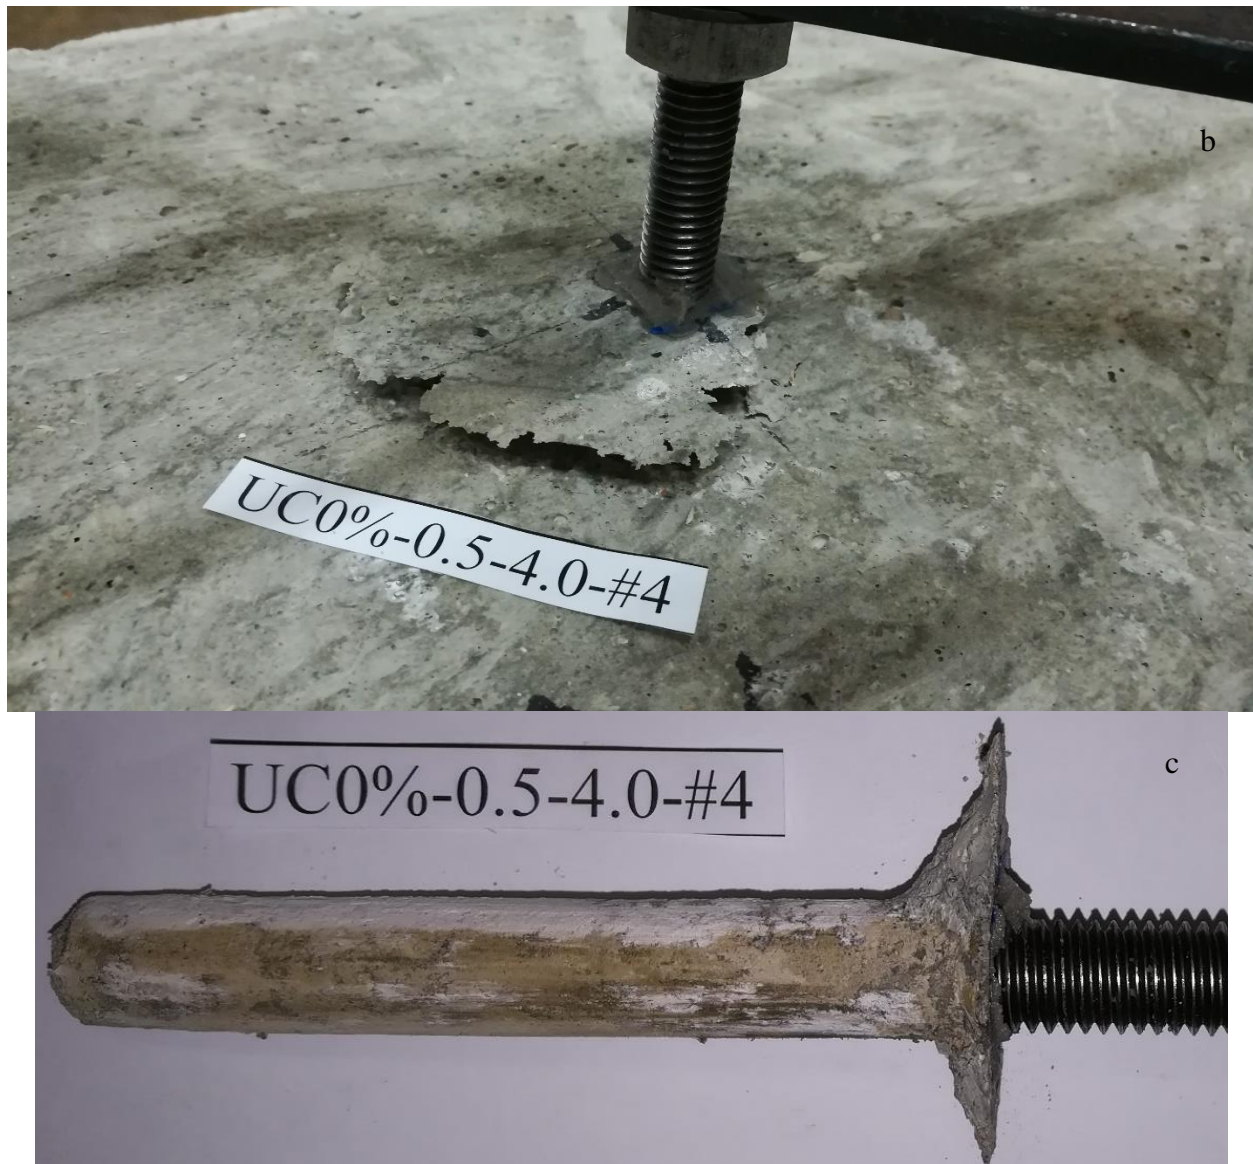
a) load-displacement behavior; b) cracked surface; c) partial cone bond failure
Figure VI.16. Observed behavior of Specimen UC0%-0.5-4.0-#4

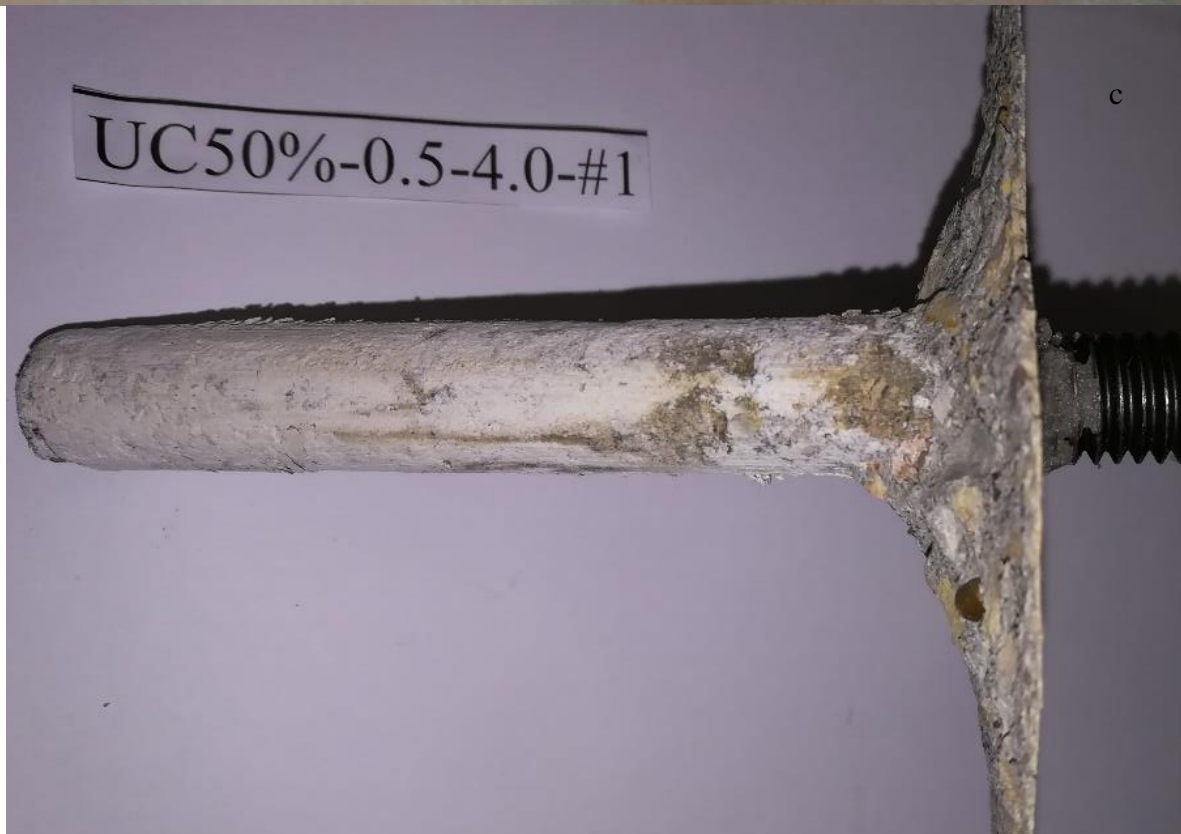
a) load-displacement behavior; b) cracked surface; c) partial cone bond failure
Figure VI.17. Observed behavior of Specimen UC50%-0.5-4.0-#1

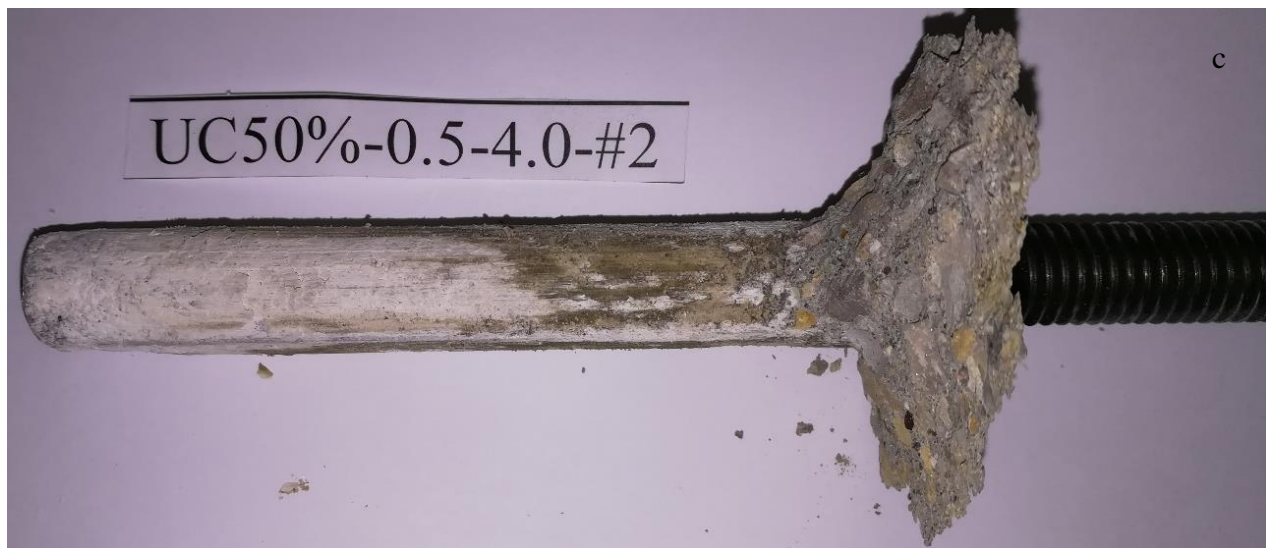
a) load-displacement behavior; b) cracked surface; c) partial cone bond failure
Figure VI.18. Observed behavior of Specimen UC50%-0.5-4.0-#2

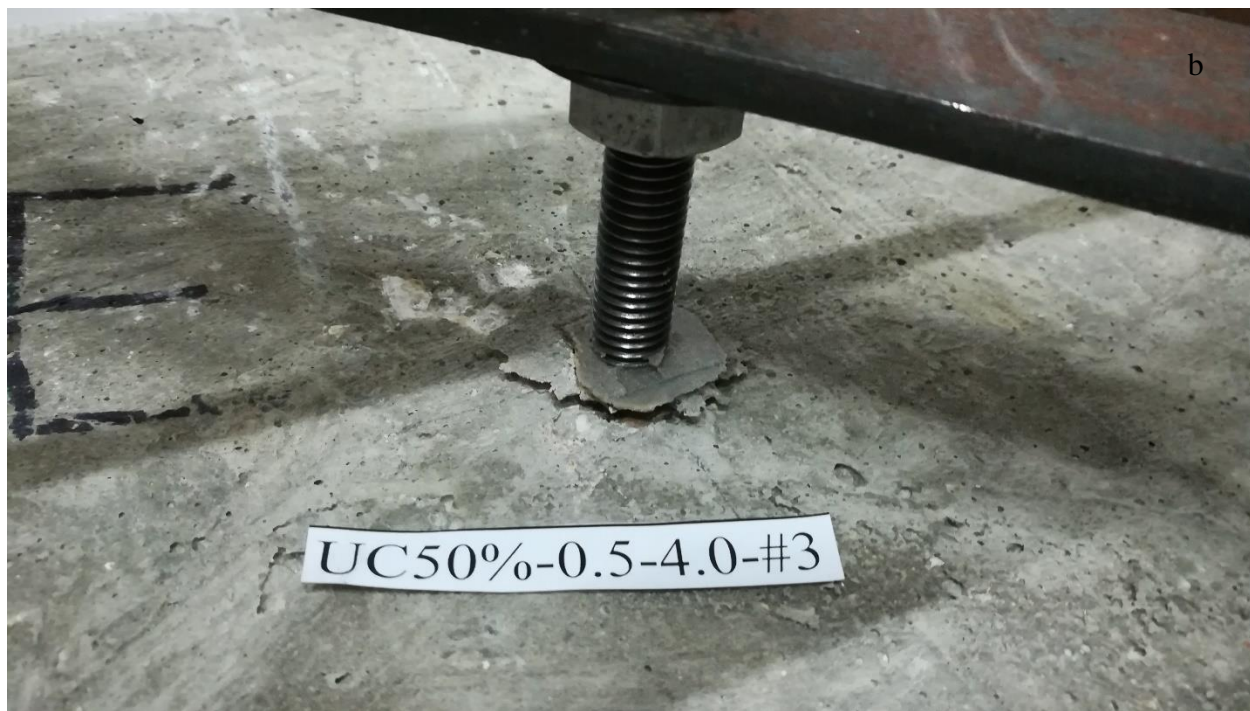
a) load-displacement behavior; b) cracked surface; c) partial cone bond failure

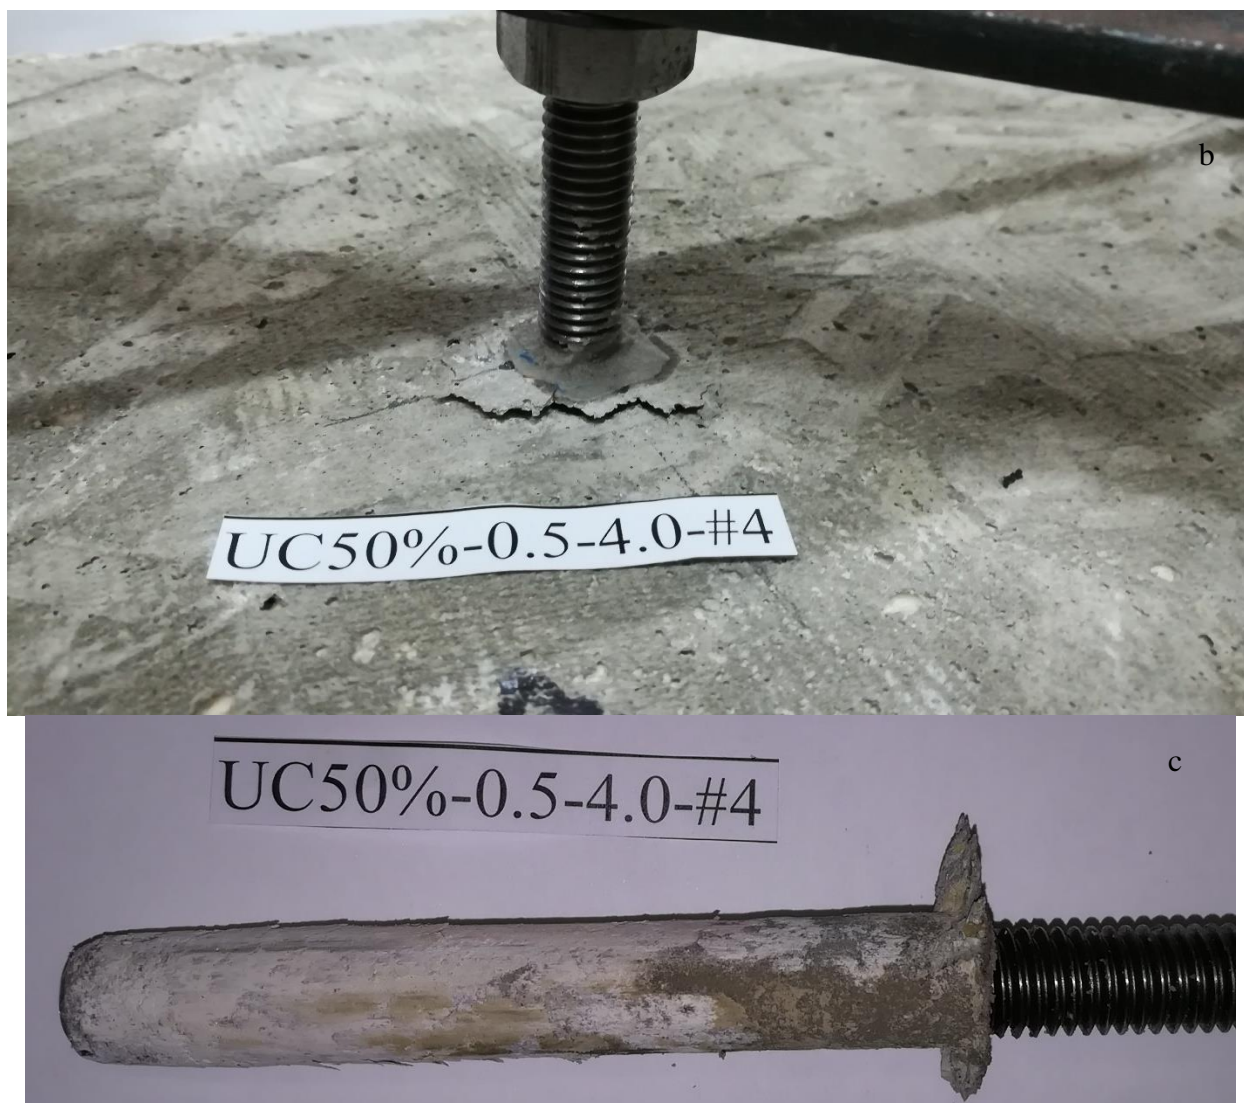
a) load-displacement behavior; b) cracked surface; c) partial cone bond failure
Figure VI.20. Observed behavior of Specimen UC50%-0.5-4.0-#4

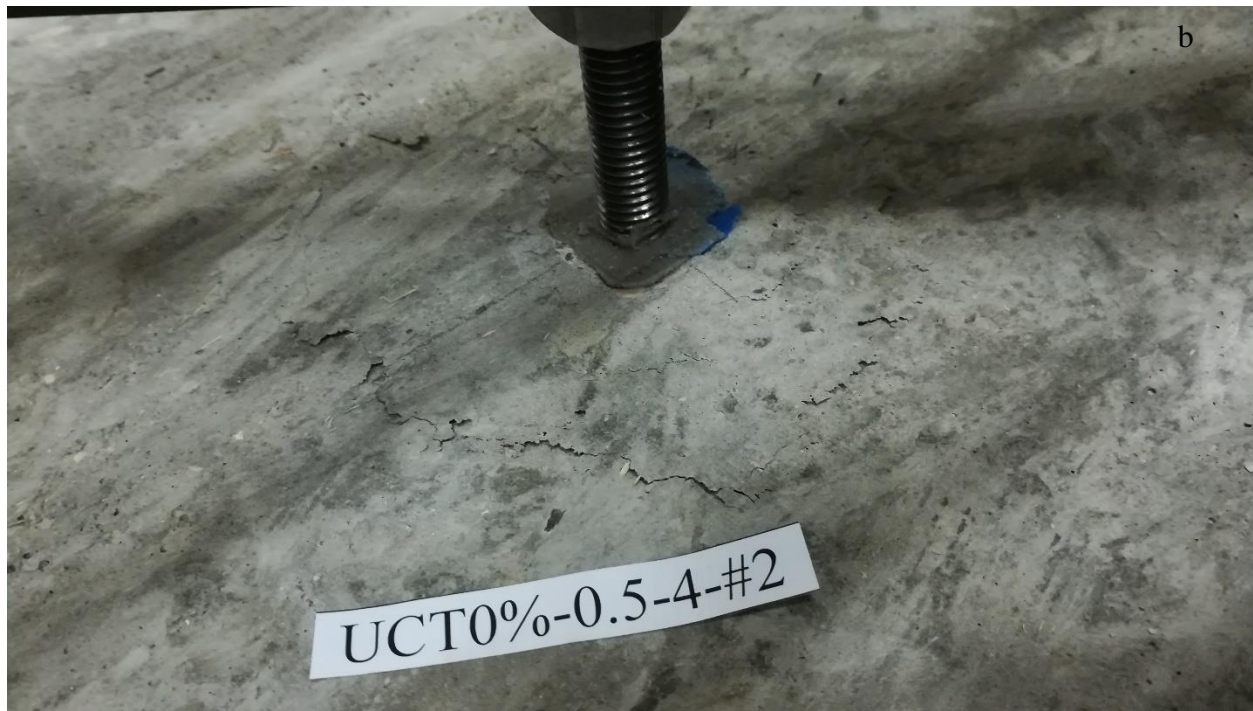
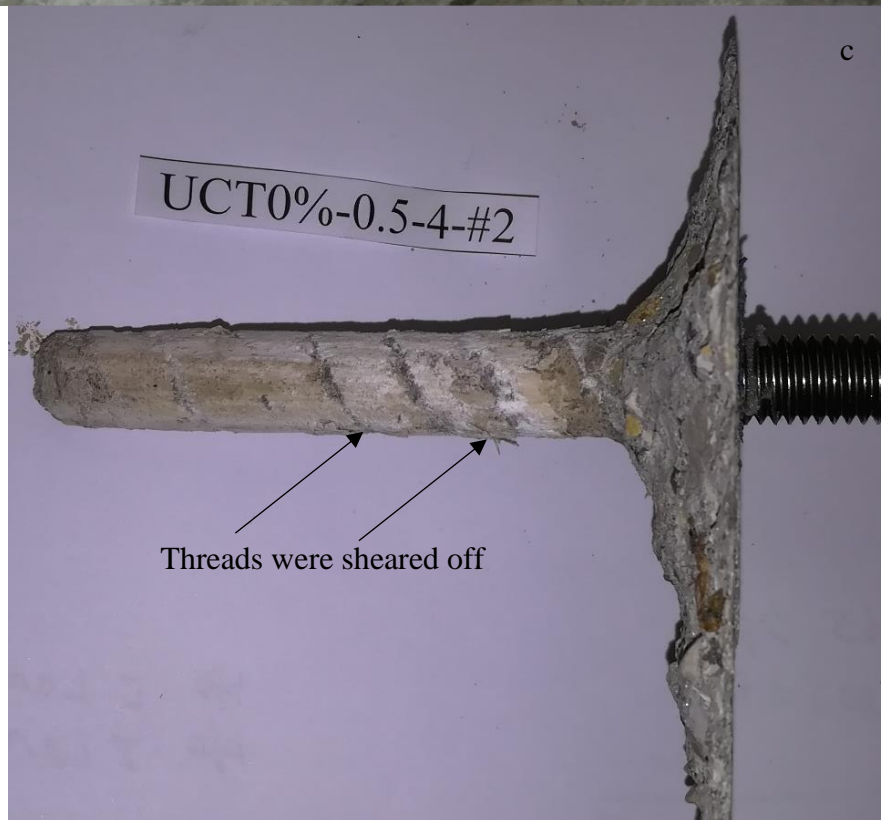
a) load-displacement behavior; b) cracked surface; c) partial cone bond failure
Figure VI.22. Observed behavior of Specimen UCT0%-0.5-4.0-#2

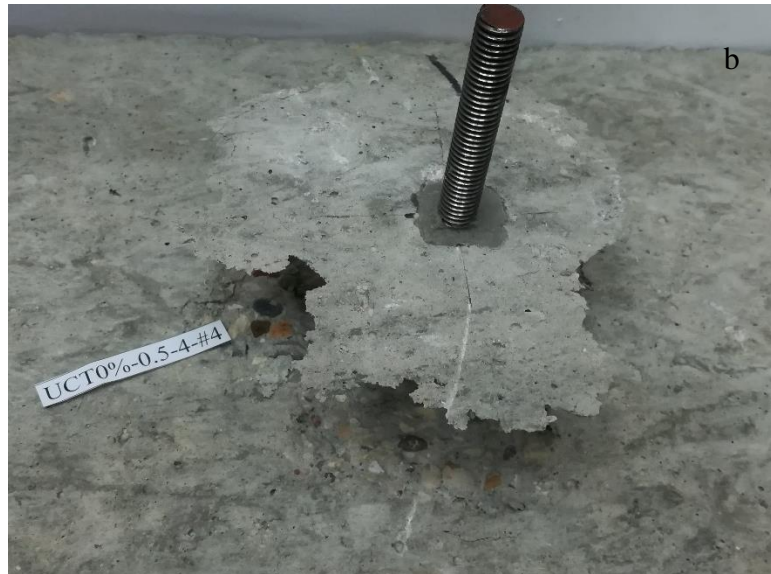
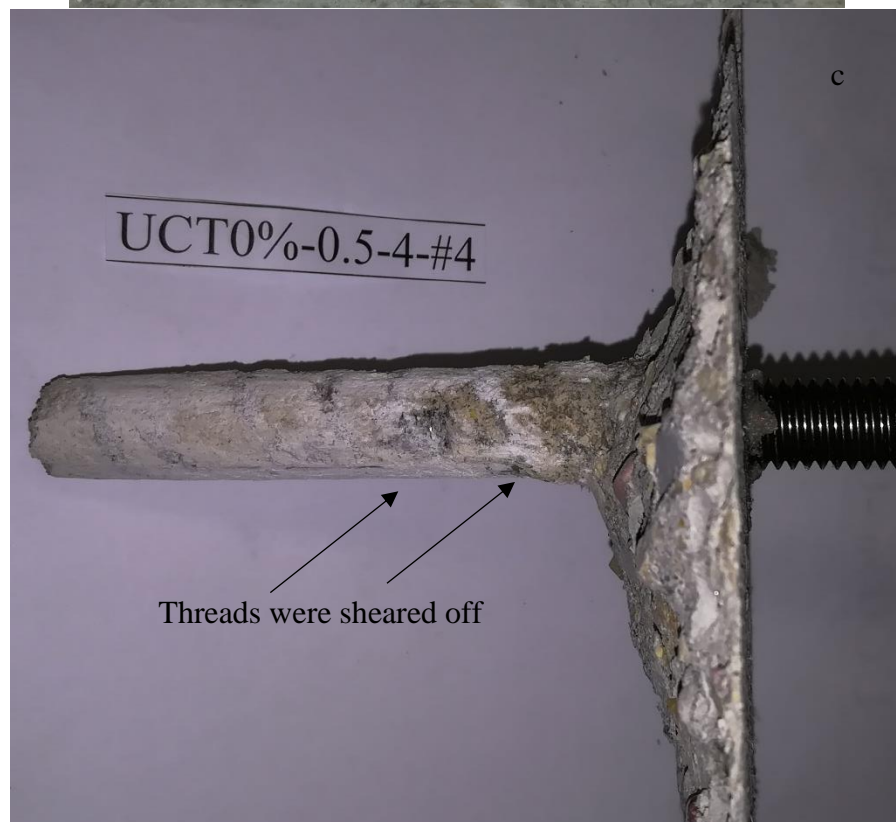
a) load-displacement behavior; b) cracked surface; c) partial cone bond failure
Figure VI.24. Observed behavior of Specimen UCT0%-0.5-4.0-#4

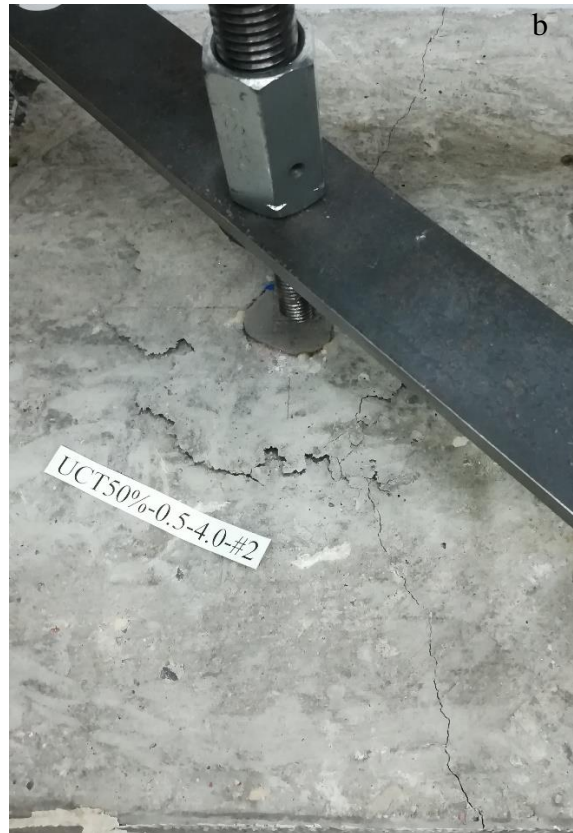
a) load-displacement behavior; b) cracked surface; c) partial cone bond failure
Figure VI.26. Observed behavior of Specimen UCT50%-0.5-4.0-#2
