August 2020

Novel Adhesive Anchoring System Through Engineered Interface

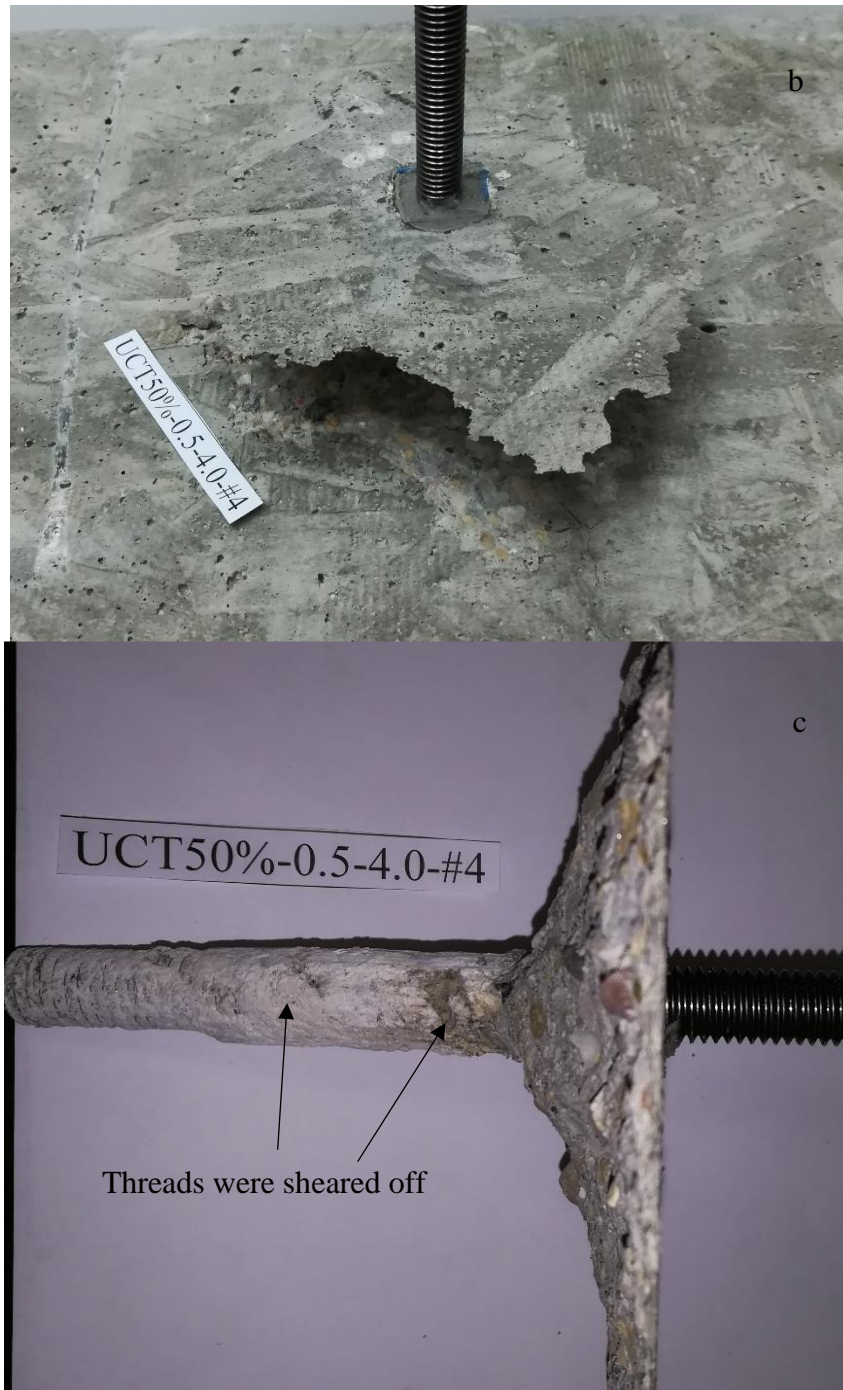
a) load-displacement behavior; b) cracked surface; c) partial cone bond failure
Figure VI.28. Observed behavior of Specimen UCT50%-0.5-4.0-#4

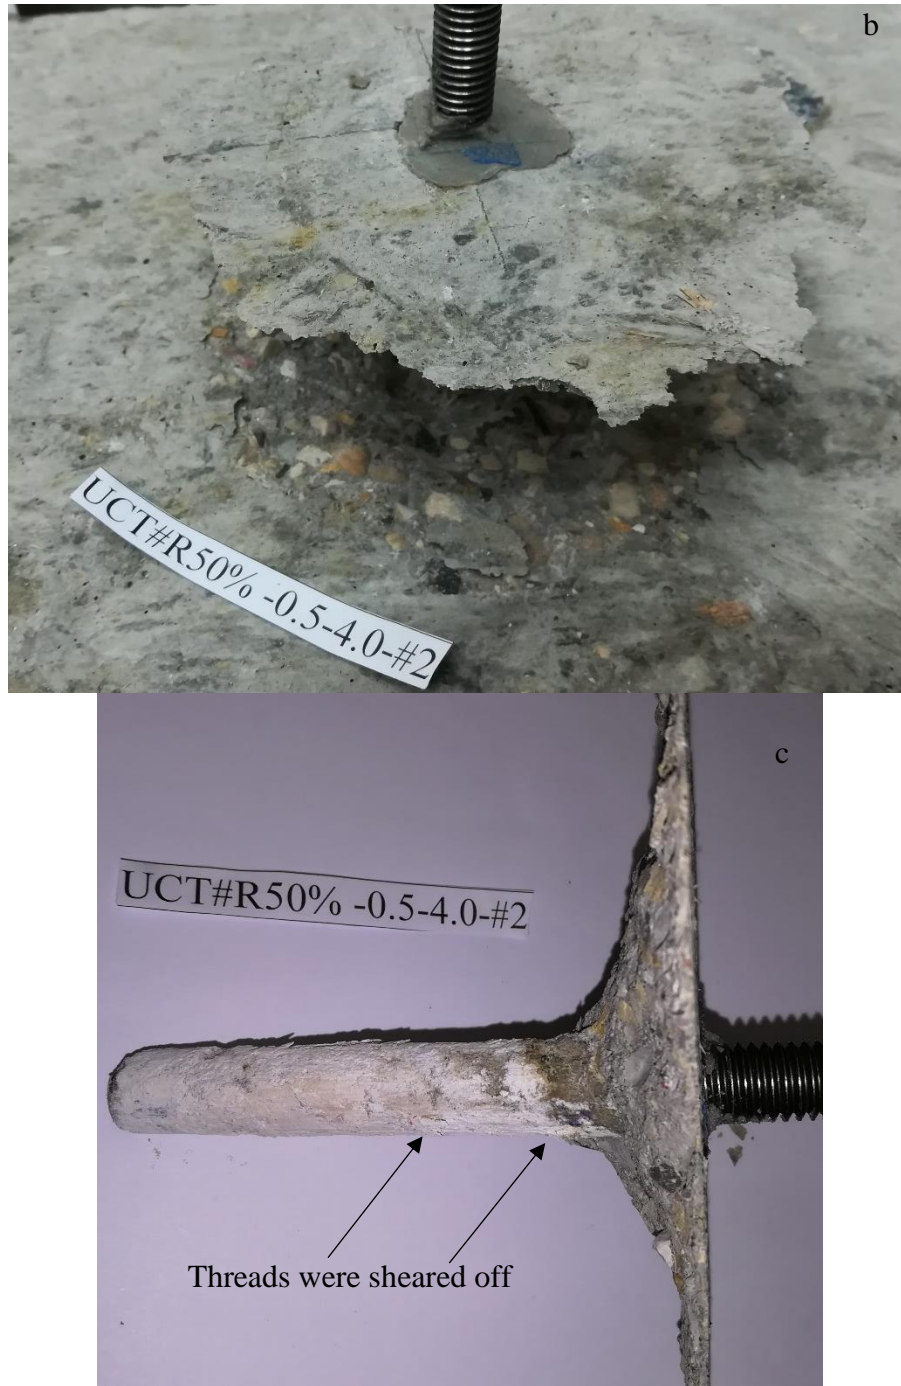
a) load-displacement behavior; b) cracked surface; c) partial cone bond failure
Figure VI.30. Observed behavior of Specimen UCT#R50%-0.5-4.0-#2

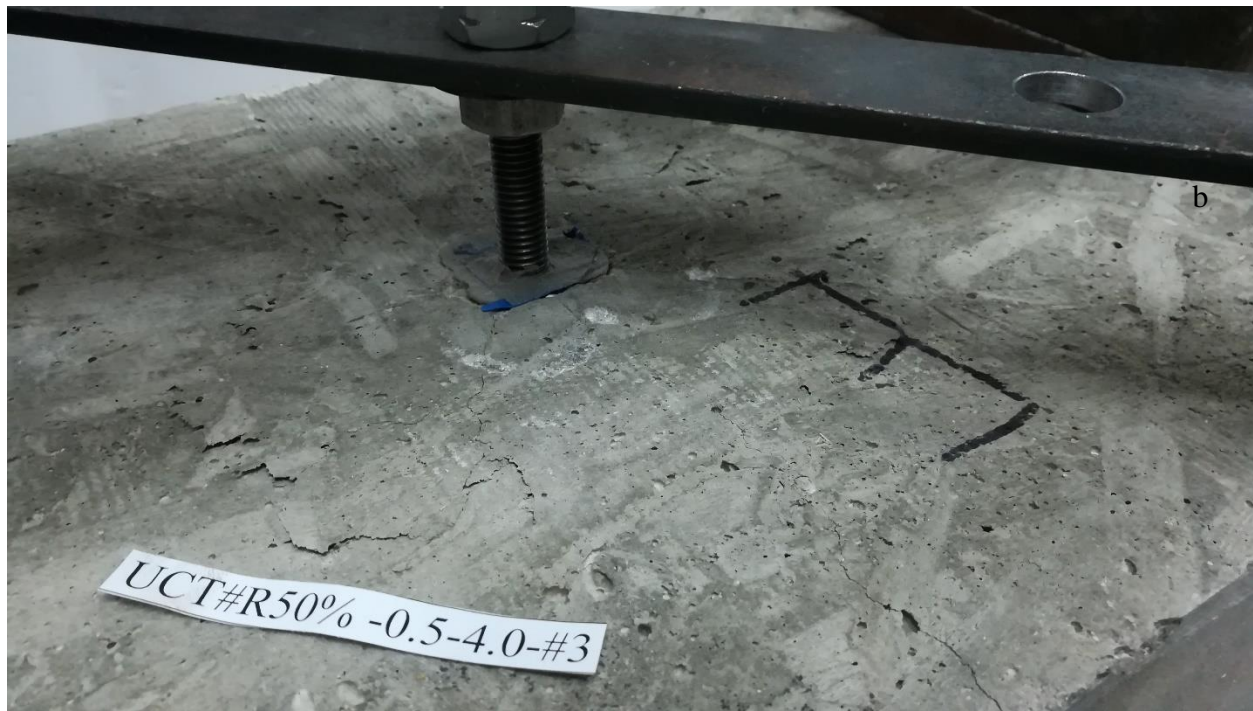
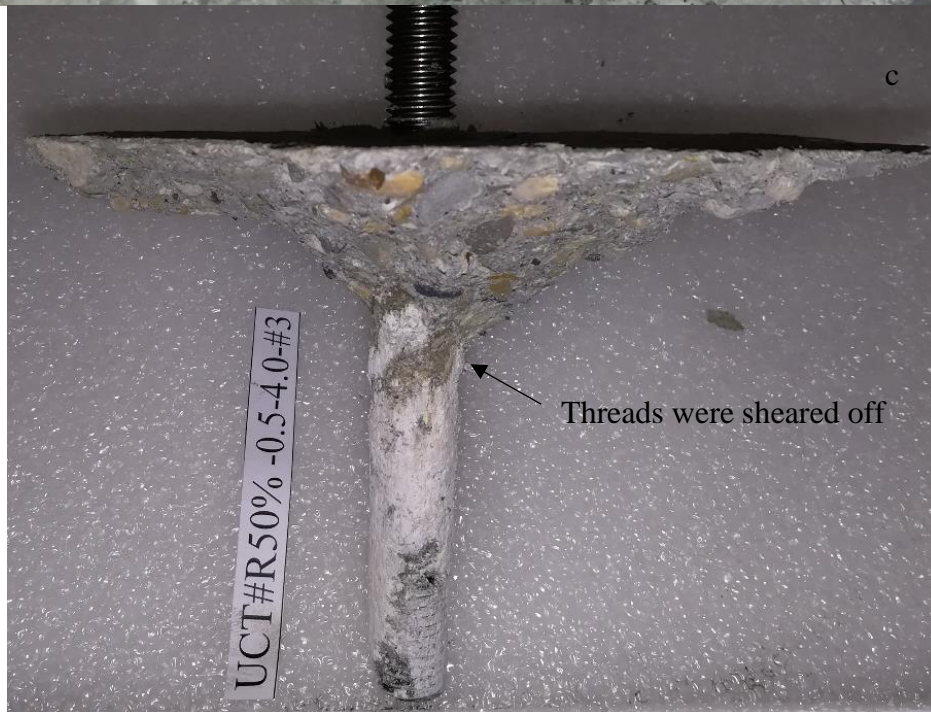
a) load-displacement behavior; b) cracked surface; c) partial cone bond failure
Figure VI.31. Observed behavior of Specimen UCT#R50%-0.5-4.0-#3

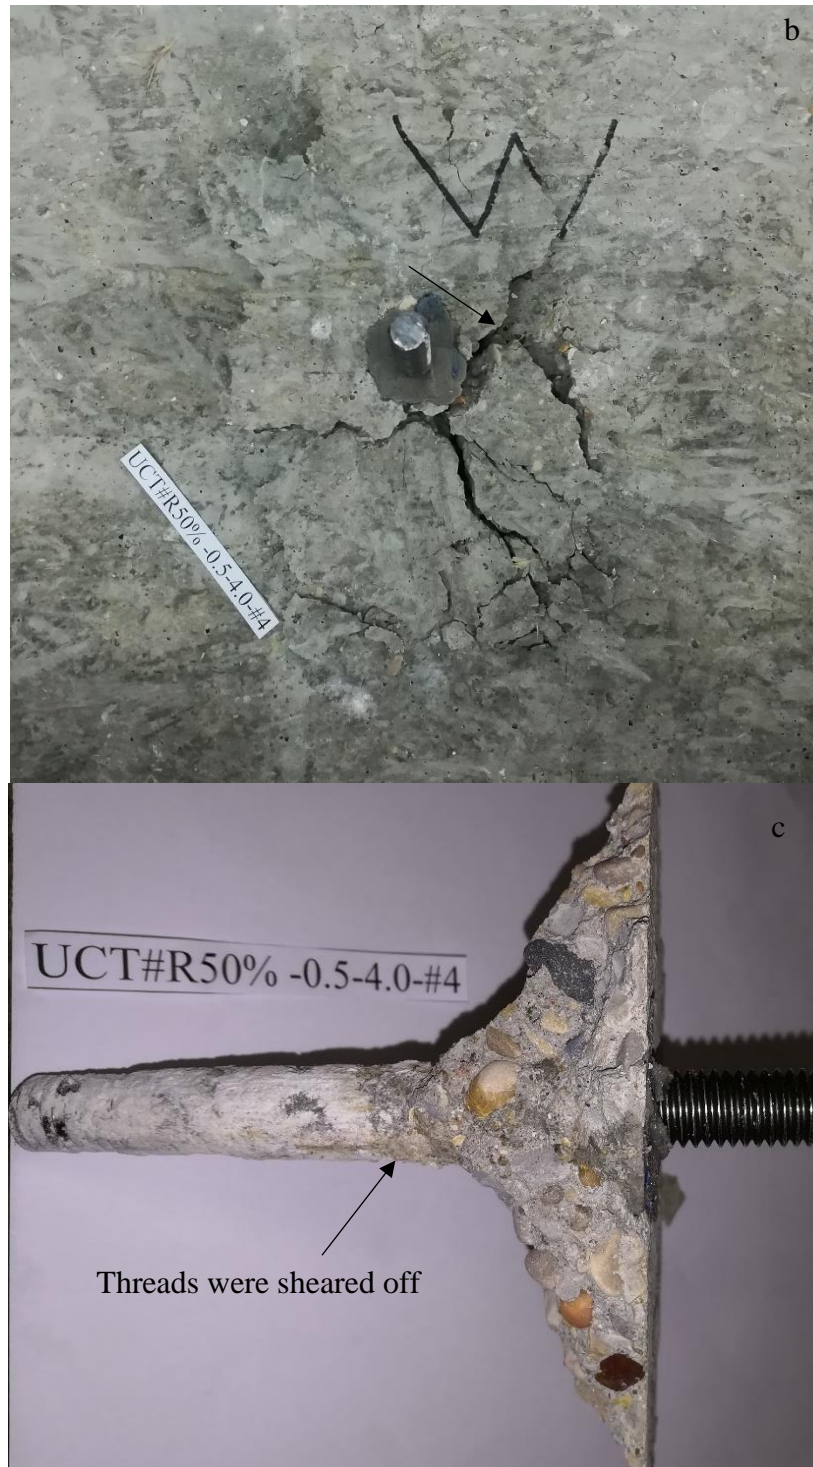
a) load-displacement behavior; b) cracked surface; c) partial cone bond failure
Figure VI.32. Observed behavior of Specimen UCT#R50%-0.5-4.0-#4

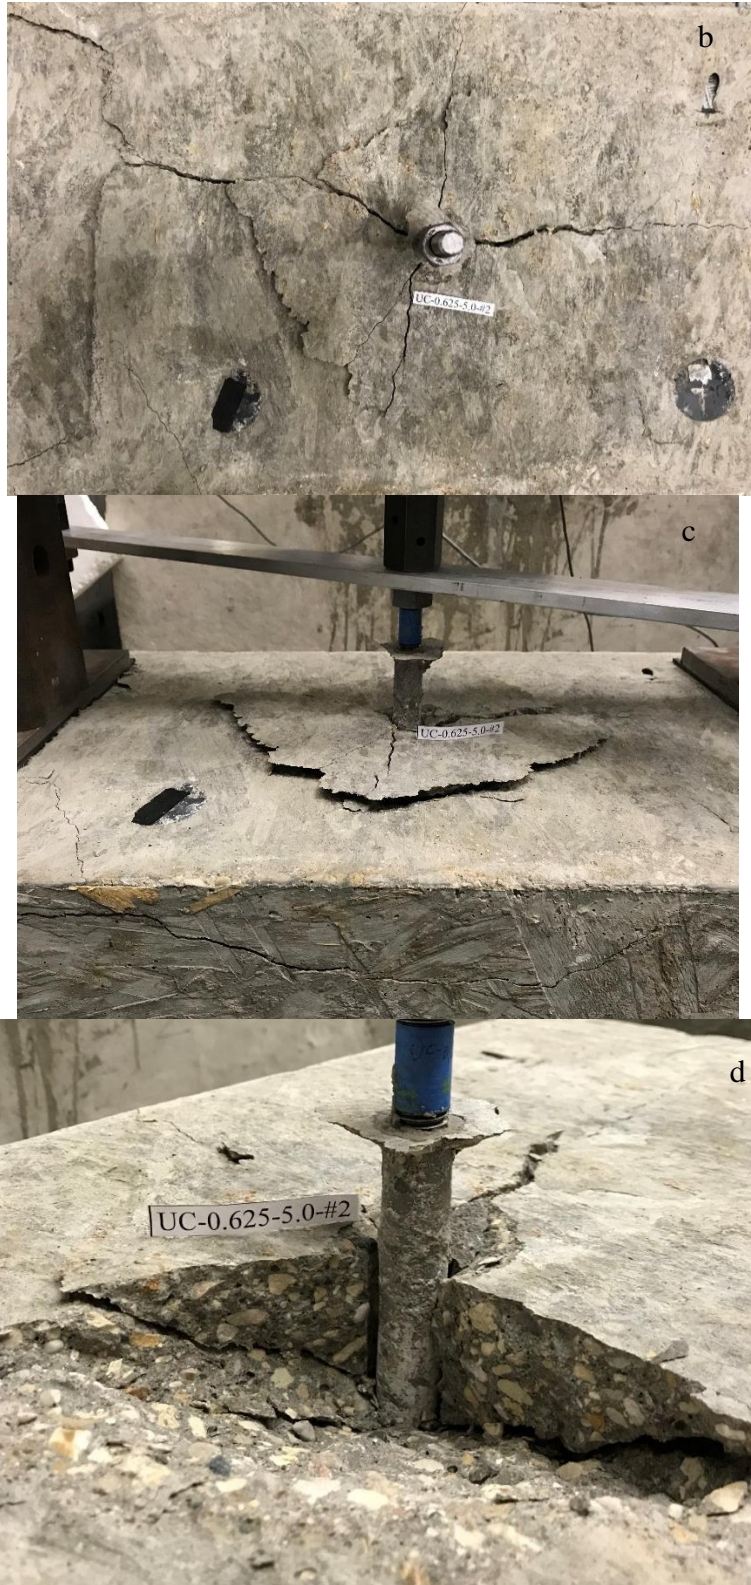
a) load-displacement behavior; b) c) cracked surface; d) concrete breakout failure.
Figure VI.34. Observed behavior of Specimen UC-0.625-5.0-#2

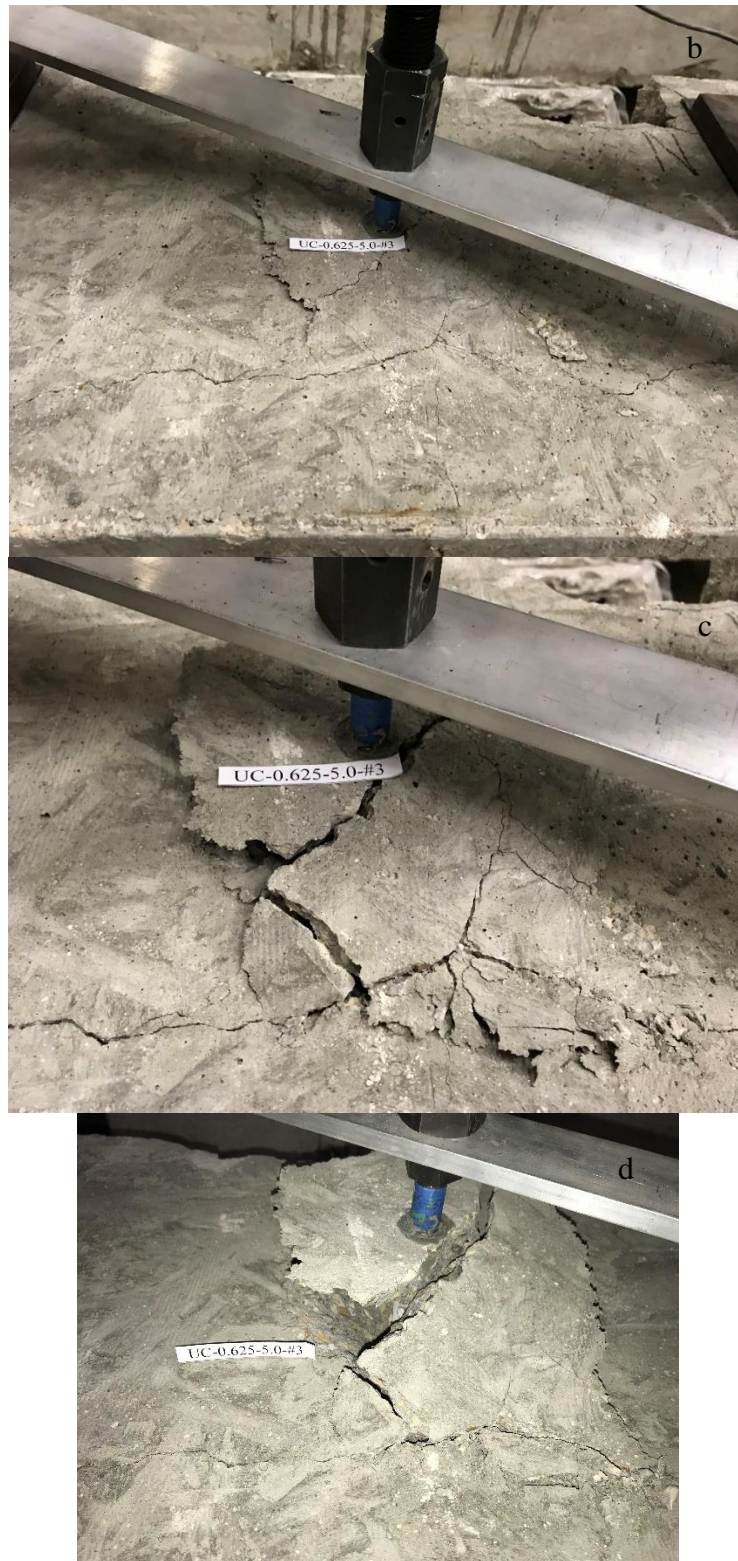
a) load-displacement behavior; b) cracked surface; c) d) partial cone bond failure.
Figure VI.35. Observed behavior of Specimen UC-0.625-5.0-#3

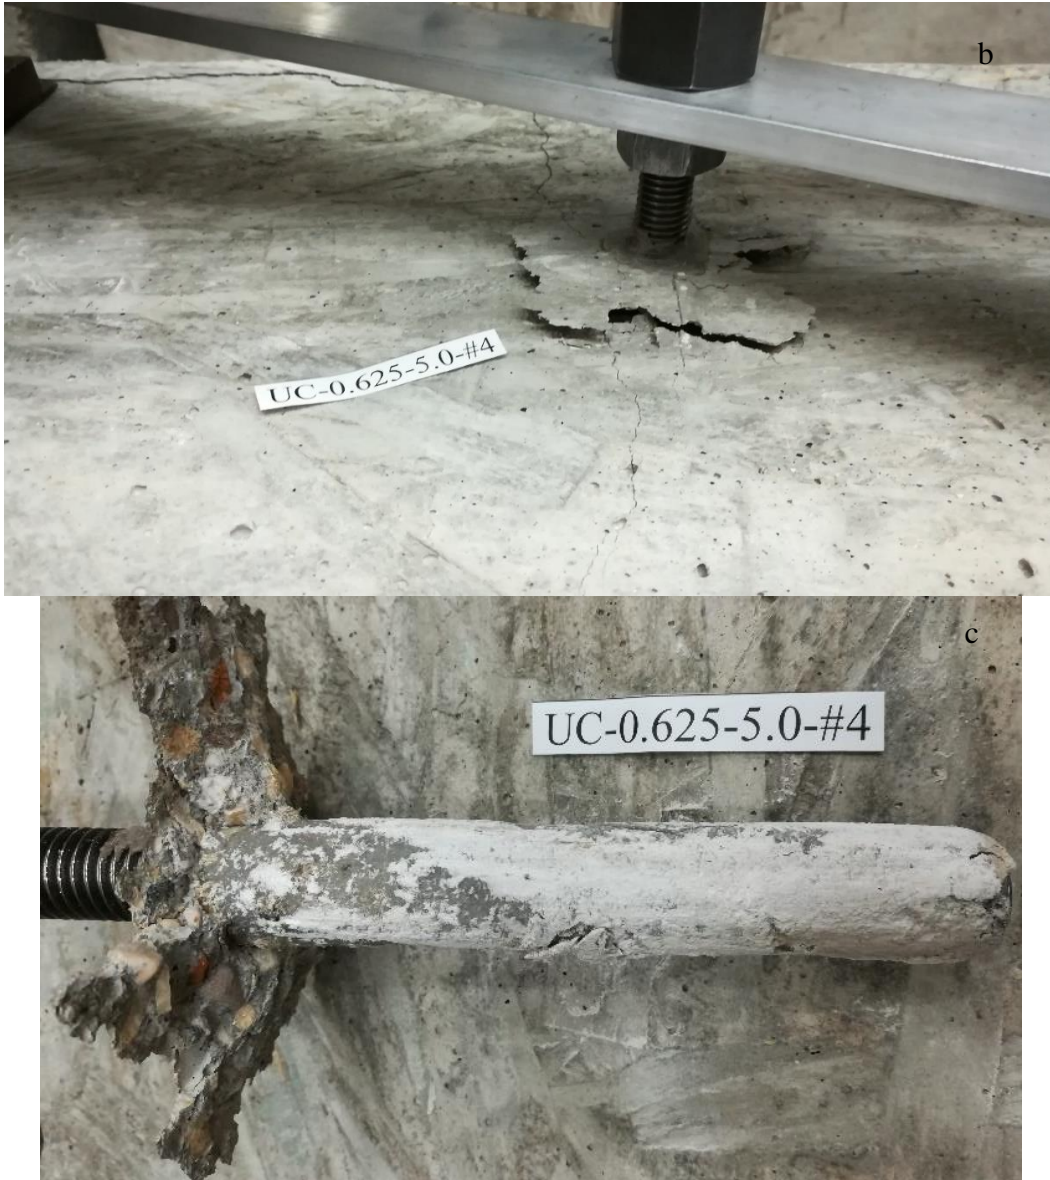
a) load-displacement behavior; b) cracked surface; c) partial cone bond failure.

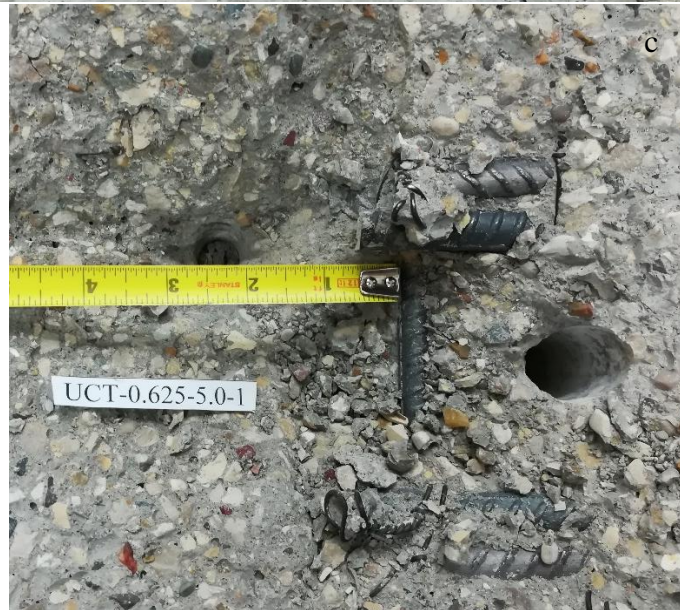
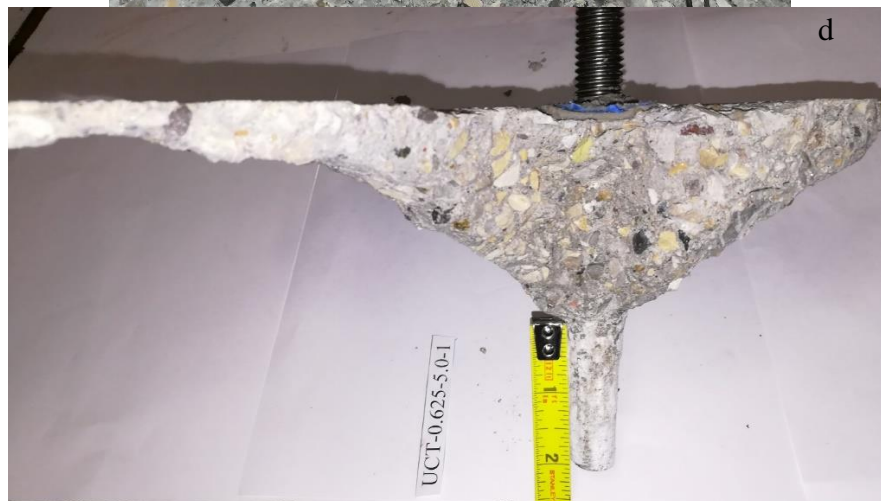
a) load-displacement behavior; b) cracked surface; c) anchor location; d) concrete breakout cone.

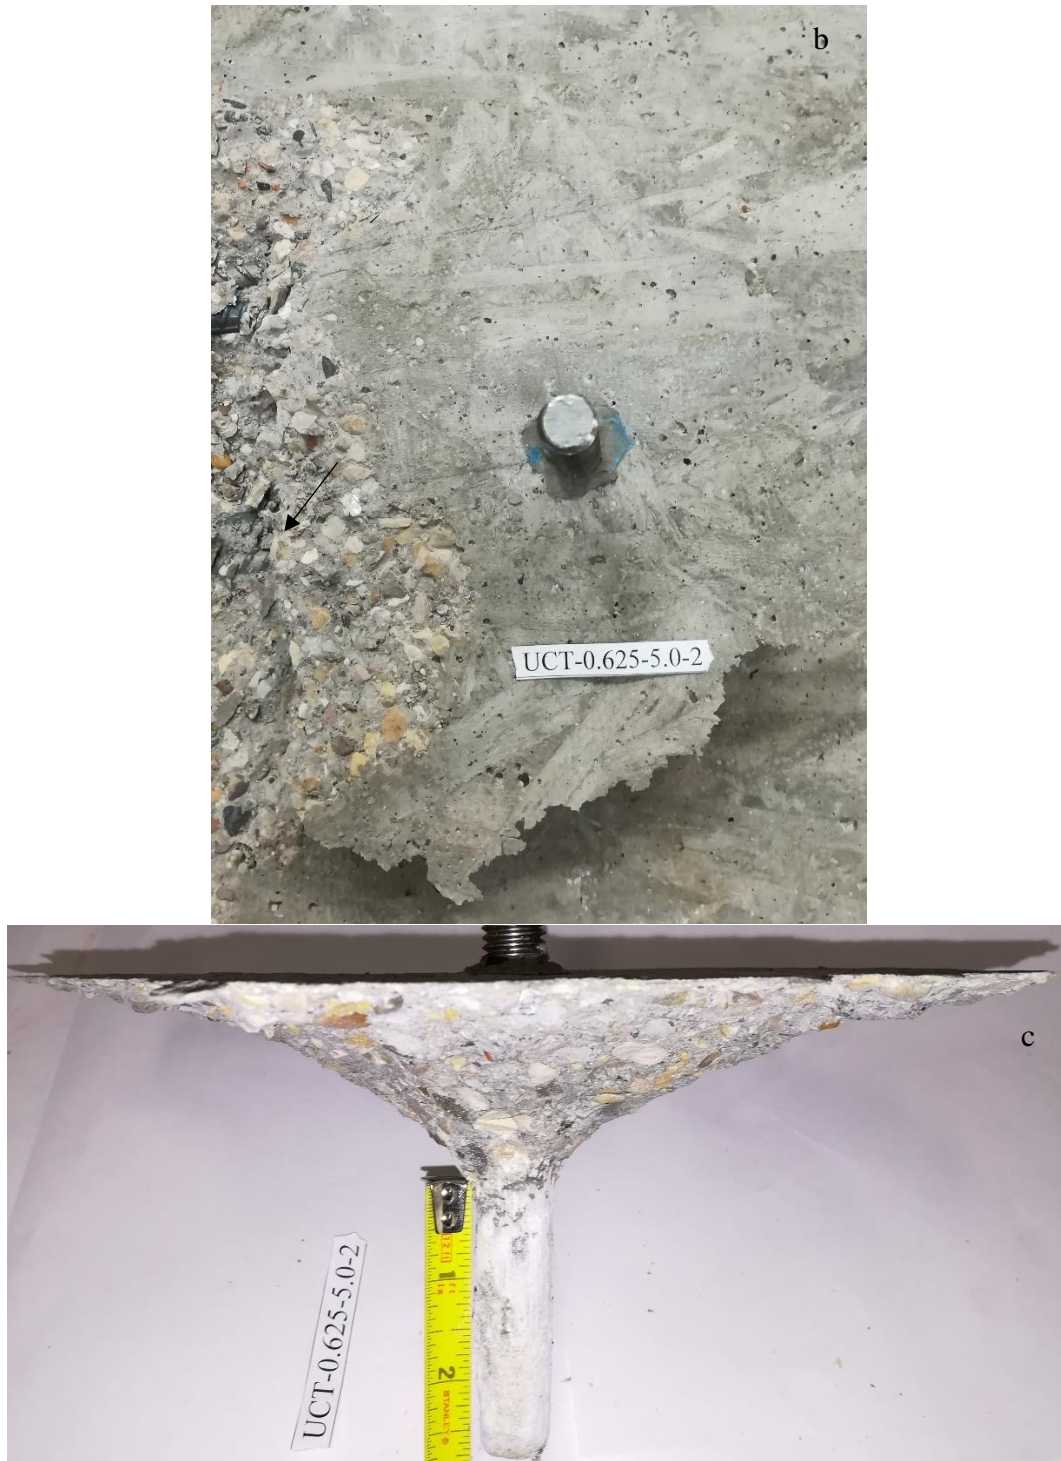
a) load-displacement behavior; b) cracked surface; c) partial cone bond failure.
Figure VI.38. Observed behavior of Specimen UCT-0.625-5.0-#2

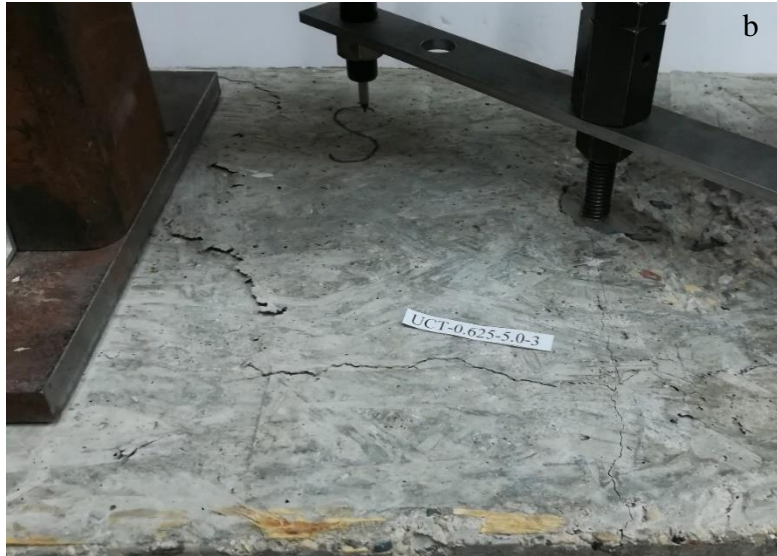
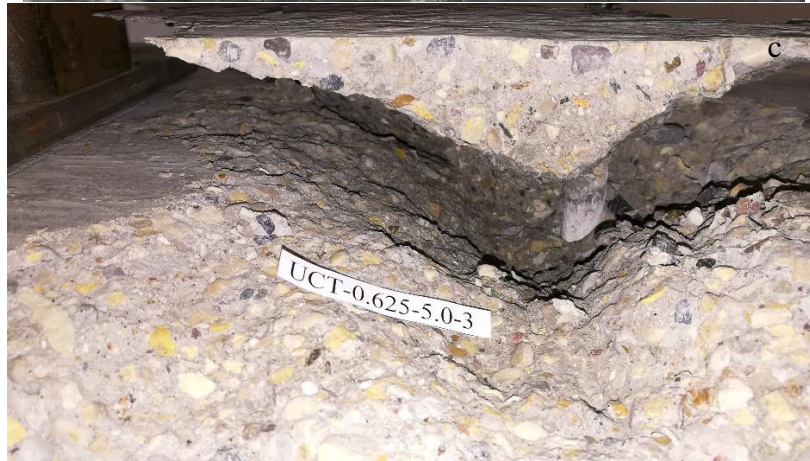
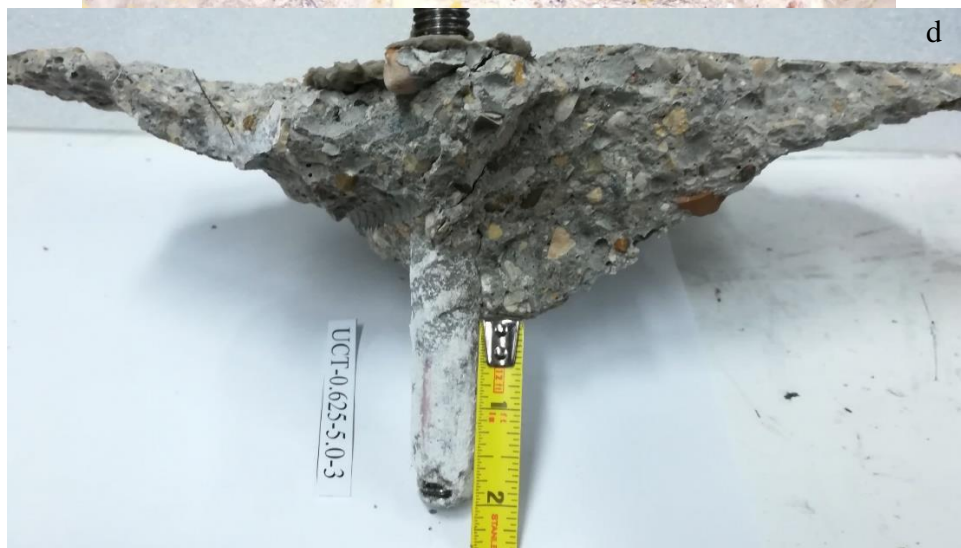
a) load-displacement behavior; b) cracked surface; c) concrete breakout cone in block; d) concrete breakout cone.

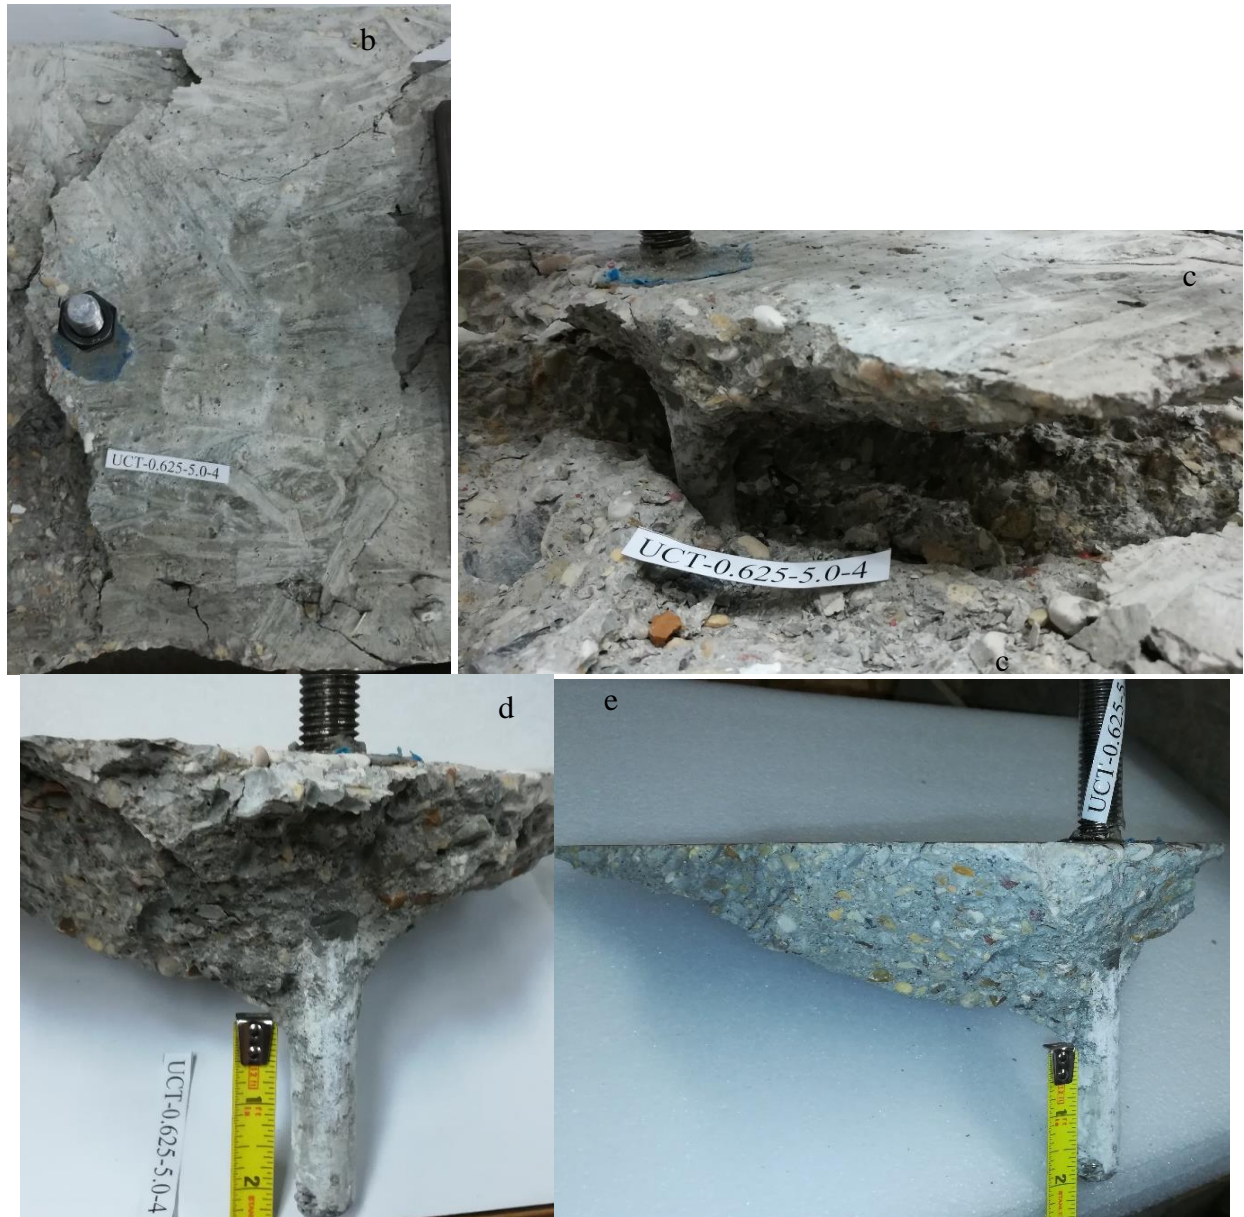
a) load-displacement behavior; b) cracked surface; c) concrete breakout cone in block; d) e) concrete breakout cone.

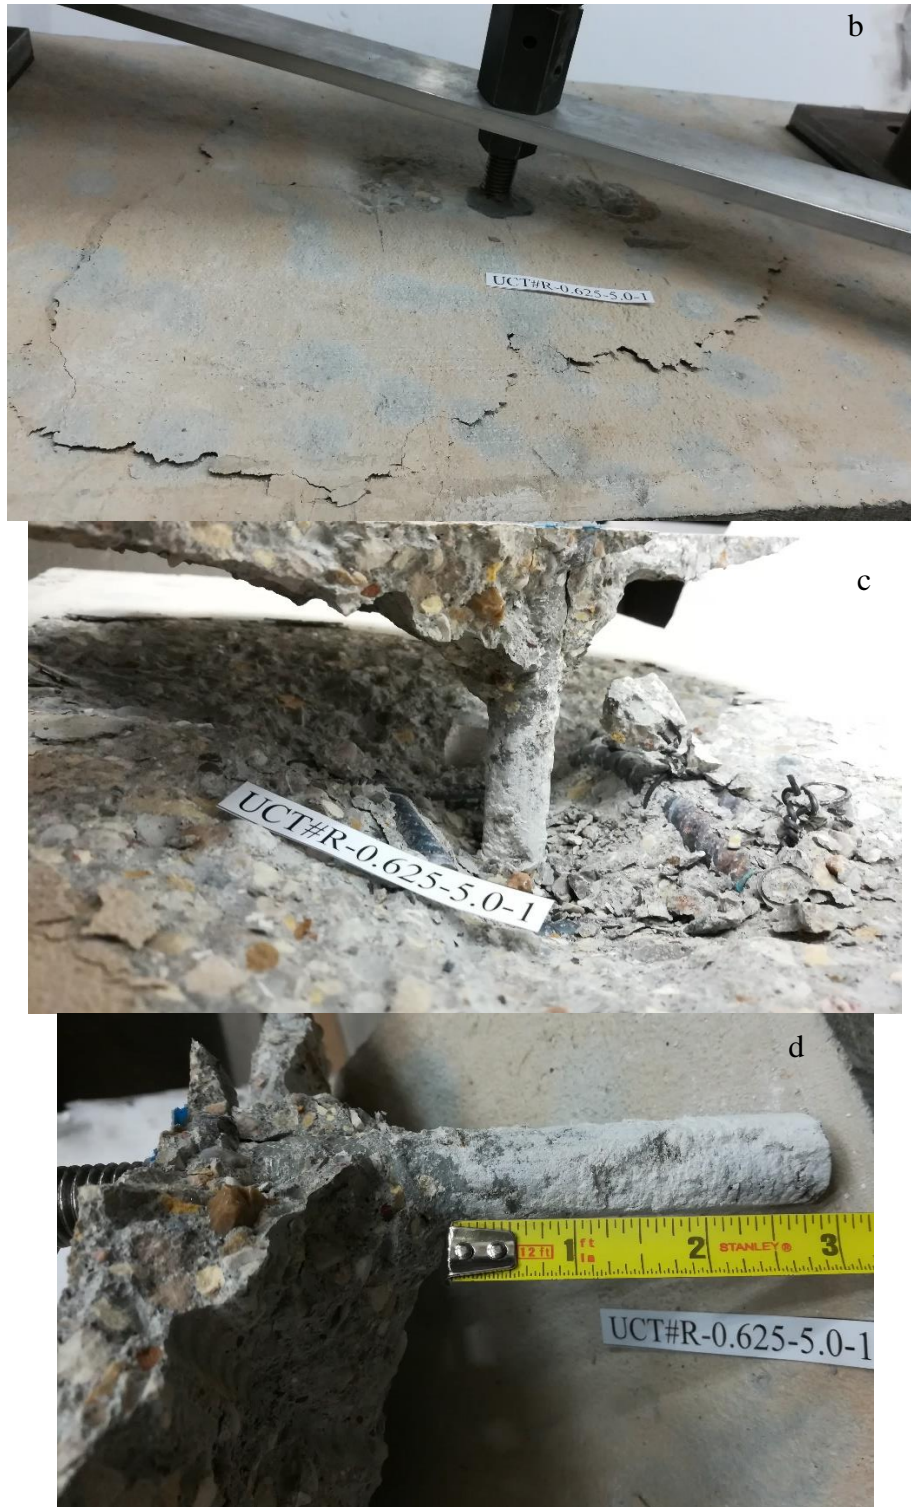
a) load-displacement behavior; b) cracked surface; c) partial cone in block; d) partial cone bond failure.
Figure VI.41. Observed behavior of Specimen UCT#R-0.625-5.0-#1

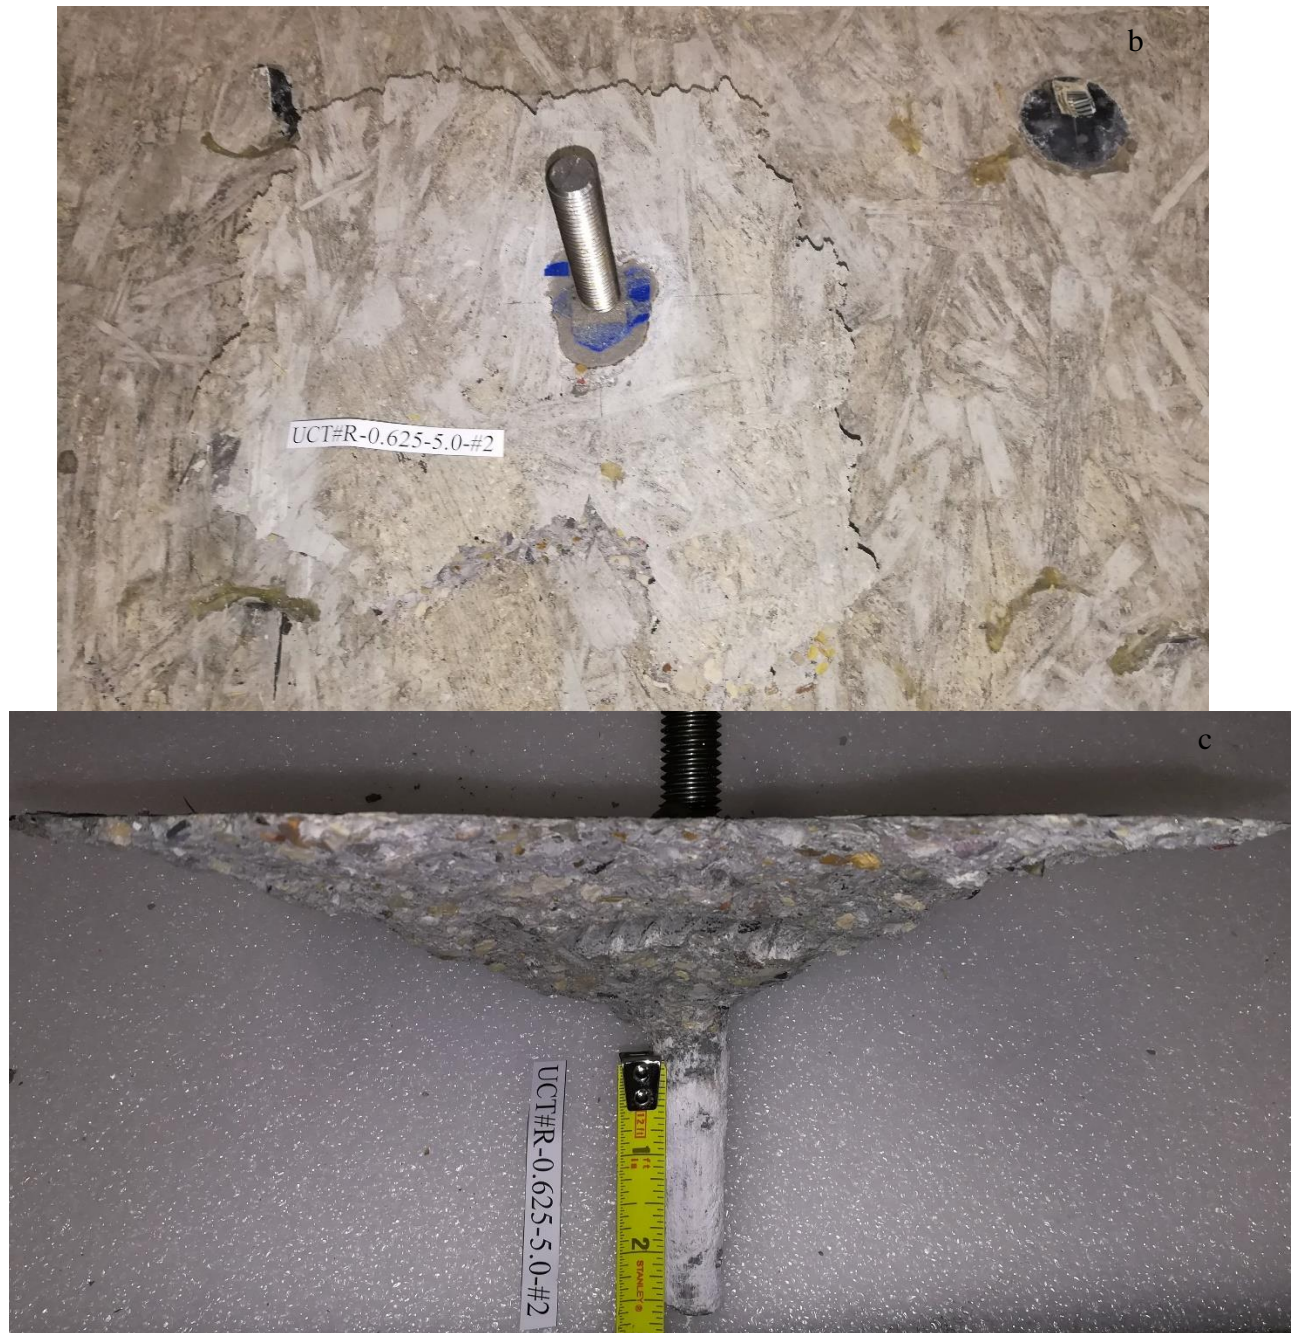
a) load-displacement behavior; b) cracked surface; c) partial cone bond failure.
Figure VI.42. Observed behavior of Specimen UCT#R-0.625-5.0-#2

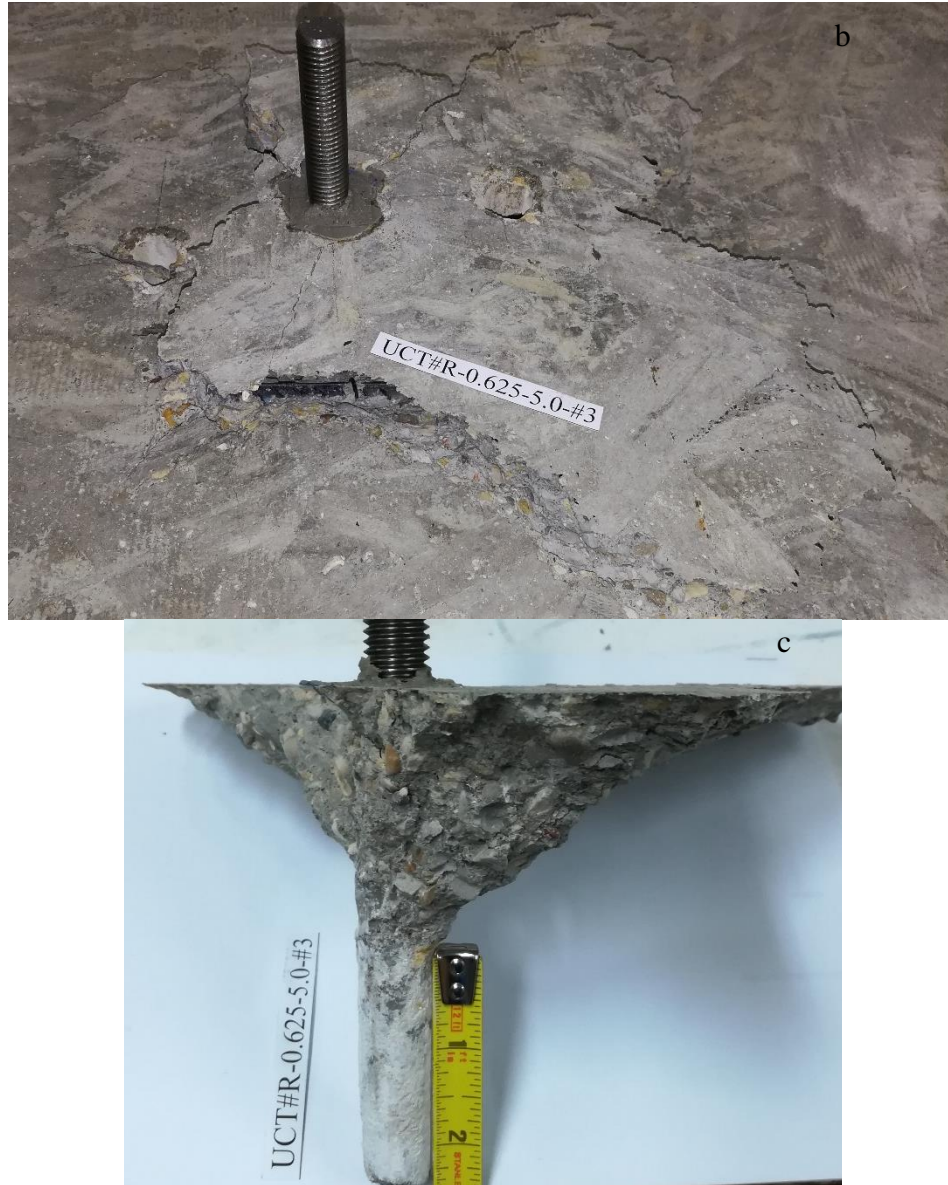
a) load-displacement behavior; b) cracked surface; c) partial cone bond failure.
Figure VI.43. Observed behavior of Specimen UCT#R-0.625-5.0-#3

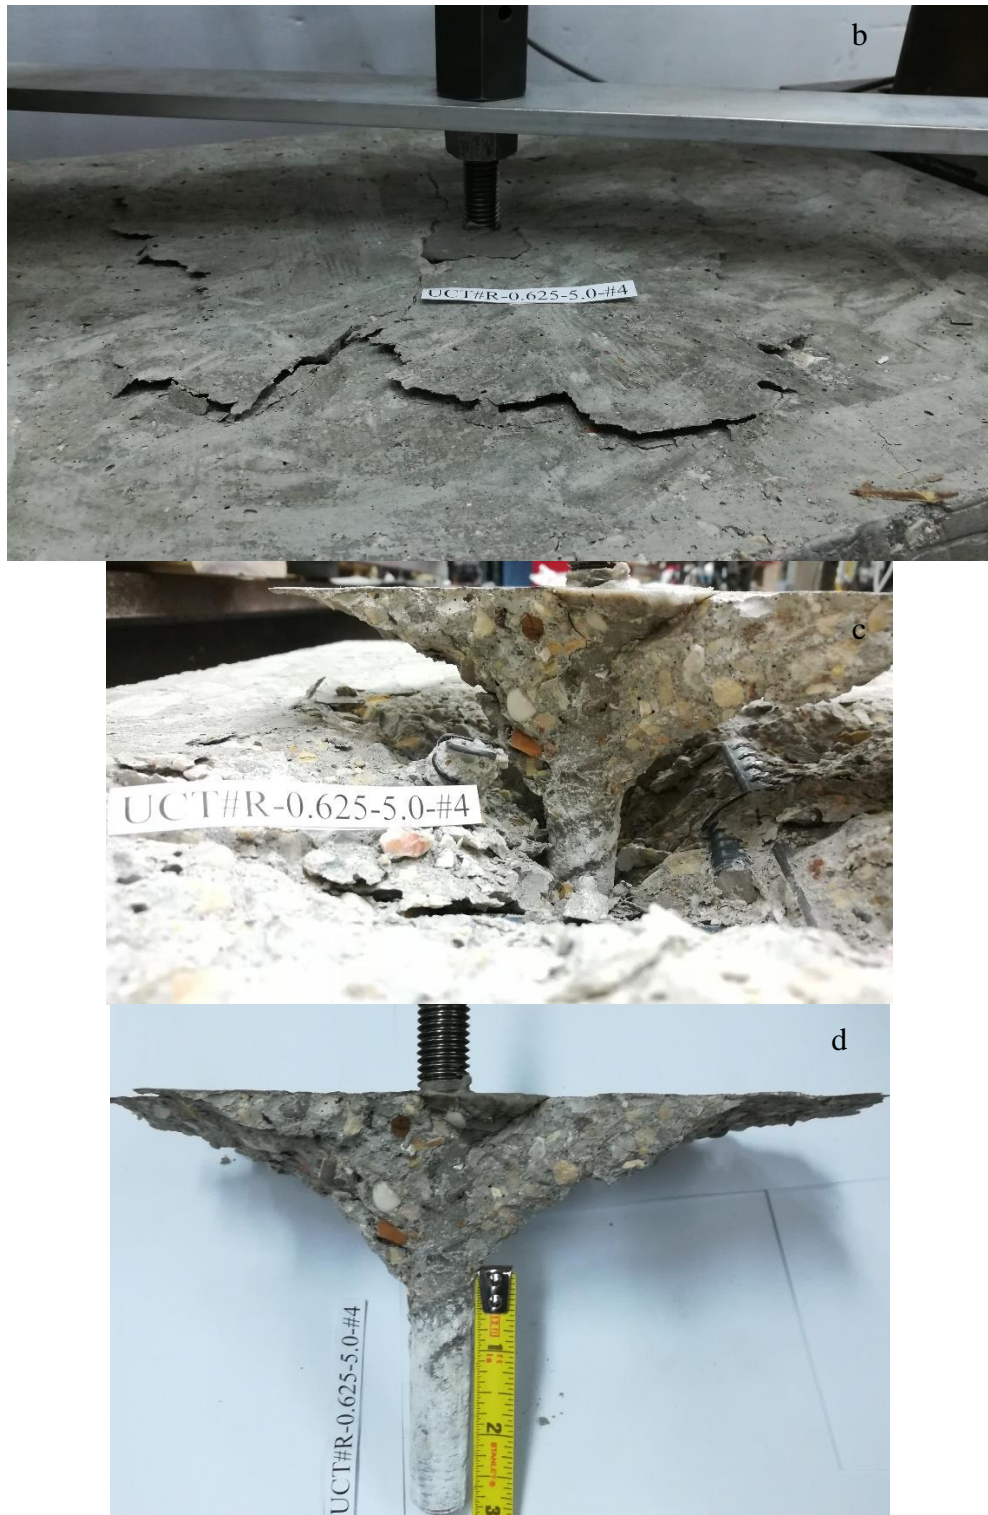
a) load-displacement behavior; b) cracked surface; c) partial cone bond failure.
Figure VI.44. Observed behavior of Specimen UCT#R-0.625-5.0-#4

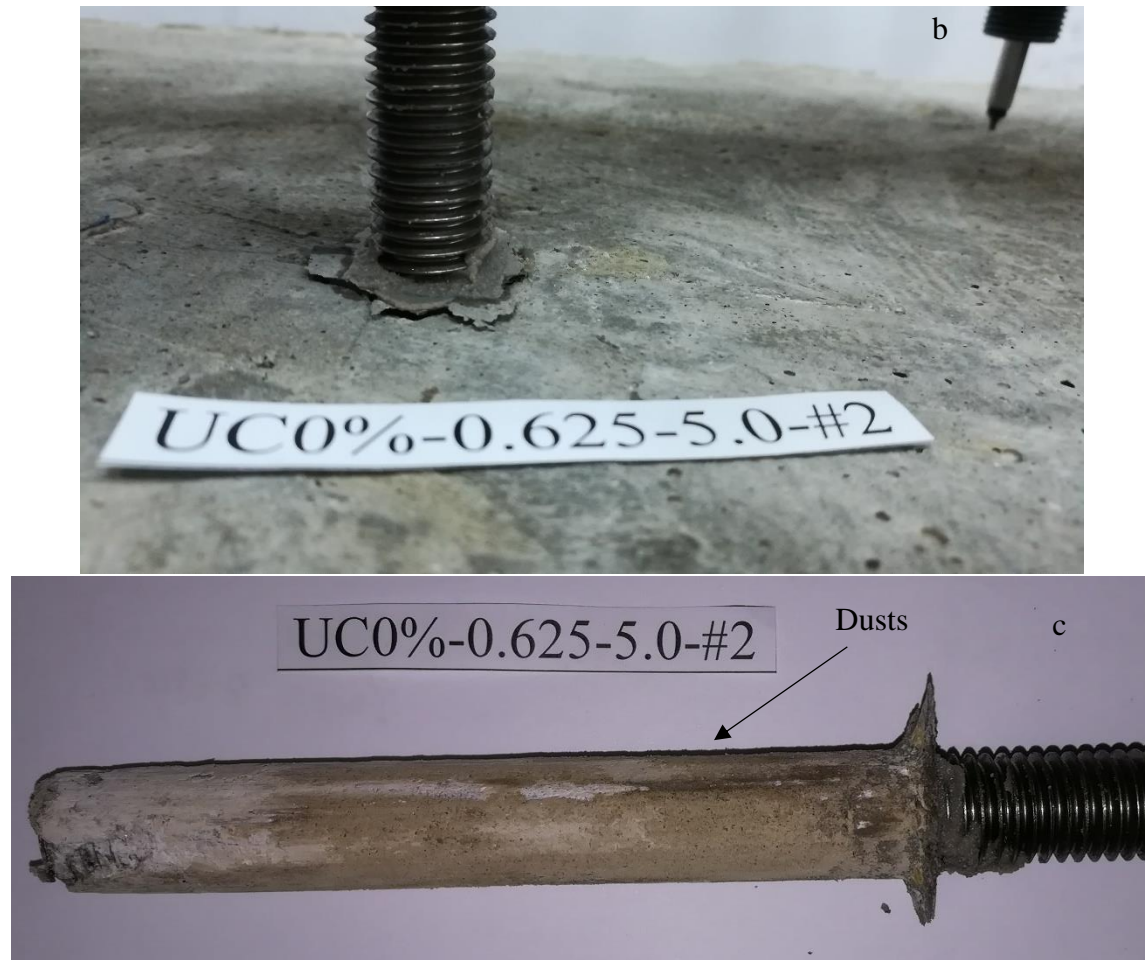
a) load-displacement behavior; b) cracked surface; c) partial cone bond failure.
Figure VI.46. Observed behavior of Specimen UC0%-0.625-5.0-#2

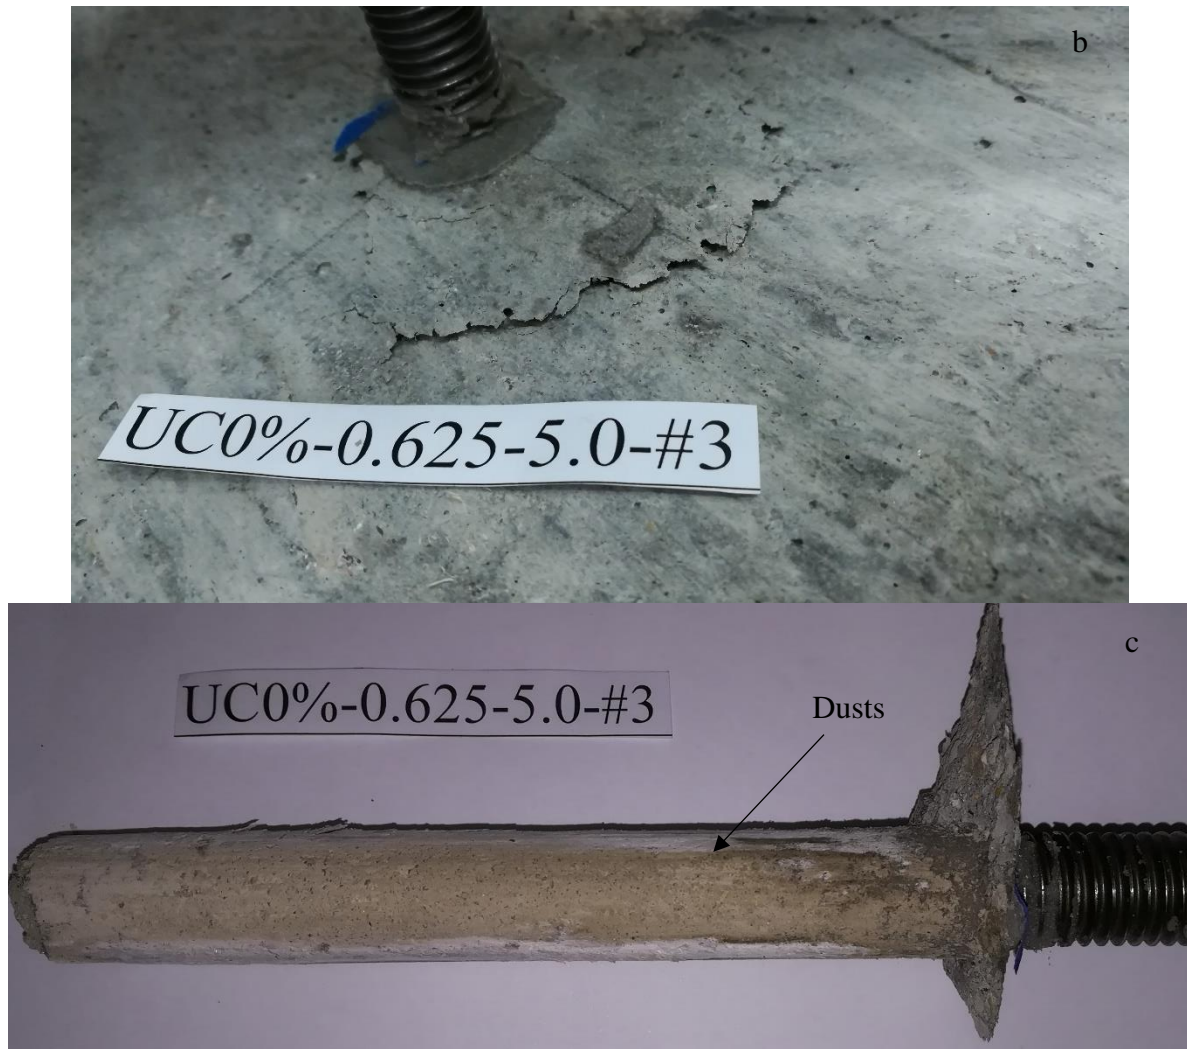
a) load-displacement behavior; b) cracked surface; c) partial cone bond failure.
Figure VI.47. Observed behavior of Specimen UC0%-0.625-5.0-#3
