August 2020

Novel Adhesive Anchoring System Through Engineered Interface

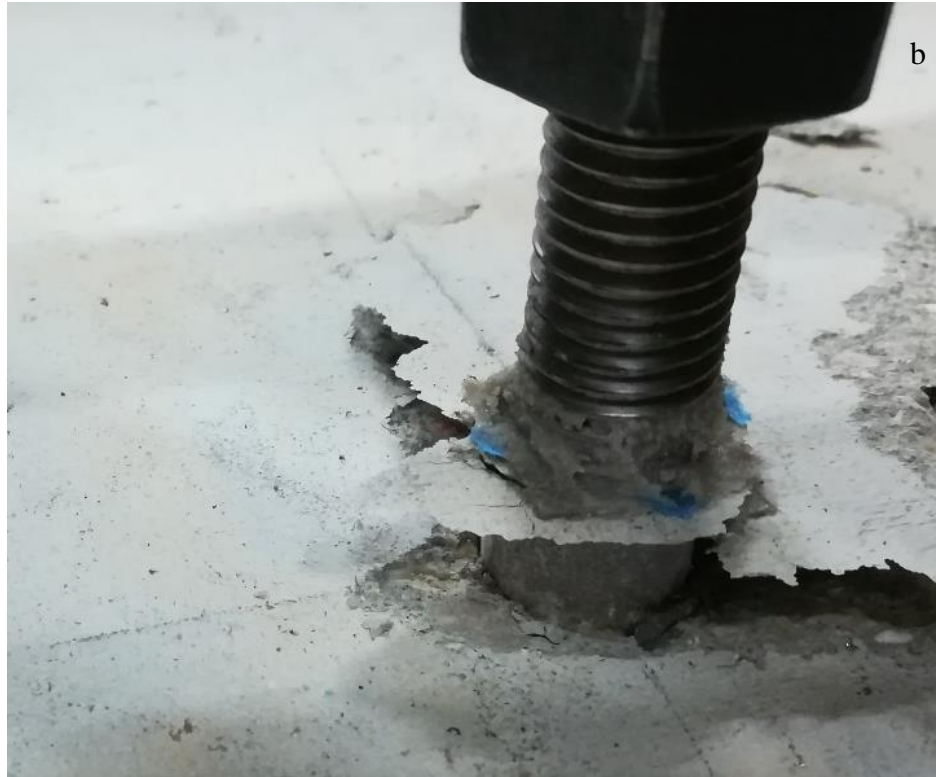
a) load-displacement behavior; b) cracked surface; c) partial cone bond failure.

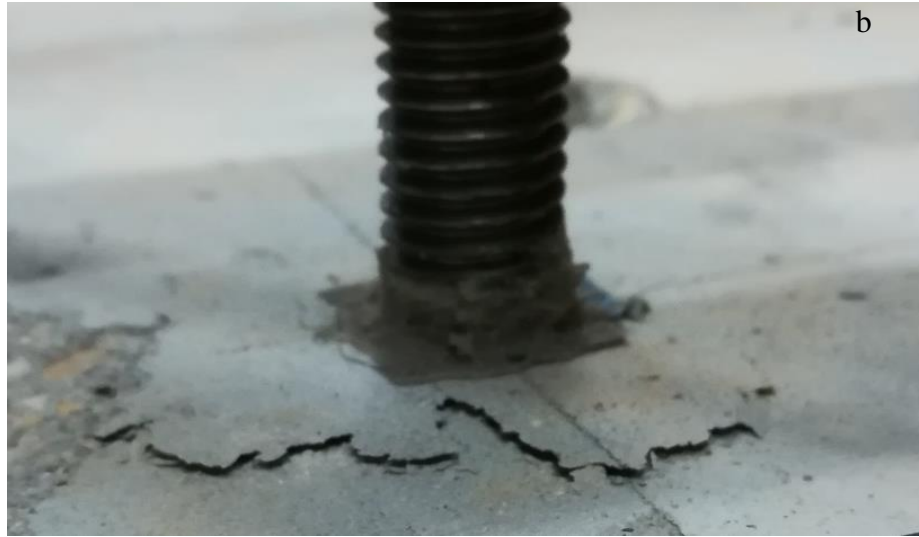
a) load-displacement behavior; b) cracked surface; c) partial cone bond failure.

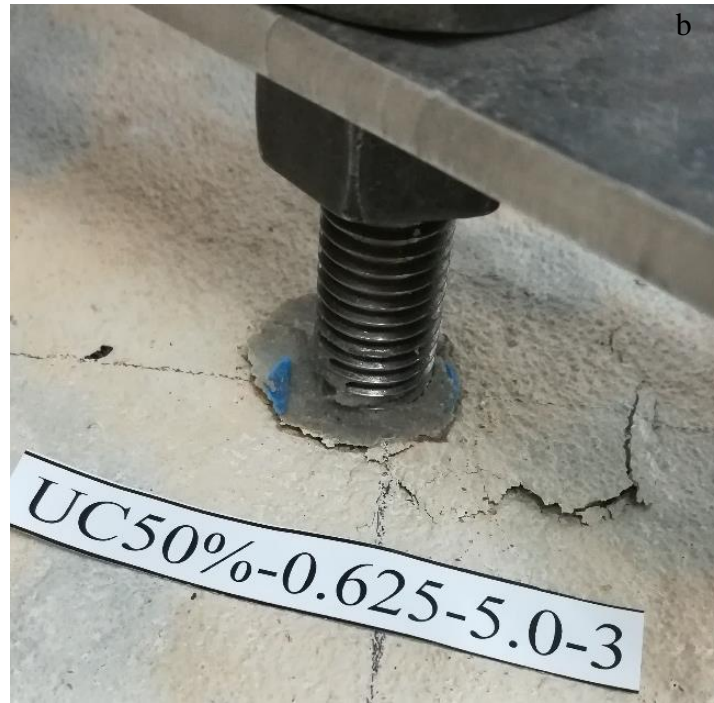
a) load-displacement behavior; b) cracked surface; c) partial cone bond failure.
Figure VI.51. Observed behavior of Specimen UC50%-0.625-5.0-#3

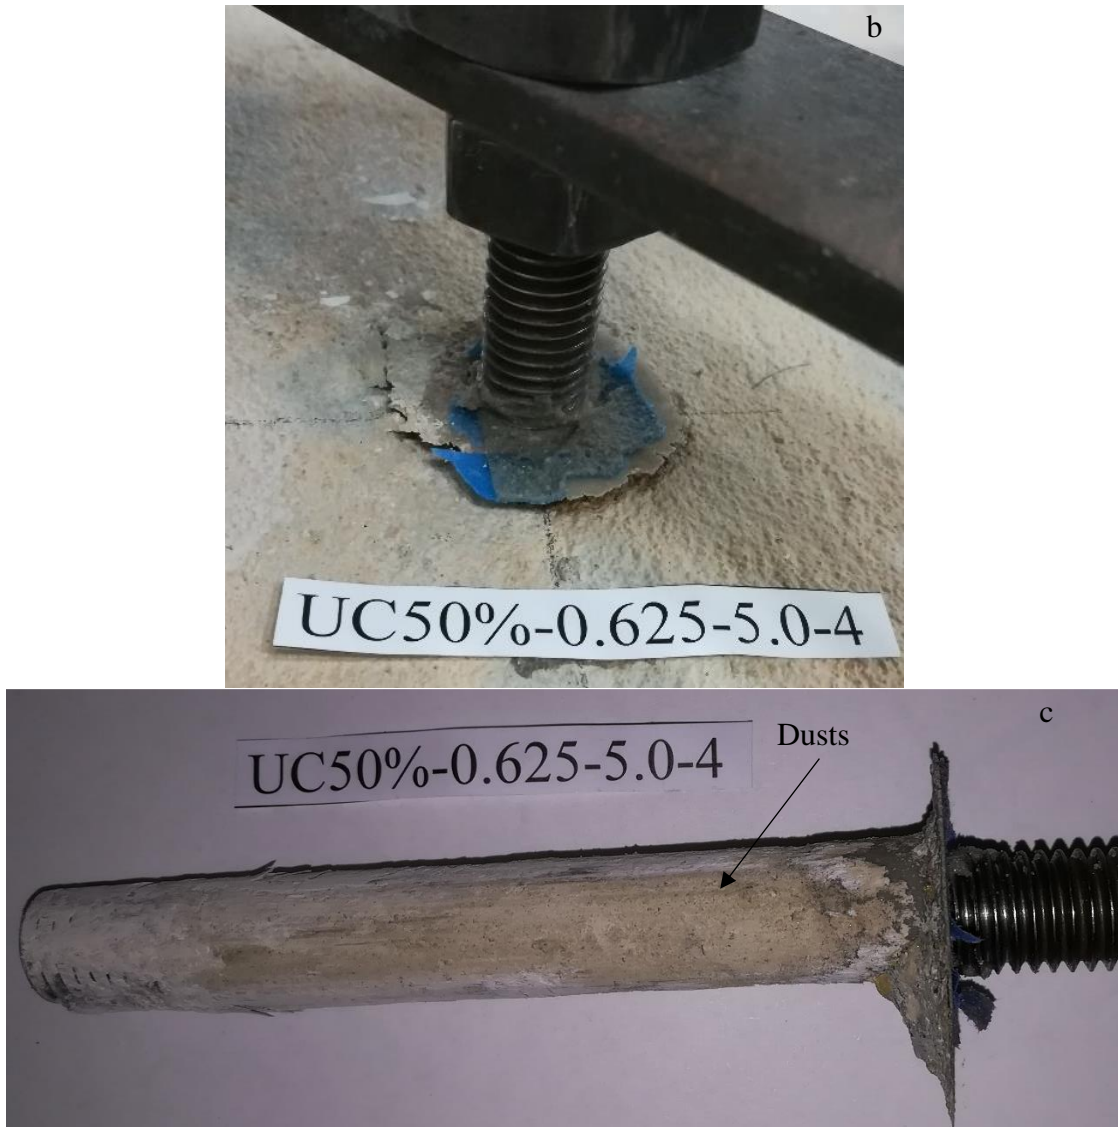
a) load-displacement behavior; b) cracked surface; c) partial cone bond failure.
Figure VI.52. Observed behavior of Specimen UC50%-0.625-5.0-#4

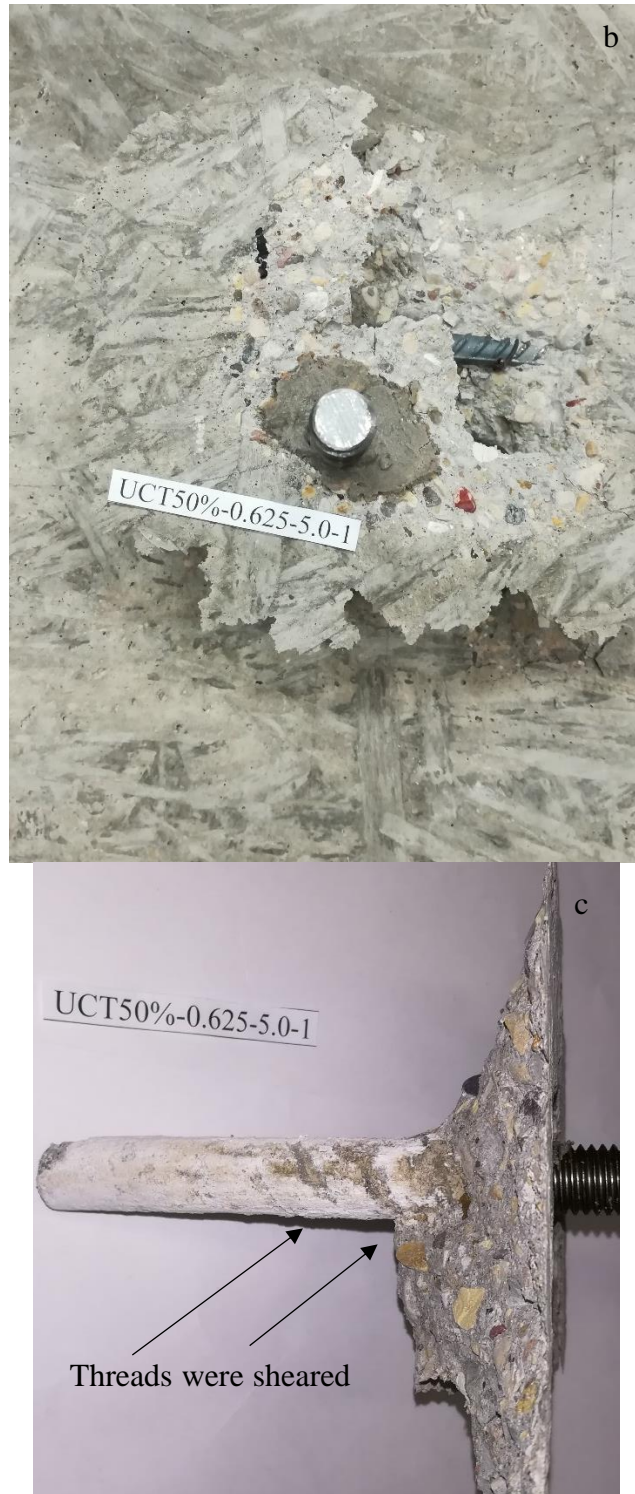
a) load-displacement behavior; b) cracked surface; c) partial cone bond failure.
Figure VI.53. Observed behavior of Specimen UCT50%-0.625-5.0-#1

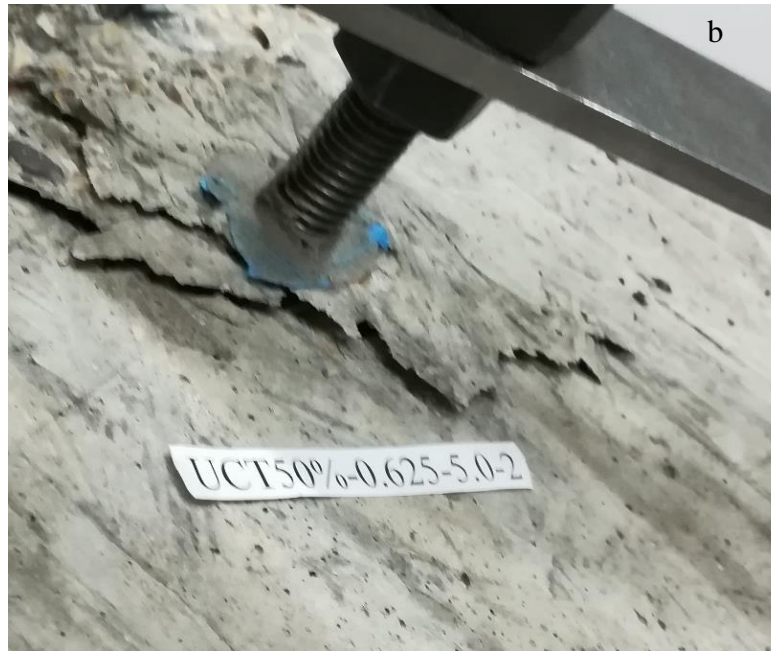
a) load-displacement behavior; b) cracked surface; c) partial cone bond failure.
Figure VI.54. Observed behavior of Specimen UCT50%-0.625-5.0-#2

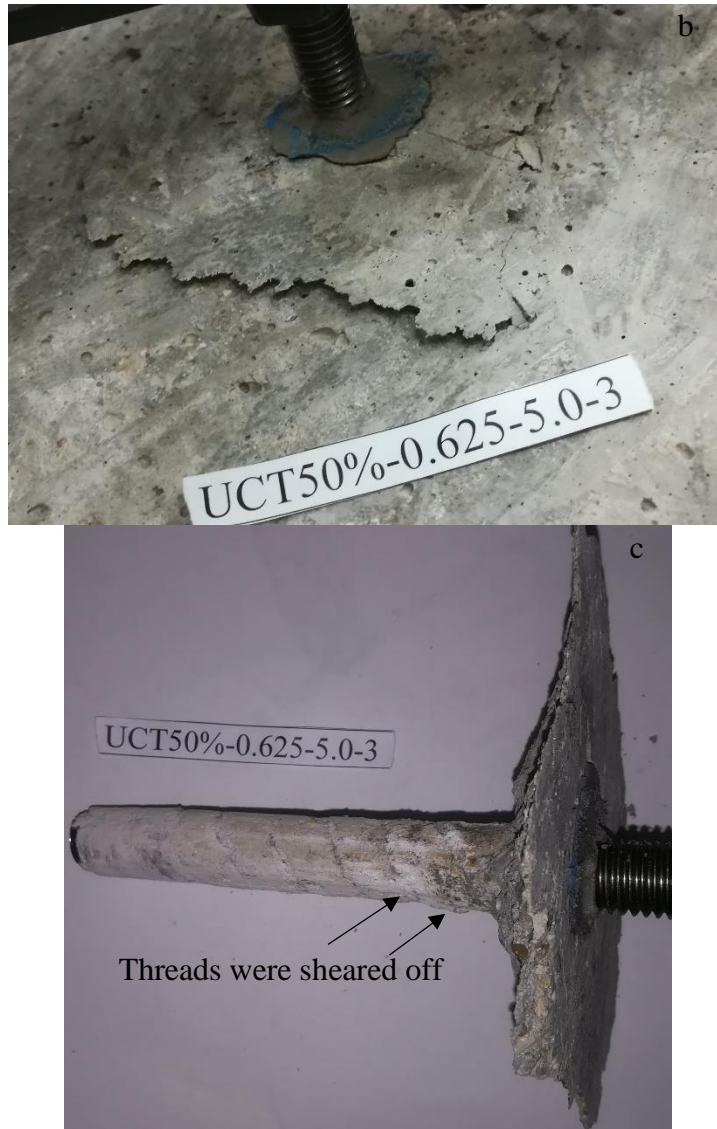
a) load-displacement behavior; b) cracked surface; c) partial cone bond failure.
Figure VI.55. Observed behavior of Specimen UCT50%-0.625-5.0-#3

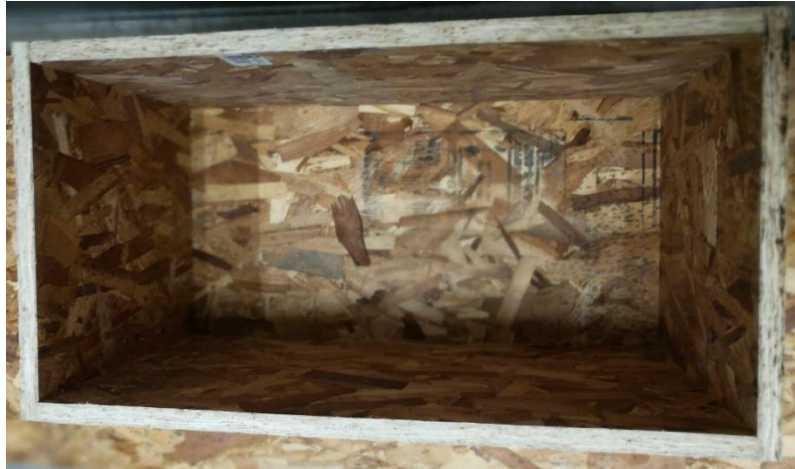
18" x 18" x 32" - 1 block

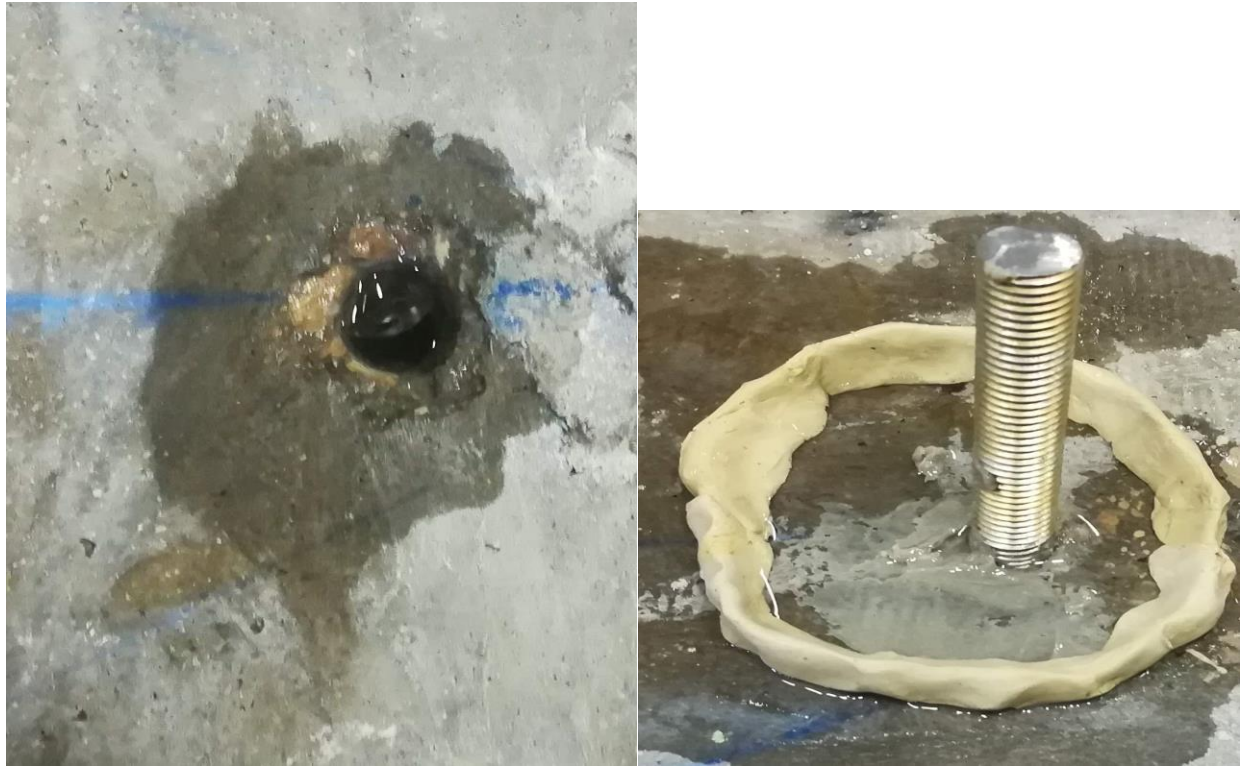
Figure IX.1. Water-filled the hole and ponding water

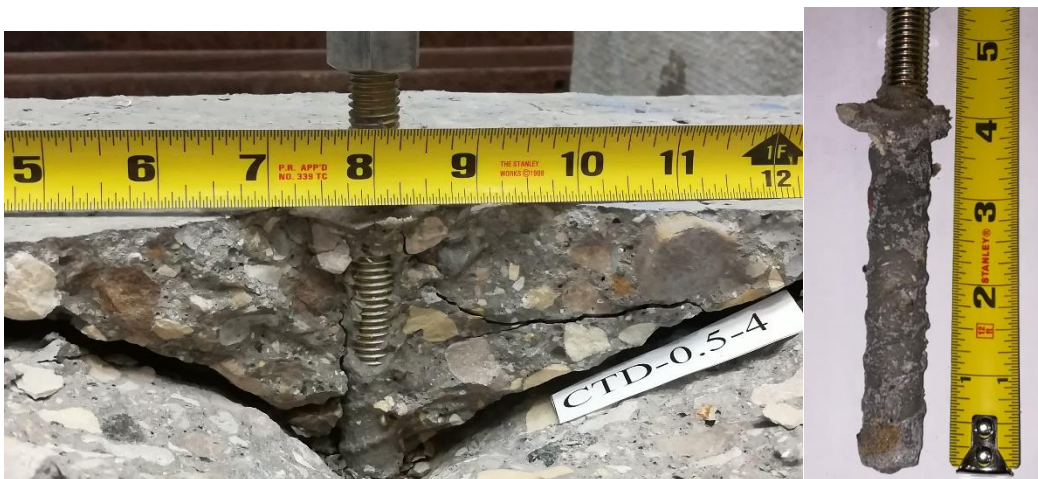
Figure IX.8. Concrete breakout failure of CTD (3032018)
