System for Detection of Defects in Cables of Bridge Structures

SYSTEM FOR DETECTION OF DEFECTS IN CABLES OF BRIDGE STRUCTURES

Doctor of Philosophy

The University of Wisconsin – Milwaukee

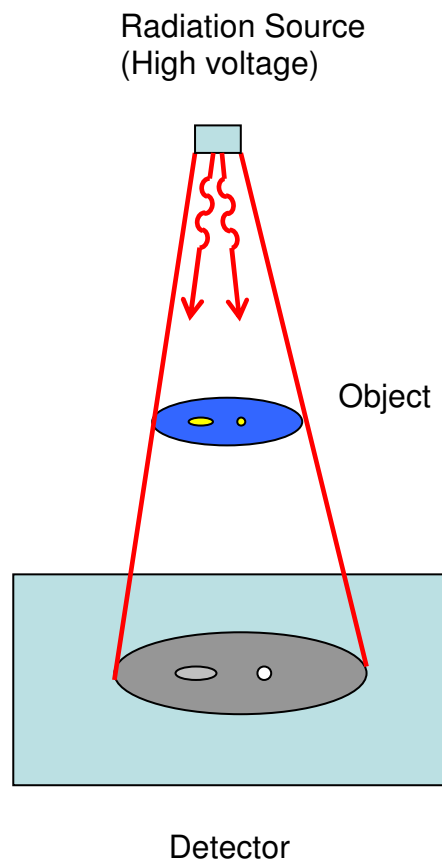
Figure 2.1 X-ray Method: X-ray diagram showing radiation beams penetrating an object and being collected at the receiver end to generate an image.

Figure 2.1 shows a general setup for an X-ray inspection method with a material under inspection. X-rays or Gamma-rays enter the material under test from one side and some or all exit from the other side. The beam usually travels in a straight line. However, it goes under scattering, and absorption process; the amount of scattering and absorption depends on the material's molecular structure. The beams that penetrate through the material are detected and recorded either on a real-time digital monitoring receiver or on a special radiographic detector to produce 2D images [13-19].

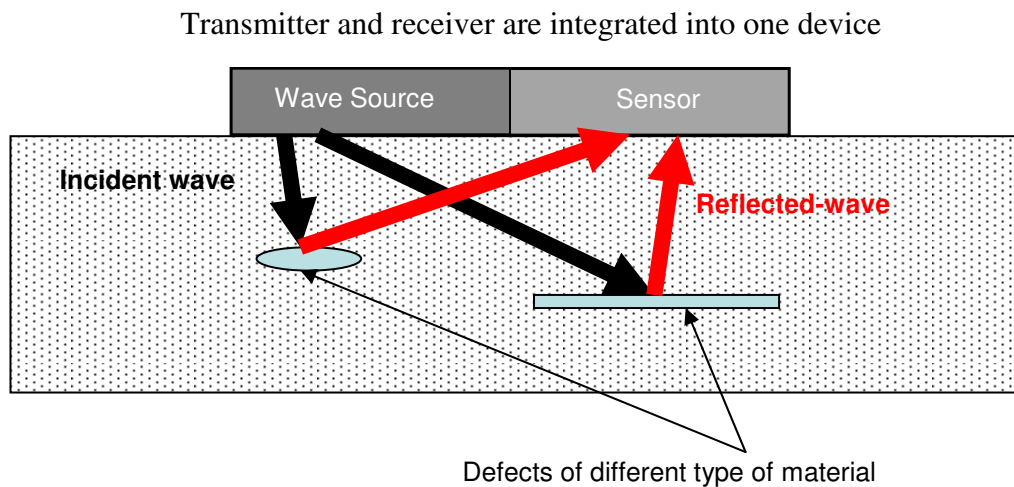
Figure 2.3 Ultrasound Method: Ultrasonic waves are generated from crystal transducer at the surface of the material. Showing reflected waves from defects inside the material.

The Ultrasound technique works on the concept of generating ultrasonic waves that travel through the material under inspection while monitoring the reflected waves [8-12]. The ultrasonic waves are typically in the range of 20 KHz to 10 MHz. The waves are usually generated by a transducer (crystal) placed at the surface of the material as seen in Figure 2.3. In ultrasound testing, the transmitter and receiver are usually integrated into one device.

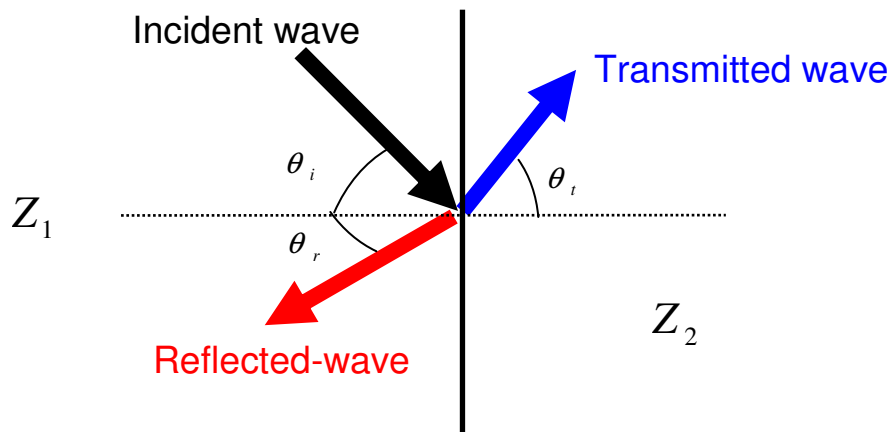
Figure 2.4 Ultrasound Method: Diagram demonstrating wave reflections at interface of two materials with different acoustic impedances.

acoustic properties than the material, which allow the waves to reflect at their boundary interface with the material. Consider a set of waves that are traveling through material # 1 and then through material # 2, each with acoustic impedance of Z_1 and Z_2 , respectively. When the waves arrive at the interface between the two materials, some of the waves reflect to material #1 and the rest are transmitted into the second material. The amount and direction of reflected and transmitted waves depend on the acoustic characteristics of the two materials and the magnitude and angle of the incident wave, as seen in Figure 2.4.

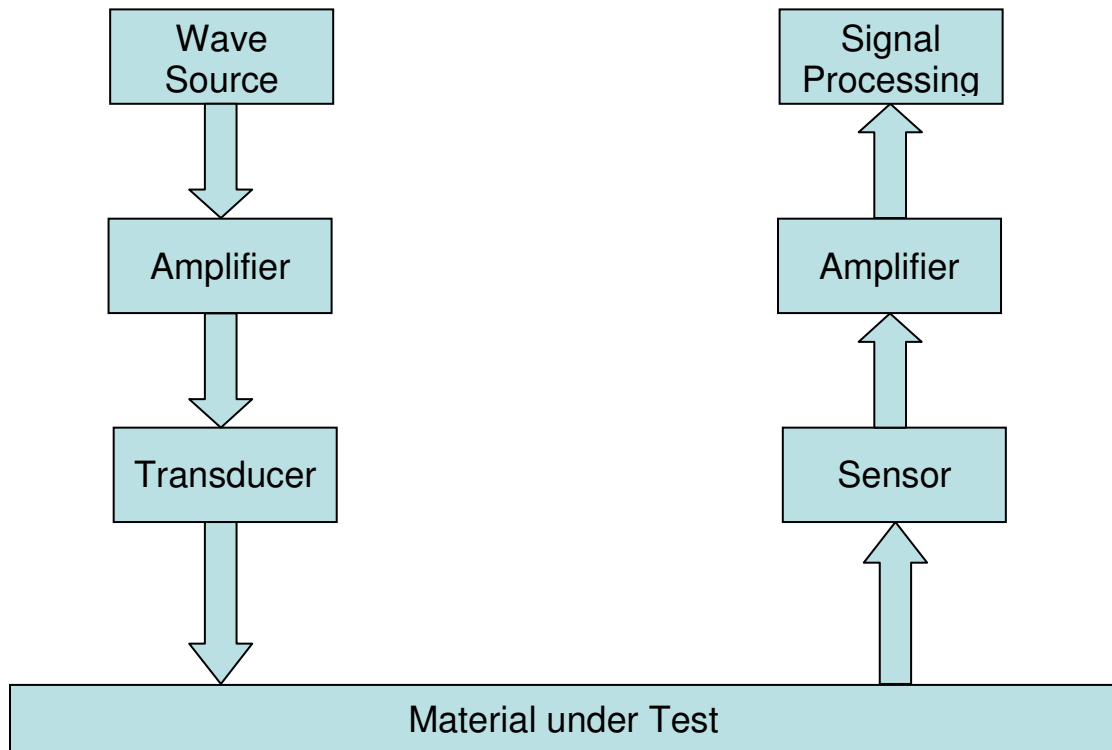
Figure 2.5 Ultrasound: Block Diagram for a typical ultrasound system.

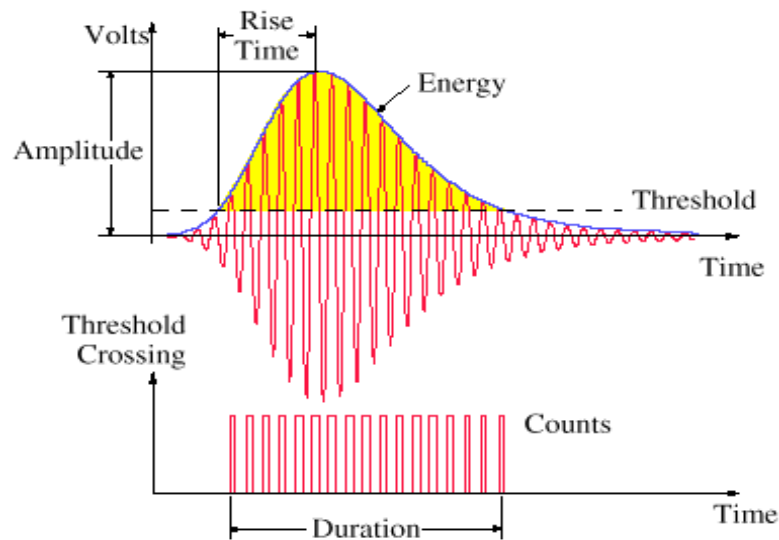
Figure 2.6 Acoustic Emissions: An example of acoustic emission signal caused by a mechanical damage to material under monitoring [45].

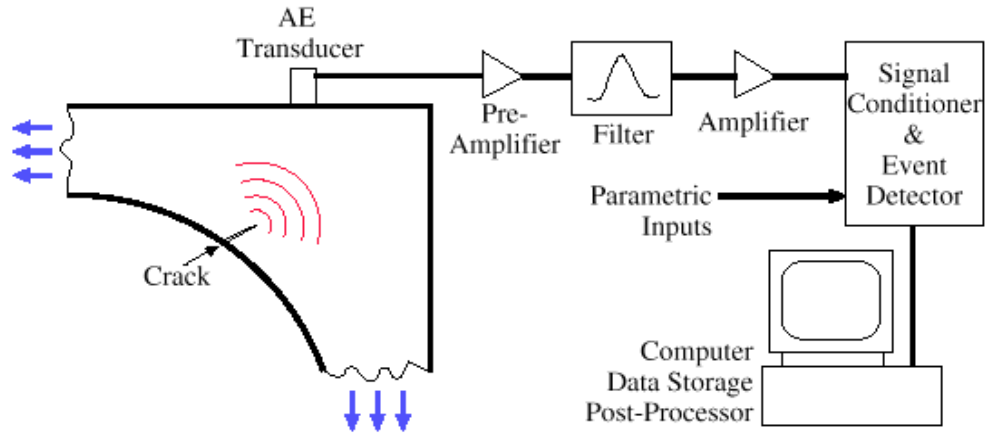
Figure 2.7 Acoustic Emissions: Block diagram for a typical acoustic emission system [45]

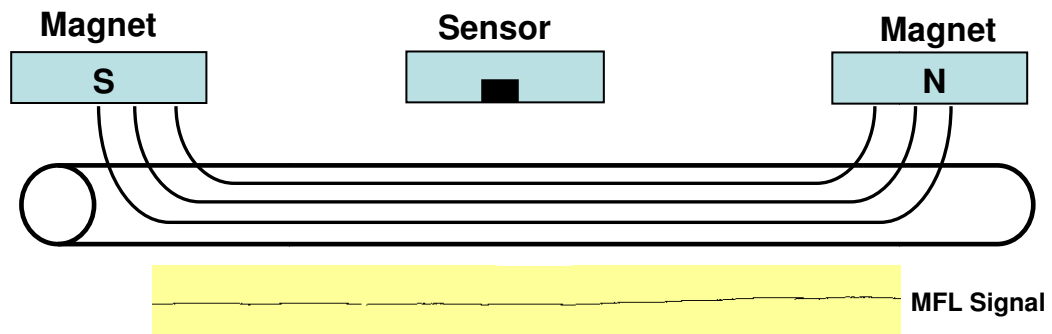
Figure 3.5 Demonstrating MFL concept with no flaw in a steel bar

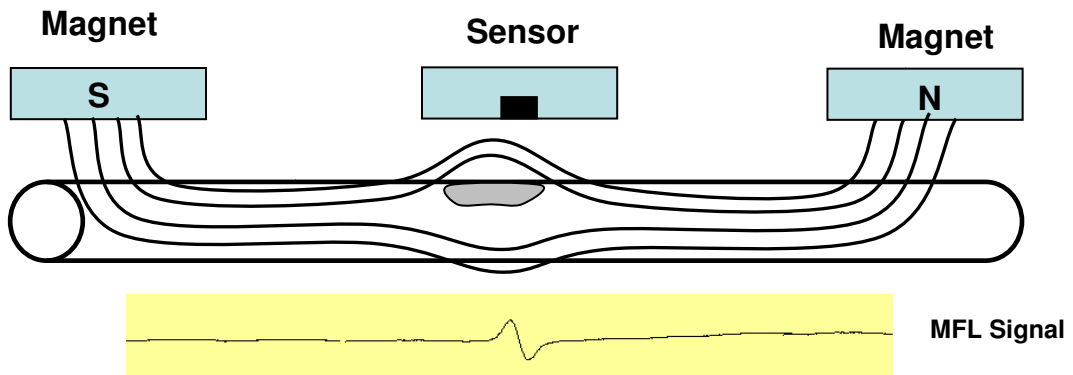
Figure 3.6 Demonstrating MFL concept with a flaw in a steel bar

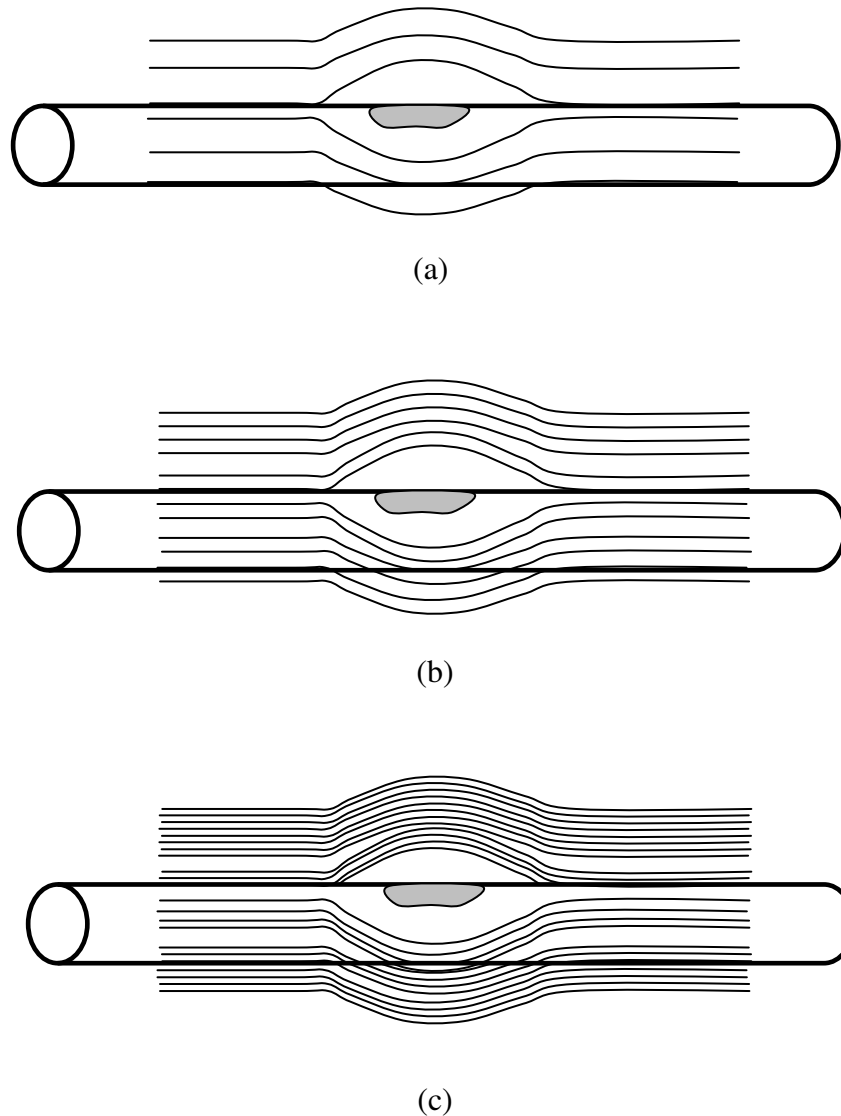
Figure 3.7 Effect of strength of magnetic field on the density of induced flux lines. (a) Low magnetic field, (b) Medium magnetic field and (c) Strong magnetic field

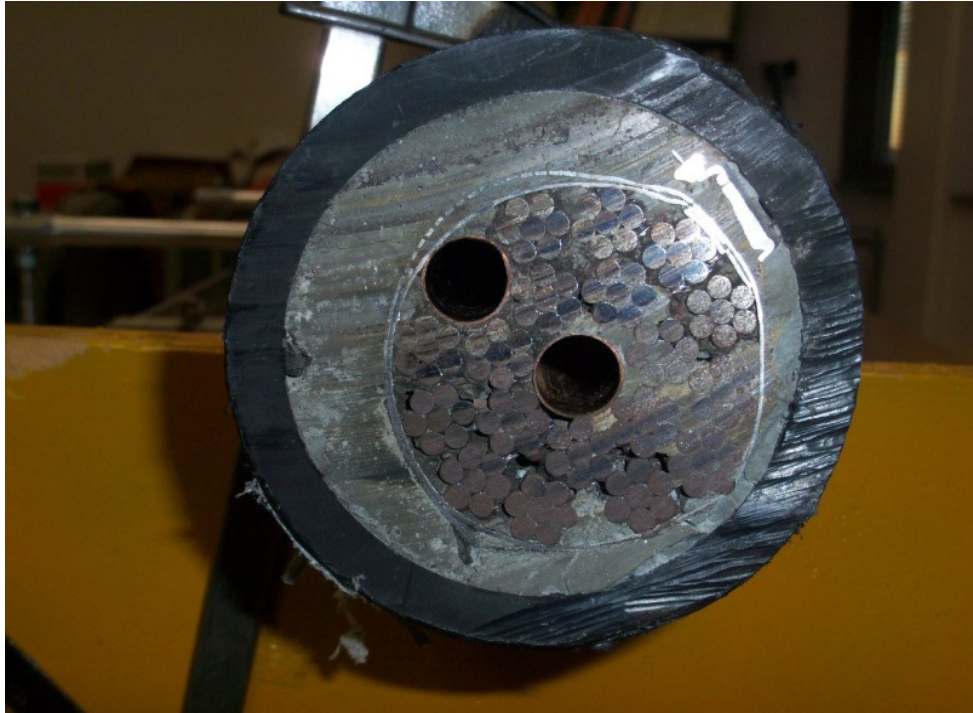
Figure 3.9 Cable showing bundle of steel wires/strands, concrete grout and protective cover

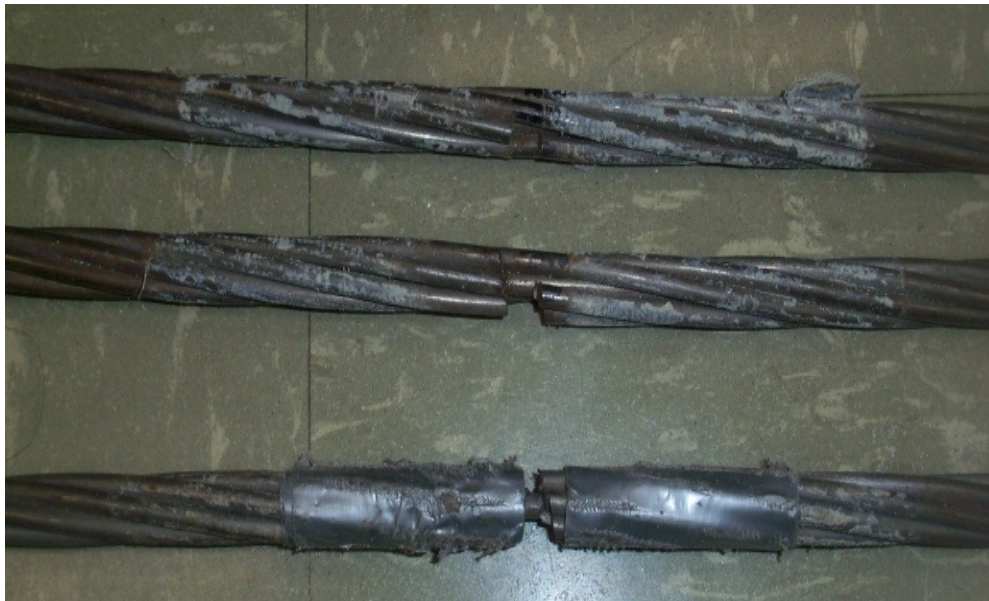
Figure 3.10 Typical steel strands with bundle of wires used in main cables of cable-stayed bridge; Showing man-made defects, from top to bottom, of one broken wire, two broken wires and five broken wires.

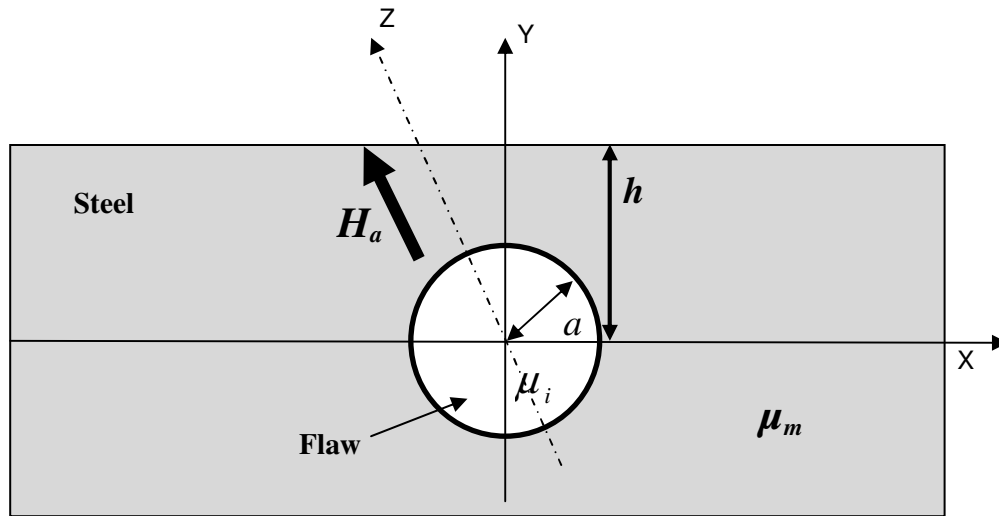
Figure 3.11 MFL Mathematical Model: Illustration of Sub-surface cylindrical flaw

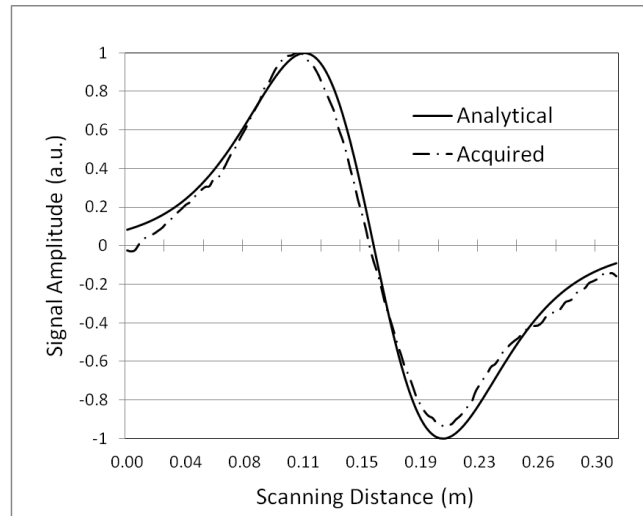
Figure 3.12 Acquired MFL signal and predicated signal based on the mathematical model in equation (3.2).

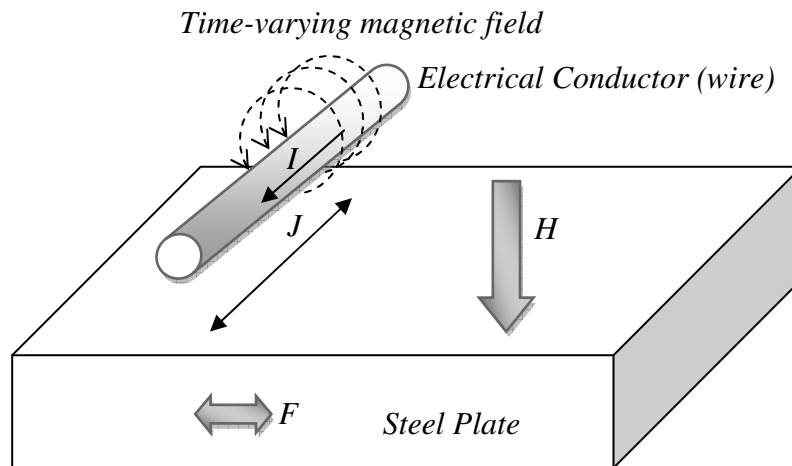
Figure 3.14 Illustration of generating transverse waves using Magnetostriction. Steel plate is exposed to a static magnetic field H whose direction is at right angle with Eddy currents flowing at the surface of the plate. The result is a force that is orthogonal to the magnetic field and the current that generates a transverse wave.

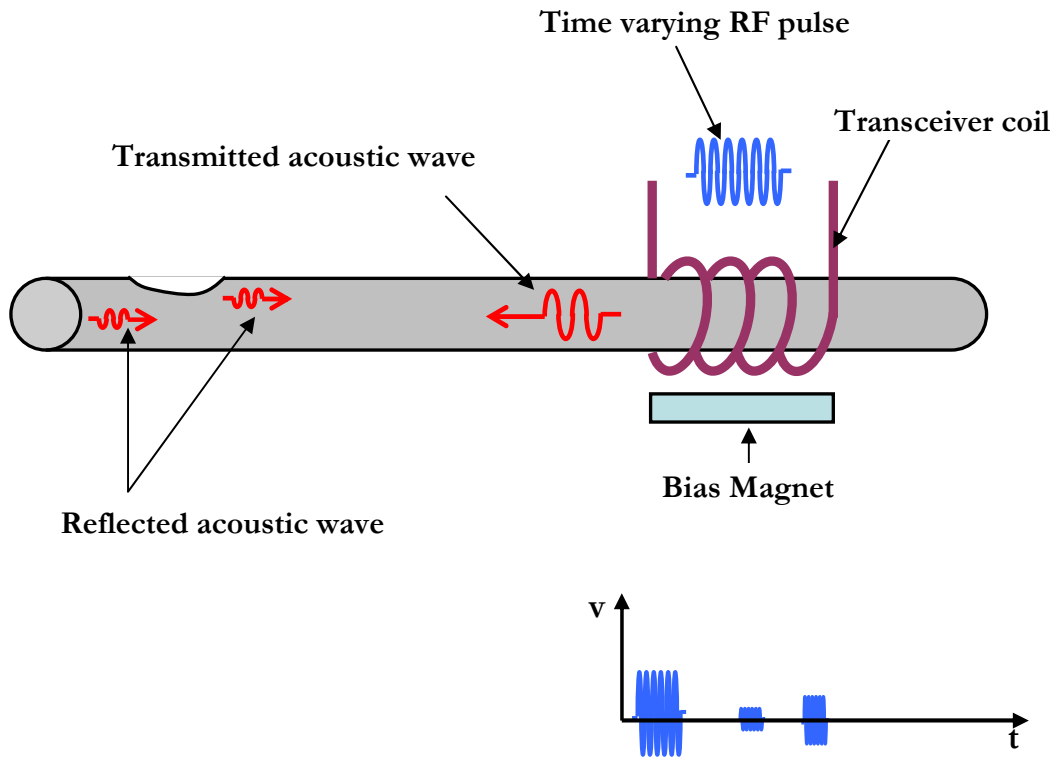
Figure 3.21 Magnetostrictive method: Demonstration of the MS method, showing a RF coil wrapped around the cable and energized by a RF pulse to produce guided waves.

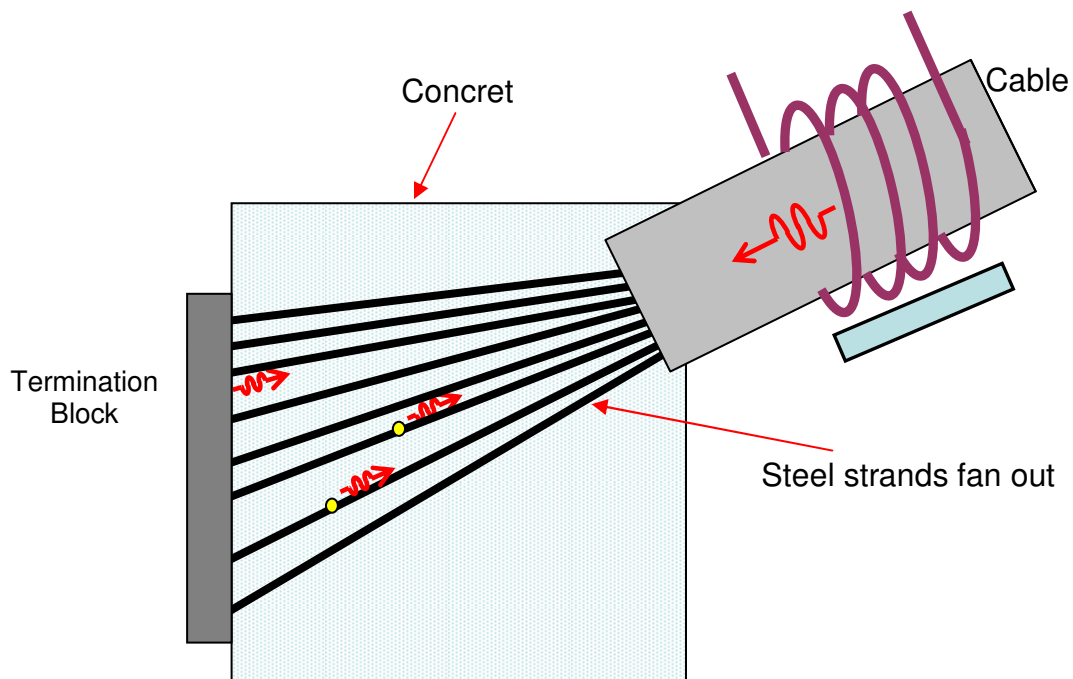
Figure 3.22 Demonstration of the use of the MS method for inspecting cable in the anchorage area

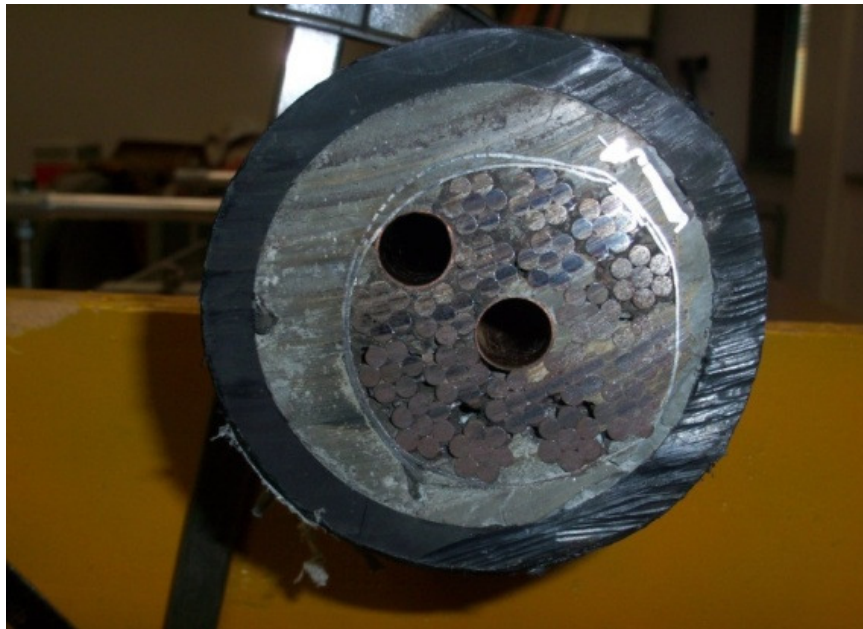
Figure 4.2 Bridge cable showing a bundle of prestressing steel strands covered with concrete grout and protective HDE cover.

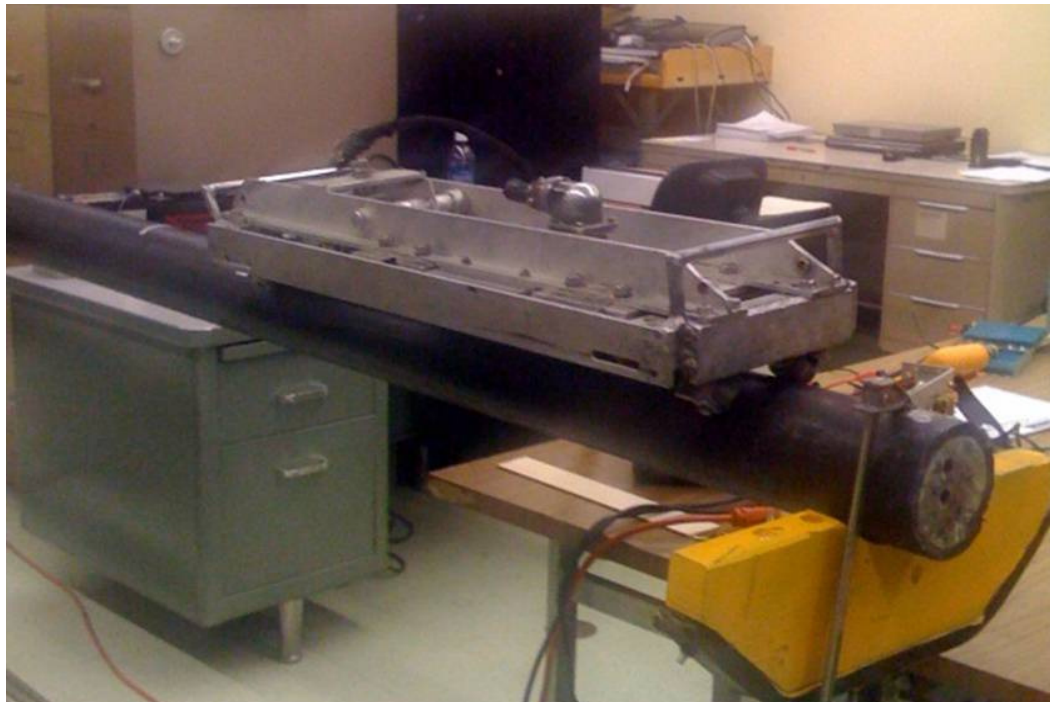
Figure 4.3 MFL system installed on a laboratory bridge cable; showing 19 strands cable, with two strands inserted in the top and center holes in the cable.

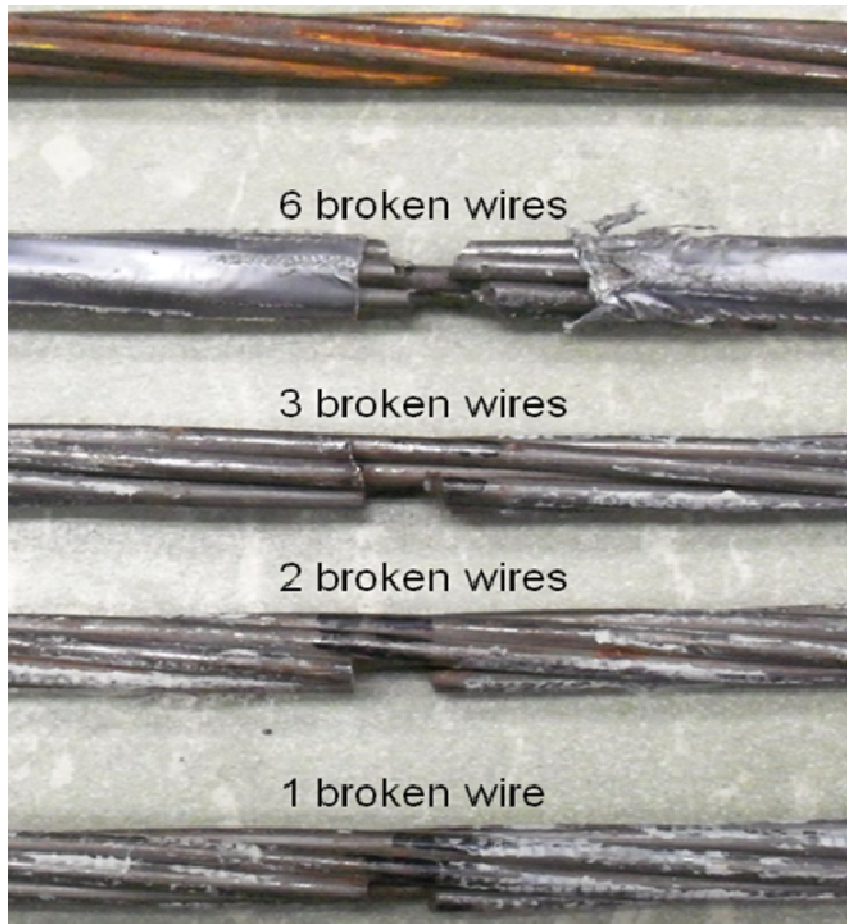
Figure 4.4 Prestressing steel strands with no flaws (top) and with different sizes of flaws.

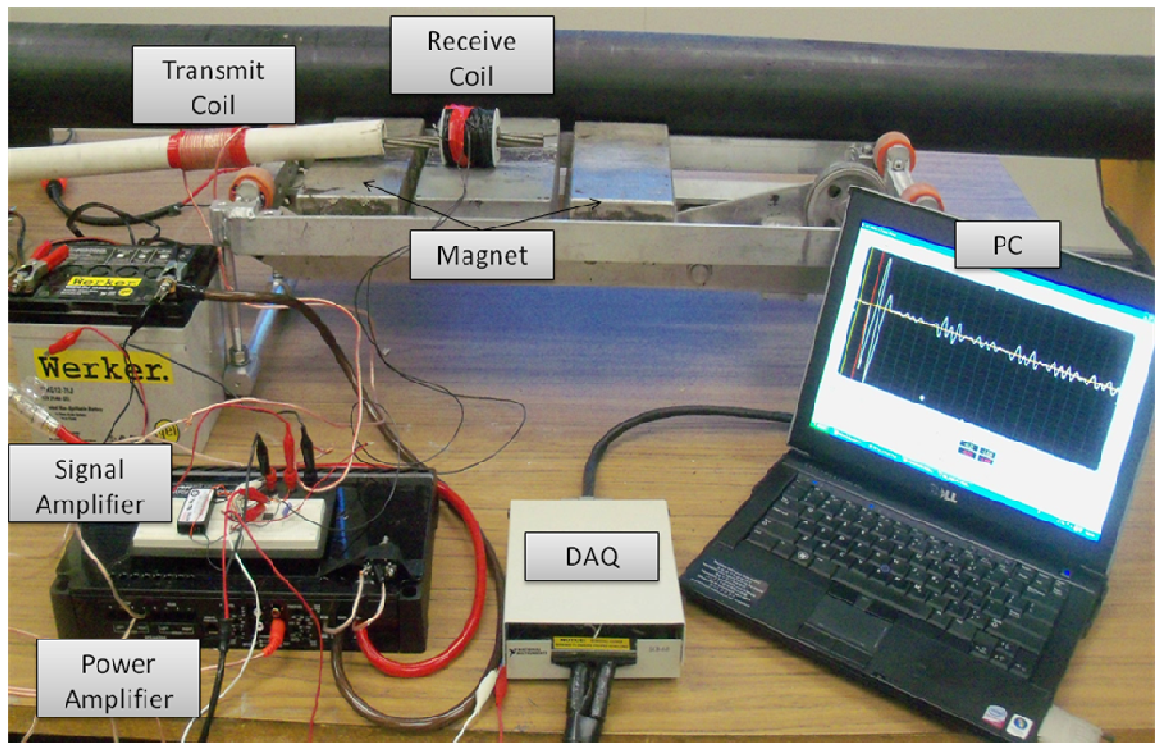
Figure 4.6 MS System Components; including, magnet, RF receive coil, RF transmit coil, small signal preamplifier, power amplifier, data acquisition interface box and PC.

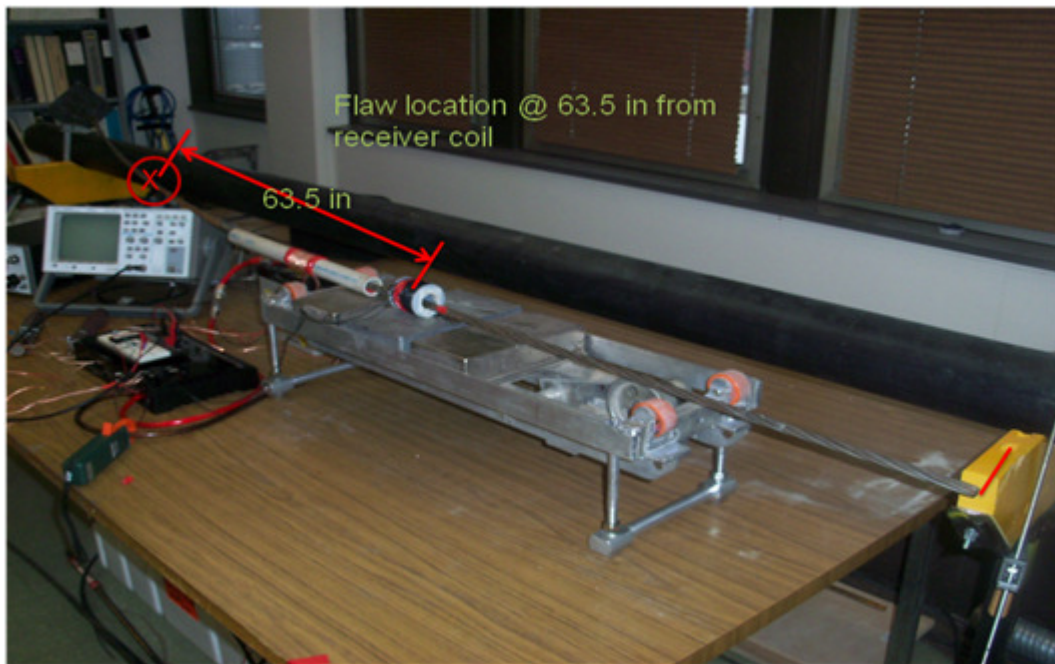
Figure 4.7 Flaw and strand placement for the MS experiments; showing a flaw location at 63.5 in from the of the receiver coil

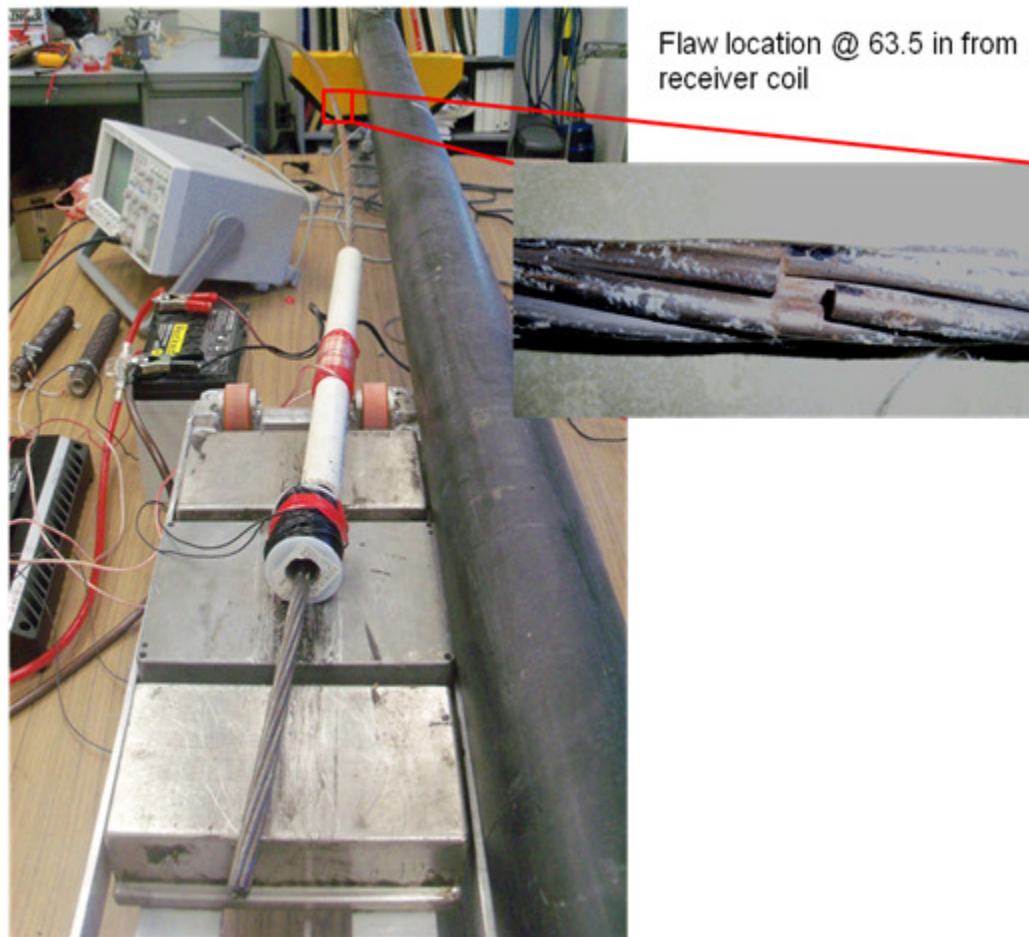
Figure 4.8 Flaw and stand placement for the MS experiments; showing 1 broken wire flaw located at 63.5 in from the receiver coil.

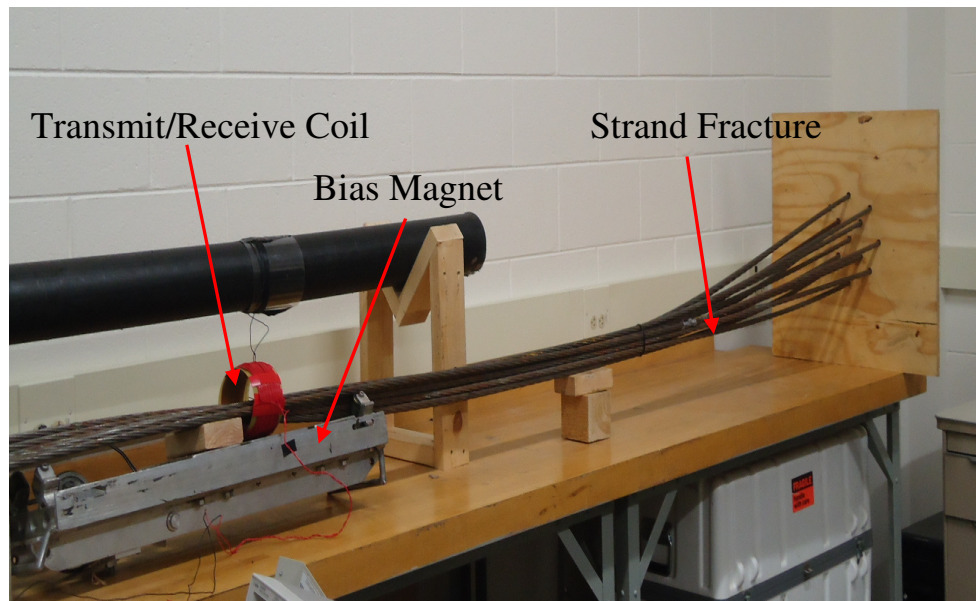
Figure 4.10 Cable-anchorage model with 13 spread out strands setup; showing bias magnet, transmit/receive coil and strand fracture location.

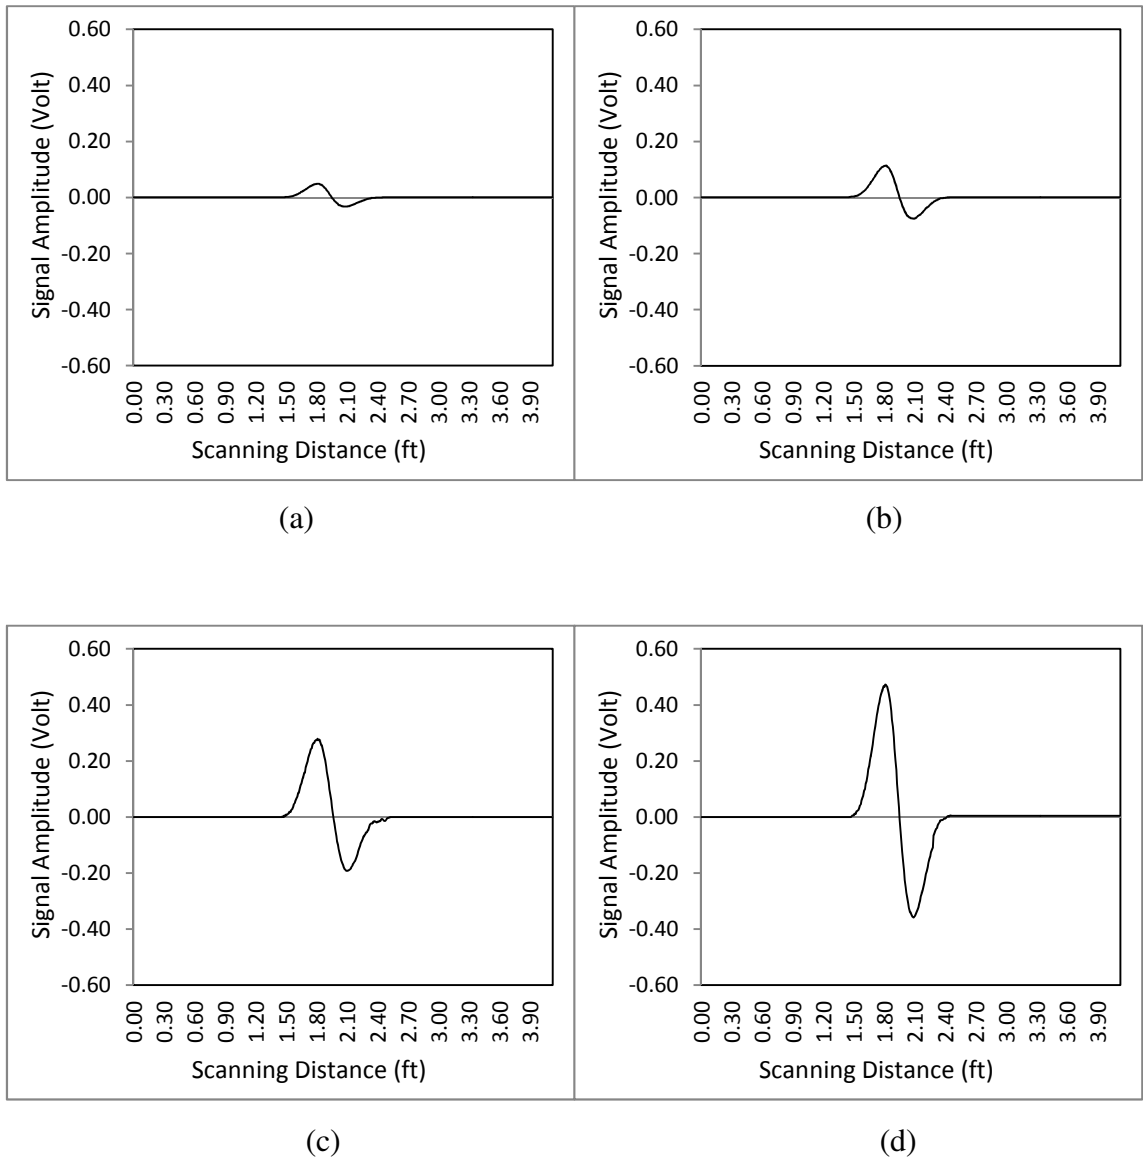
Figure 5.1 MFL signals recorded from sensors 1 through 4 for seven broken wires. Larger signal amplitude values are resulted from sensors that are located closer to the defects, i.e., data from sensor 4 (d).

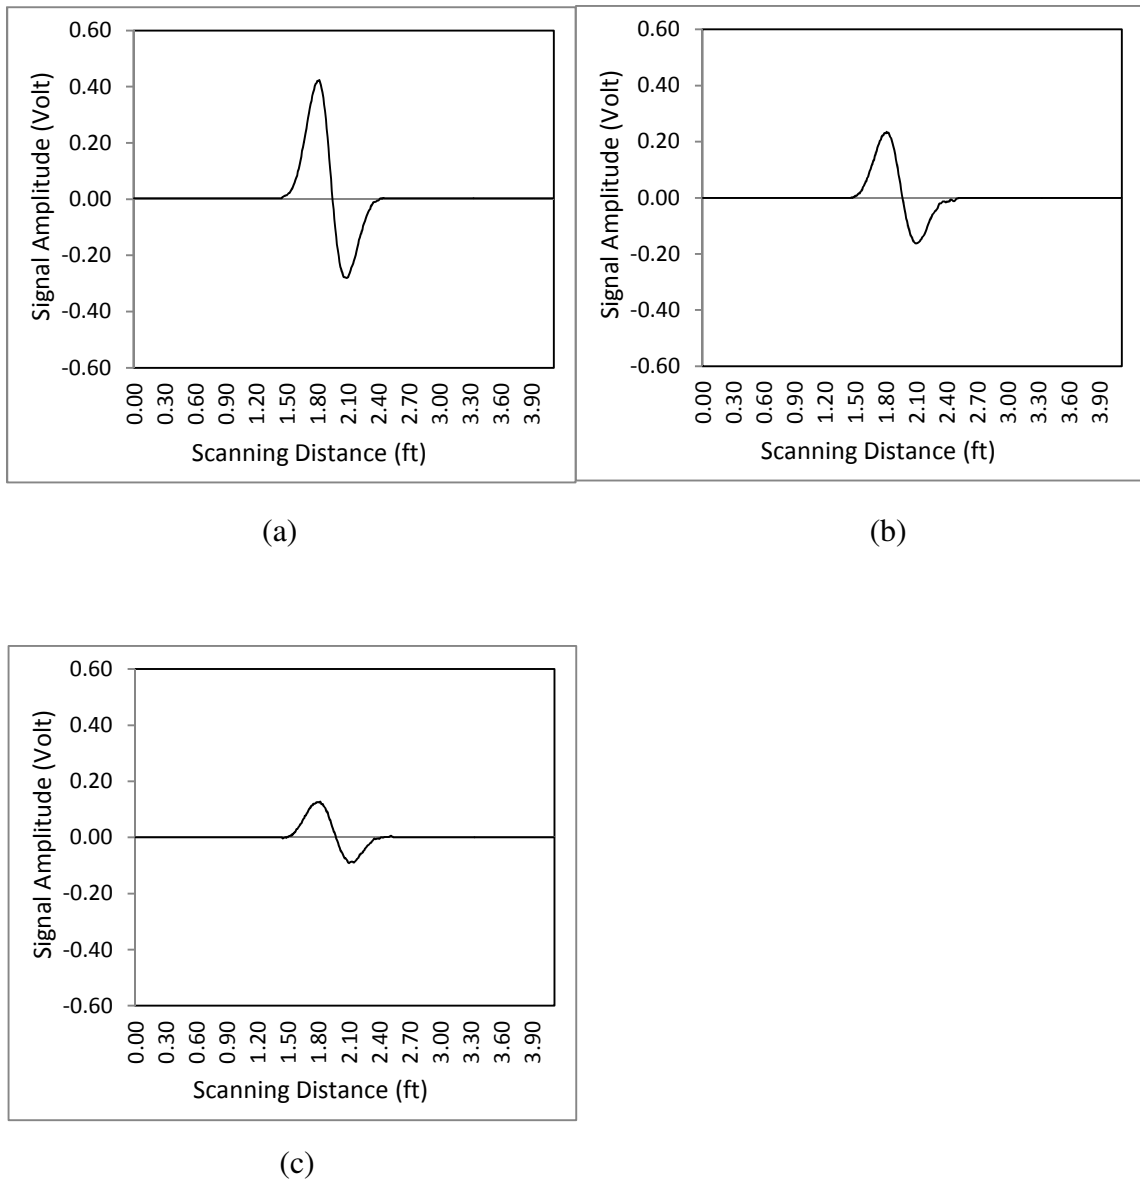
Figure 5.2 MFL signals recorded from sensors 5 through 7 for seven broken wires. Larger signal amplitude values are resulted from sensors that are located closer to defects, i.e., data from sensor 5 (a).

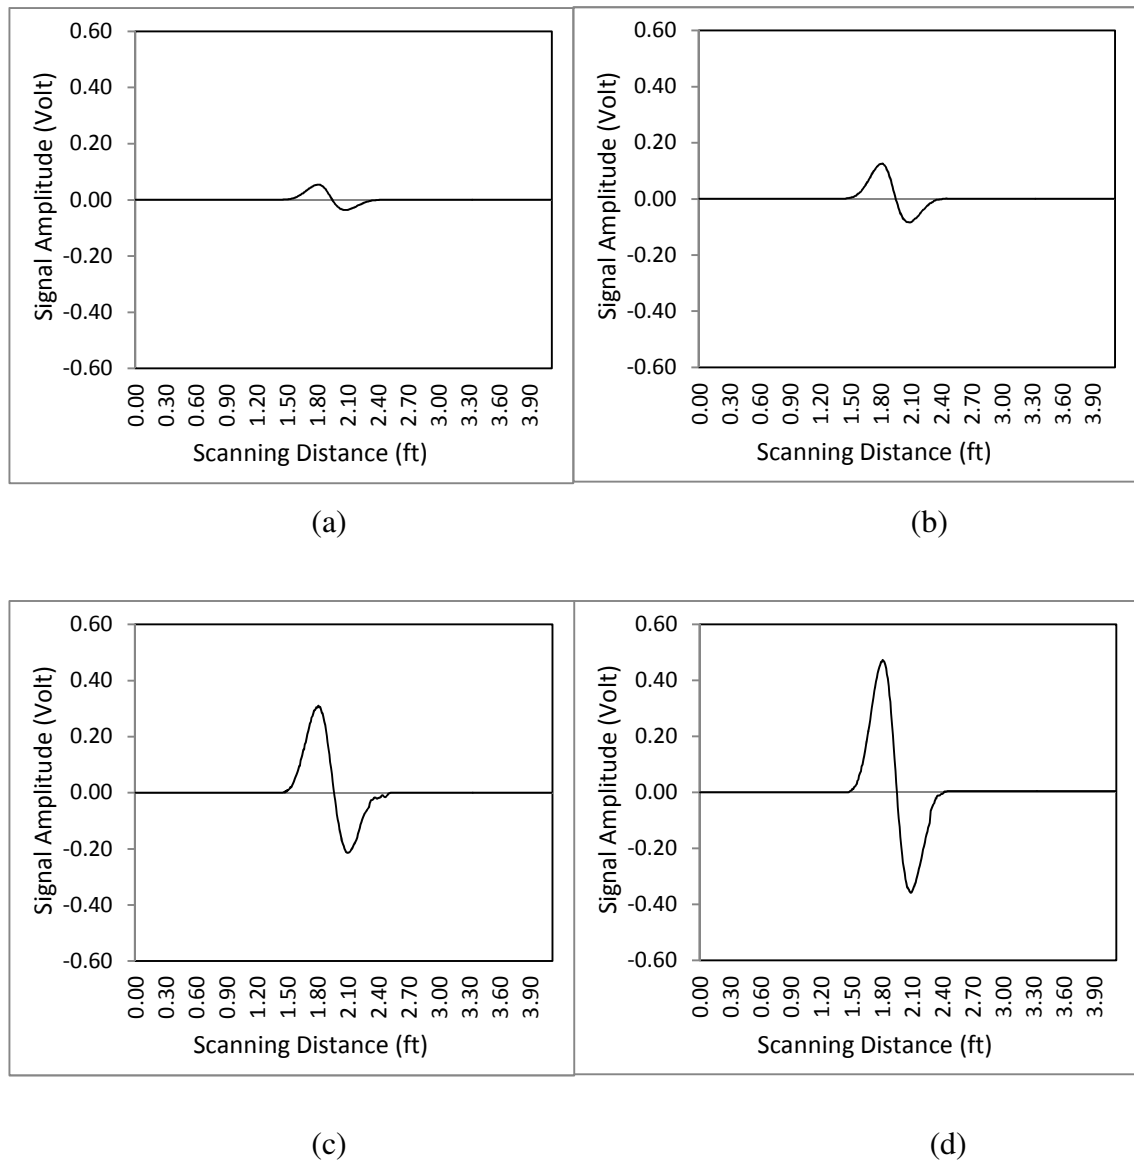
Figure 5.3 MFL signals recorded from sensors 1 through 4 for six broken wires. Larger signal amplitude values are resulted from sensors that are located closer to defects, i.e., data from sensor 4 (d).

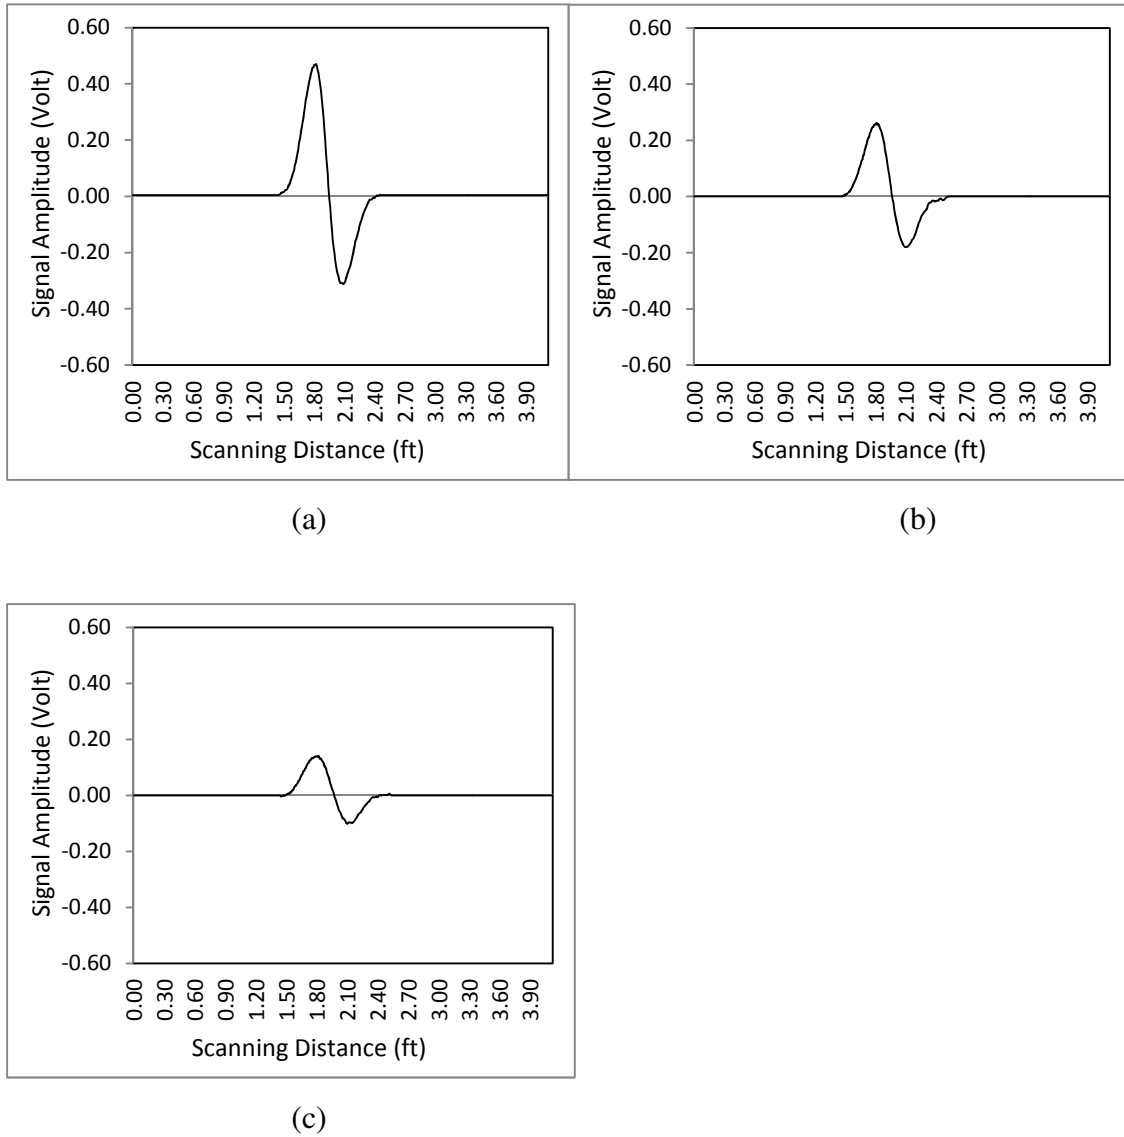
Figure 5.4 MFL signals recorded from sensors 5 through 7 for six broken wires. Larger signal amplitude values are resulted from sensors that are located closer to defects, i.e., data from sensor 5 (a).

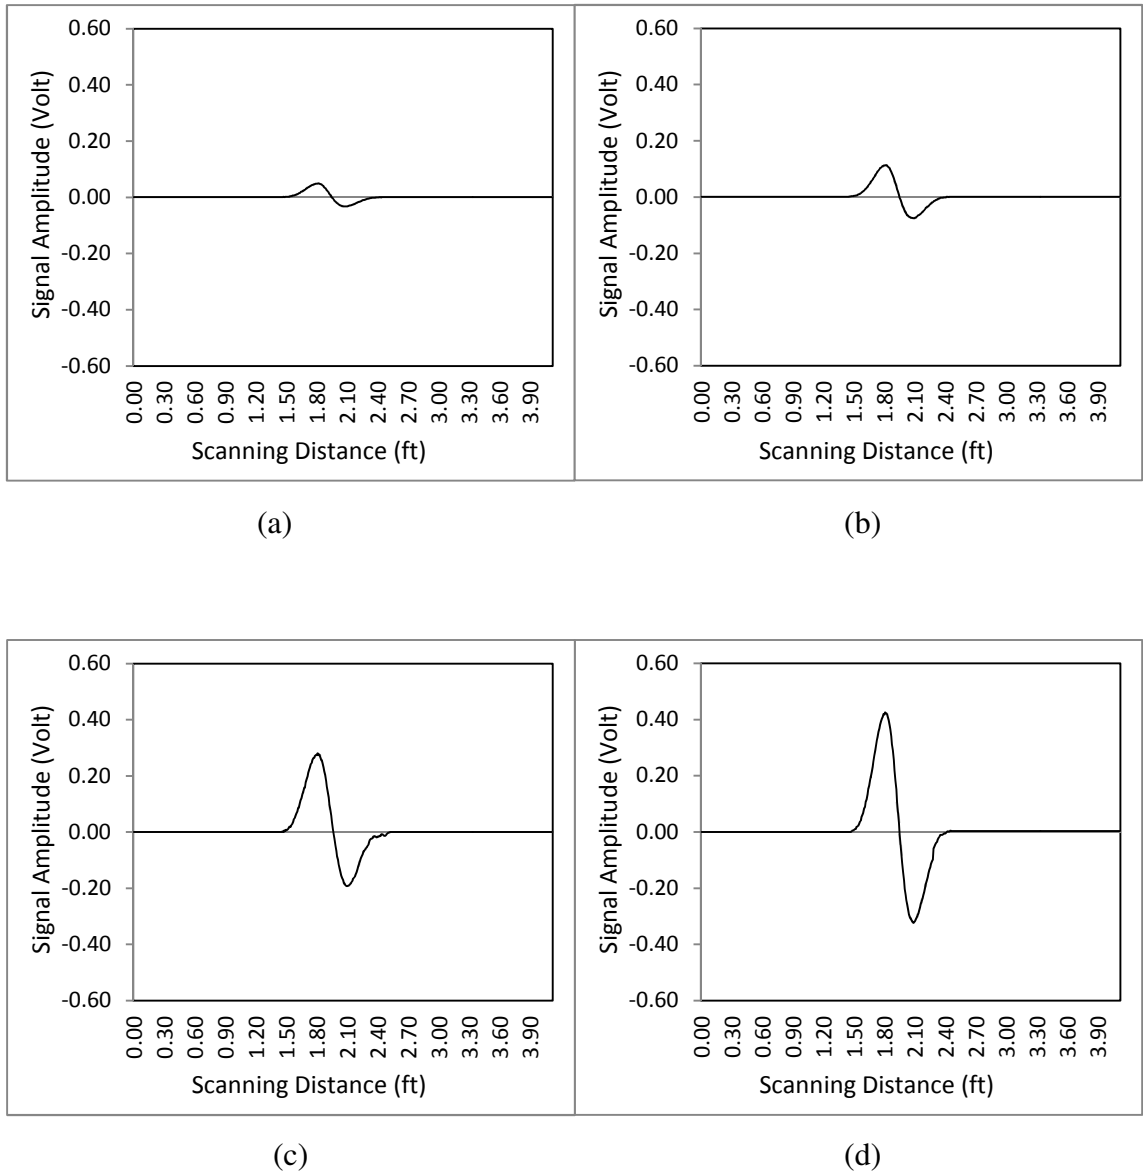
Figure 5.5 MFL signals recorded from sensors 1 through 4 for five broken wires. Larger signal amplitude values are resulted from sensors that are located closer to defects, i.e., data from sensor 4 (d).
