System for Detection of Defects in Cables of Bridge Structures

SYSTEM FOR DETECTION OF DEFECTS IN CABLES OF BRIDGE STRUCTURES

Doctor of Philosophy

The University of Wisconsin – Milwaukee

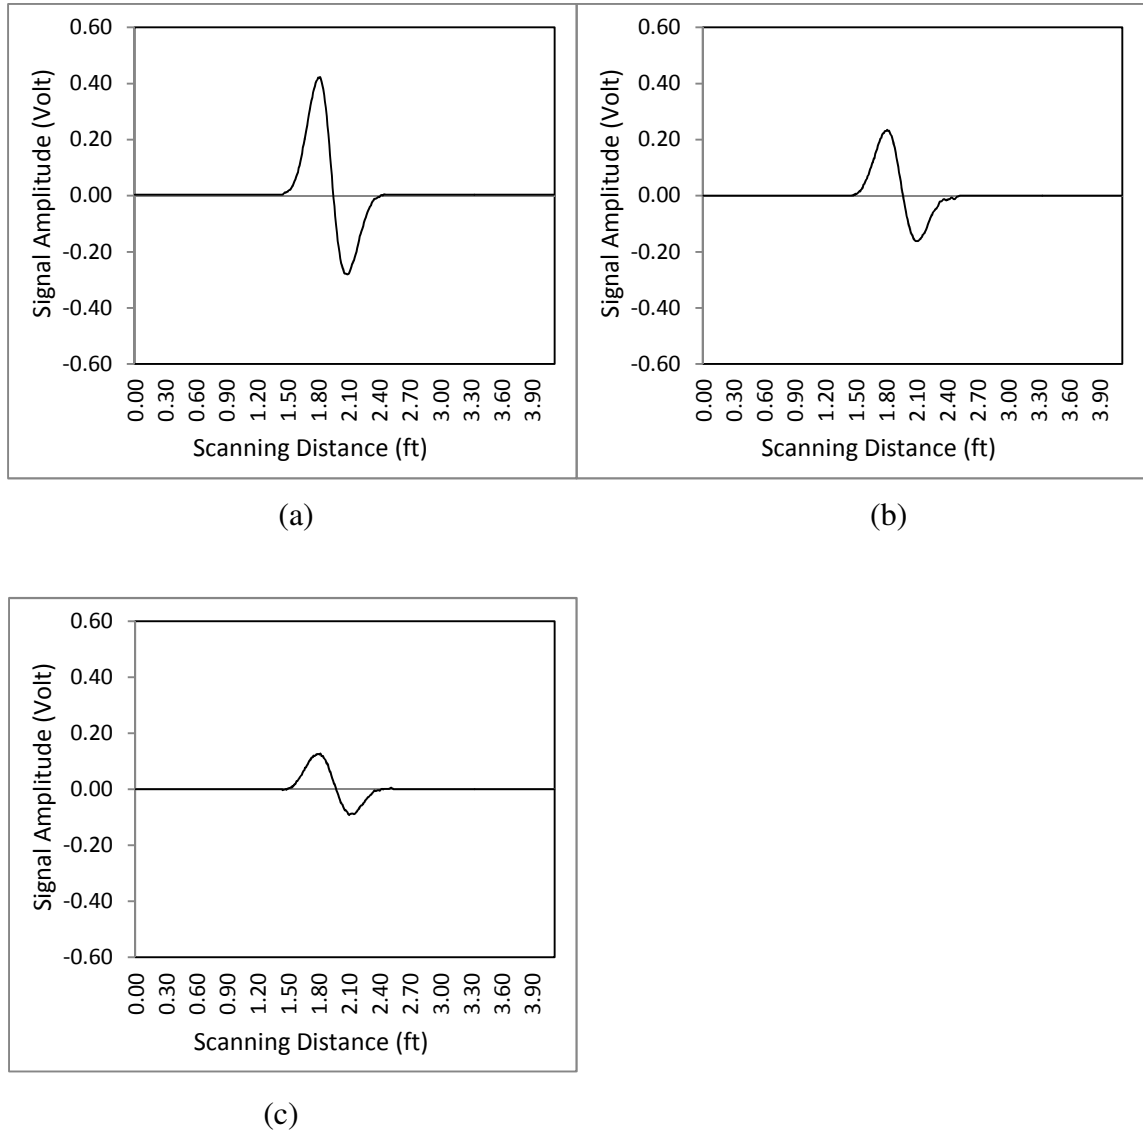
Figure 5.6 MFL signals recorded from sensors 5 through 7 for five broken wires. Larger signal amplitude values are resulted from sensors that are located closer to defects, i.e., data from sensor 3 (a).

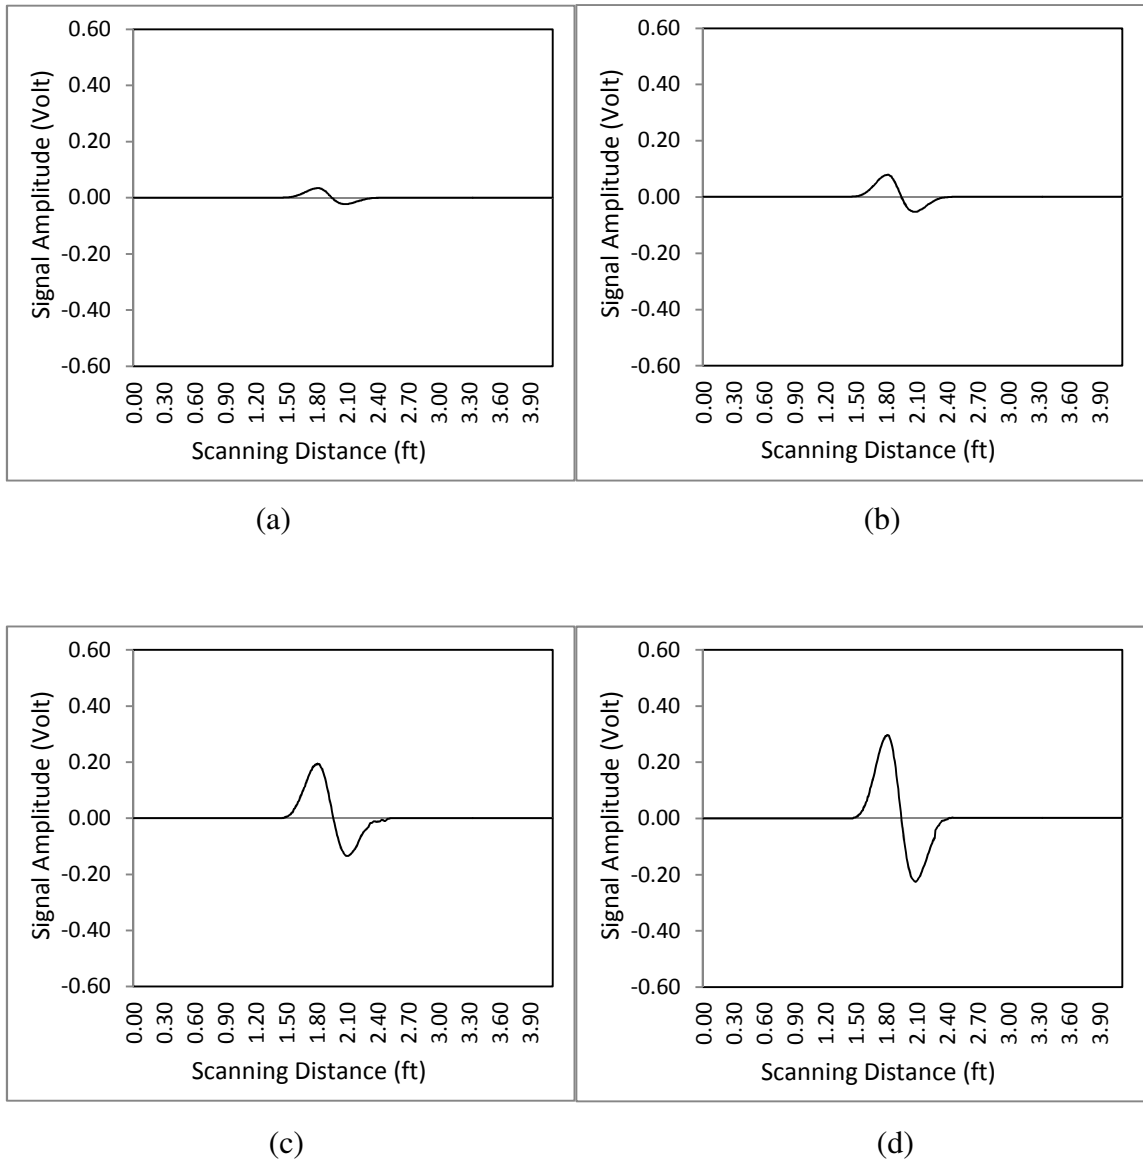
Figure 5.7 MFL signals recorded from sensors 1 through 4 for four broken wires. Larger signal amplitude values are resulted from sensors that are located closer to defects, i.e., data from sensor 4 (d).

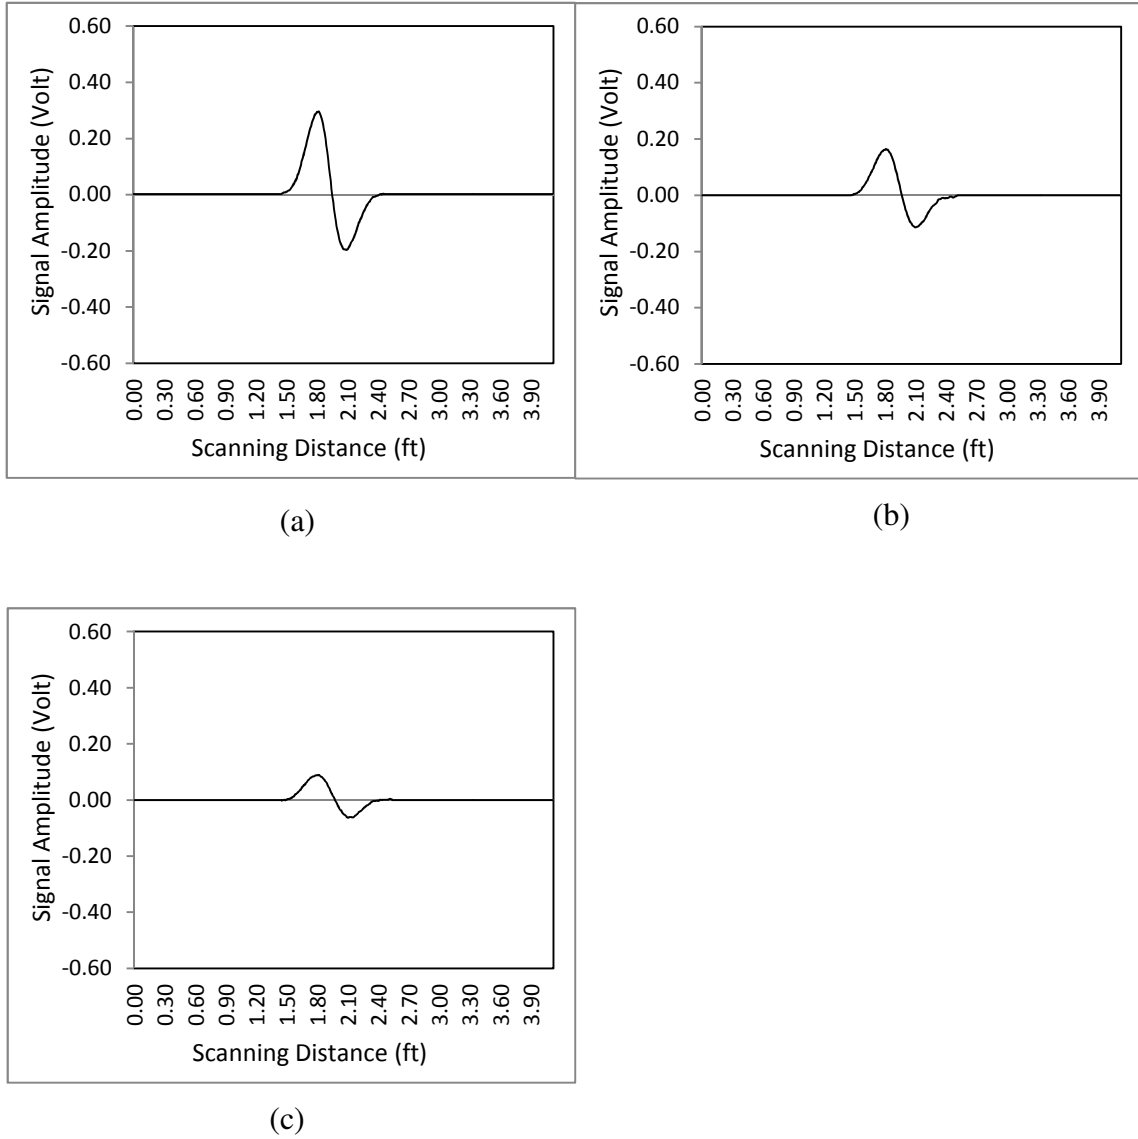
Figure 5.8 MFL signals recorded from sensors 5 through 7 for four broken wires. Larger signal amplitude values are resulted from sensors that are located closer to defects, i.e., data from sensor 3 (a).

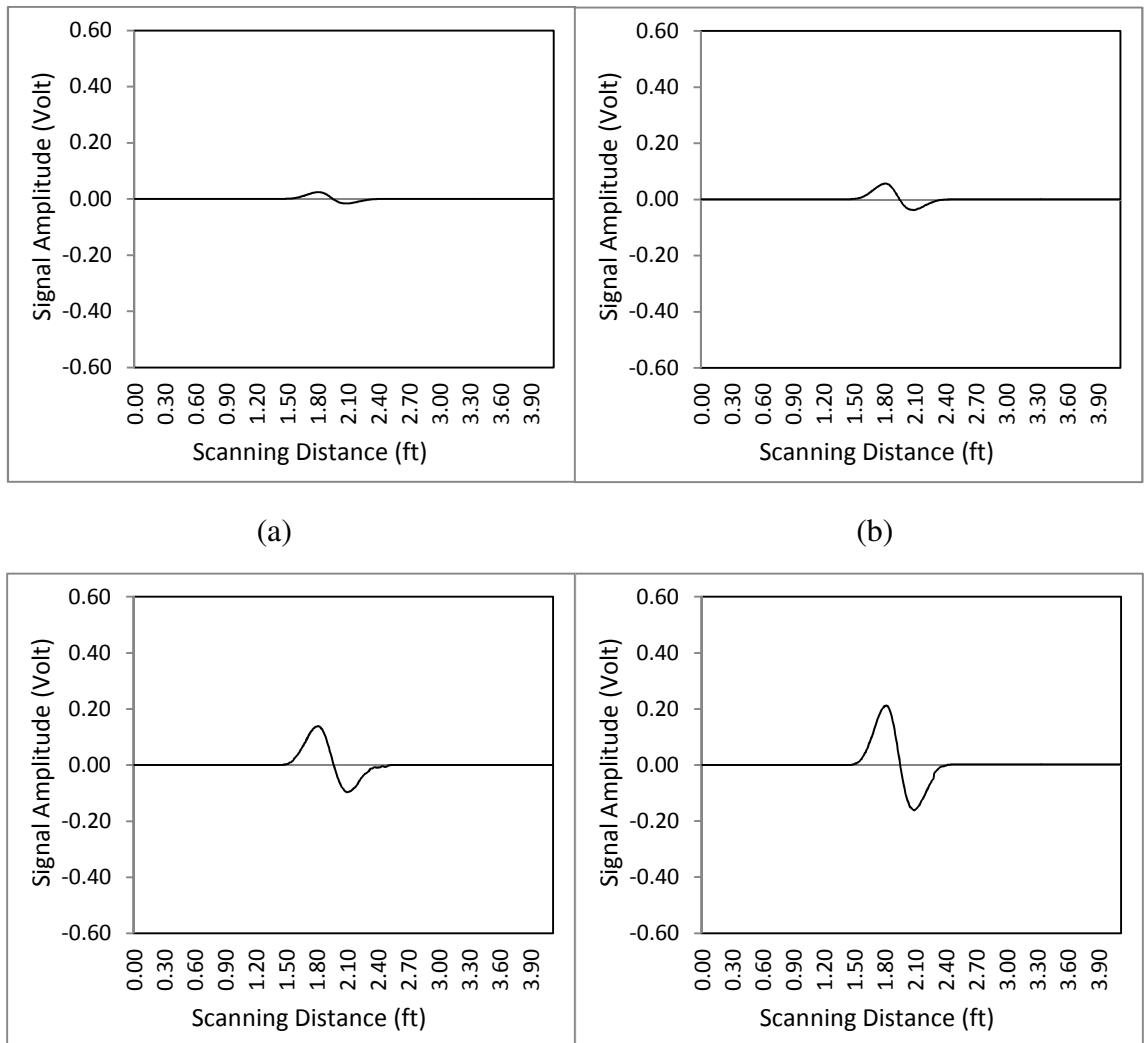
Figure 5.9 MFL signals recorded from sensors 1 through 4 for three broken wires. Larger signal amplitude values are resulted from sensors that are located closer to defects, i.e., data from sensor 4 (d).

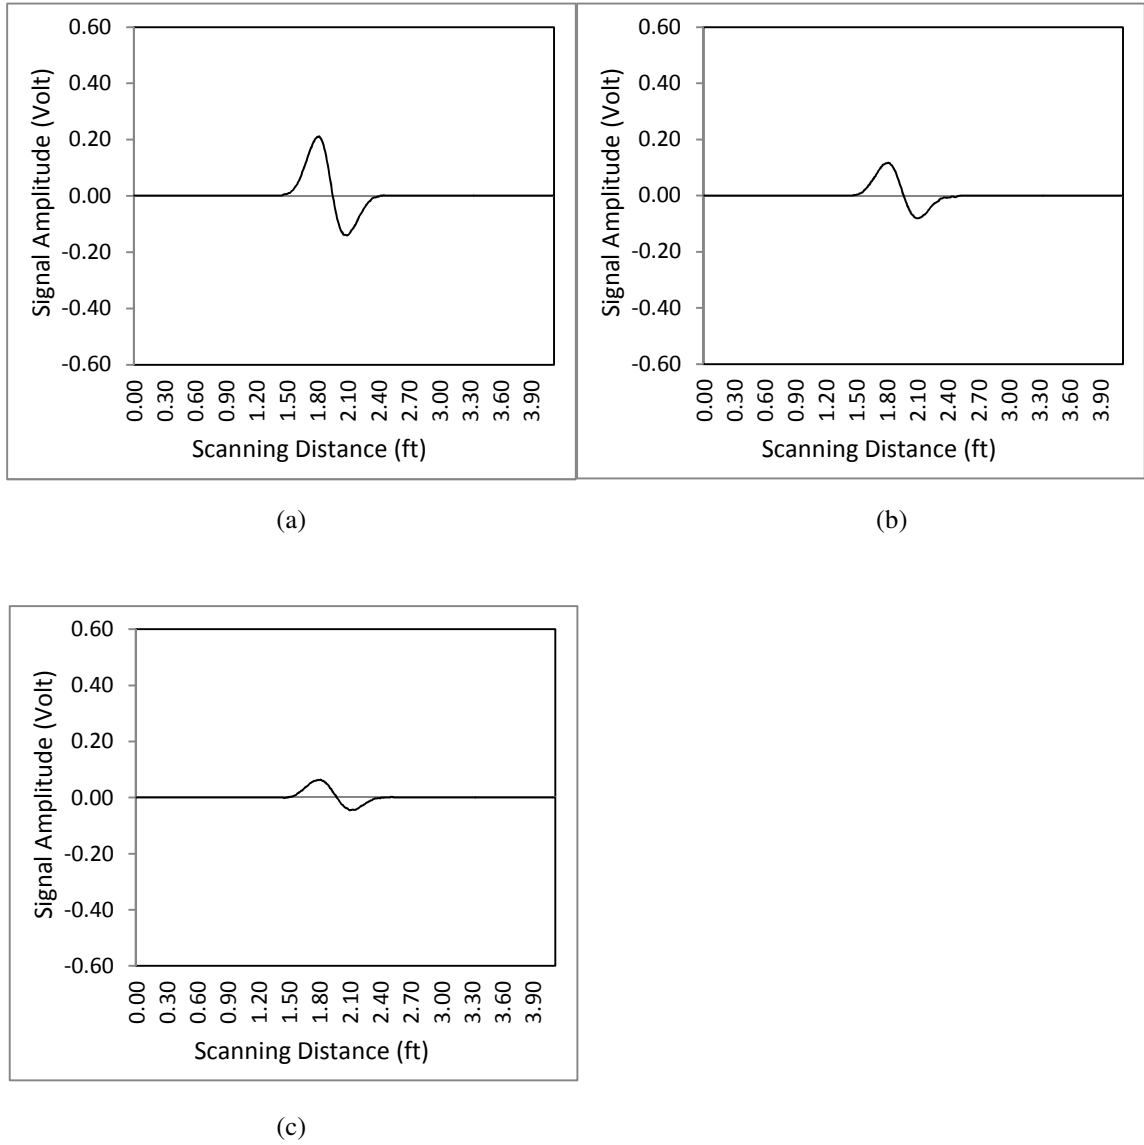
Figure 5.10 MFL signals recorded from sensors 5 through 7 for three broken wires. Larger signal amplitude values are resulted from sensors that are located closer to defects, i.e., data from sensor 3 (a).

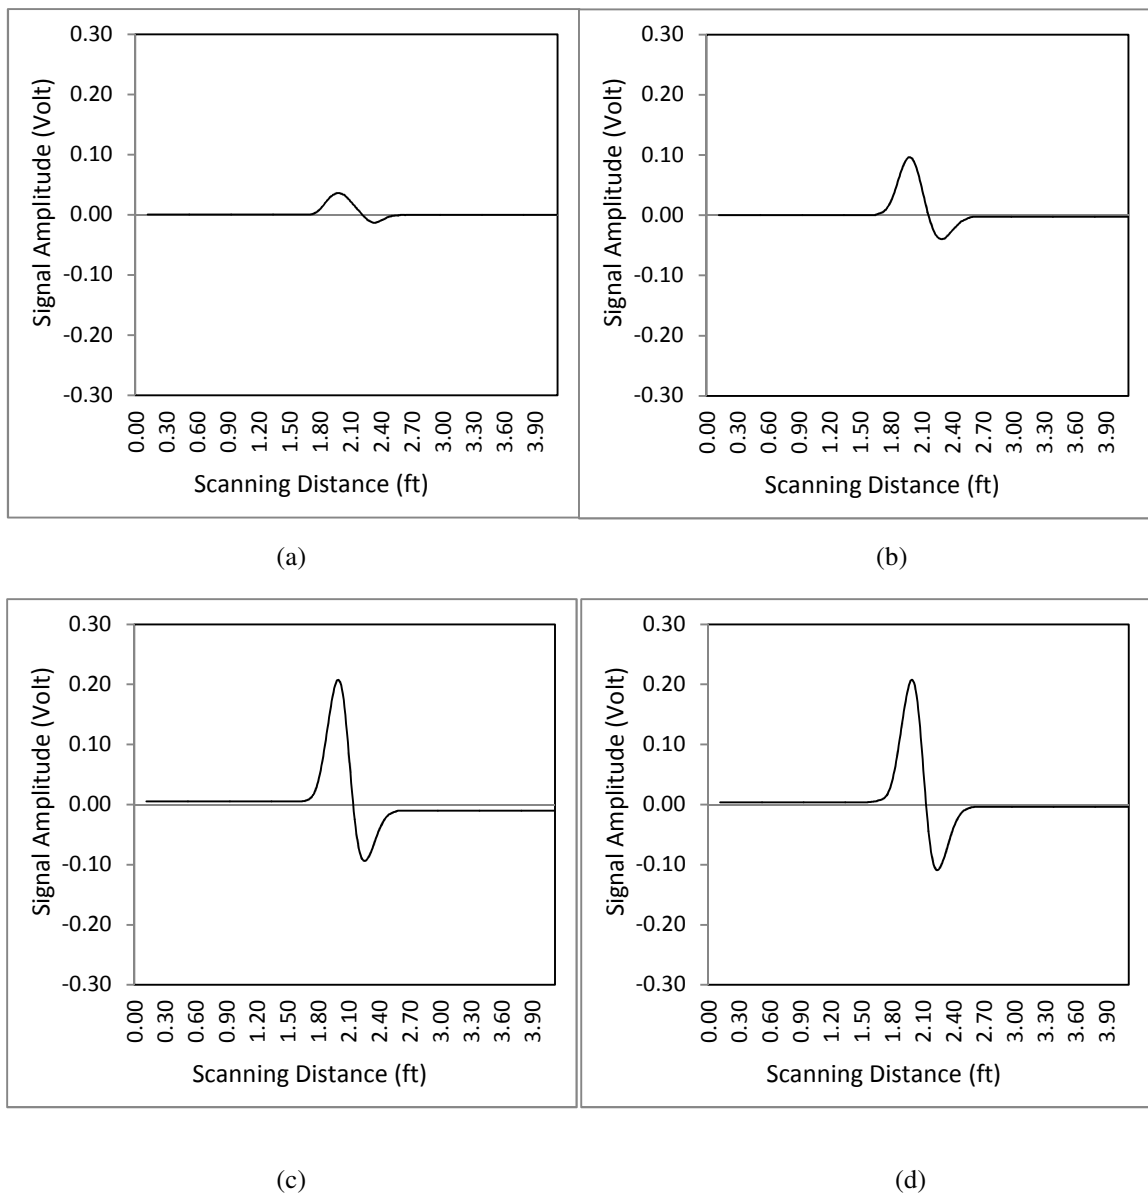
Figure 5.11 MFL signals recorded from sensors 1 through 4 for two broken wires. Larger signal amplitude values are resulted from sensors that are located closer to defects, i.e., data from sensor 4 (d).

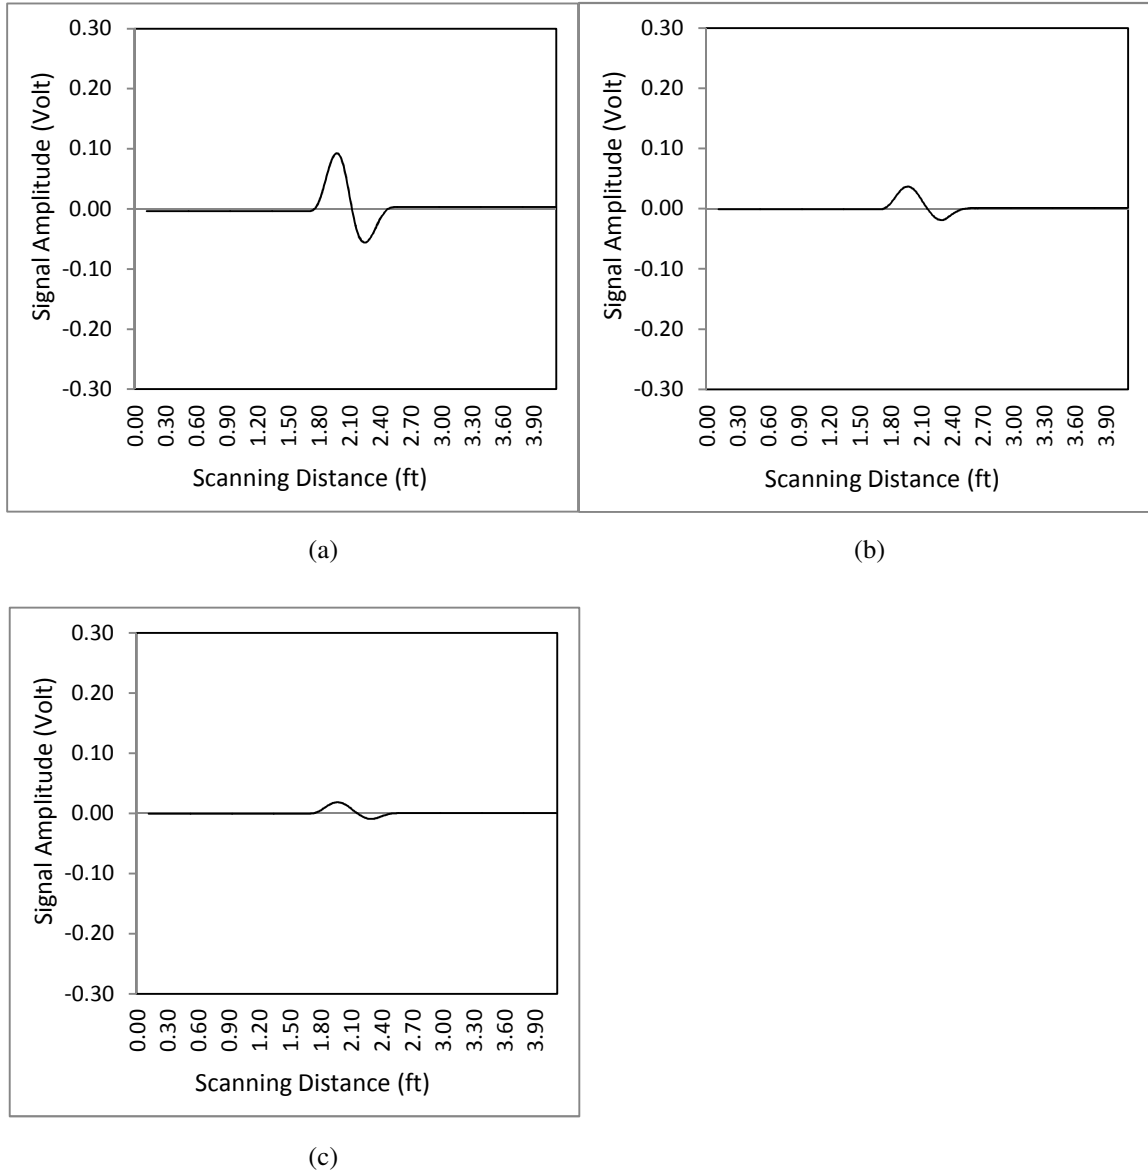
Figure 5.12 MFL signals recorded from sensors 5 through 7 for two broken wires. Larger signal amplitude values are resulted from sensors that are located closer to defects, i.e., data from sensor 3 (a).

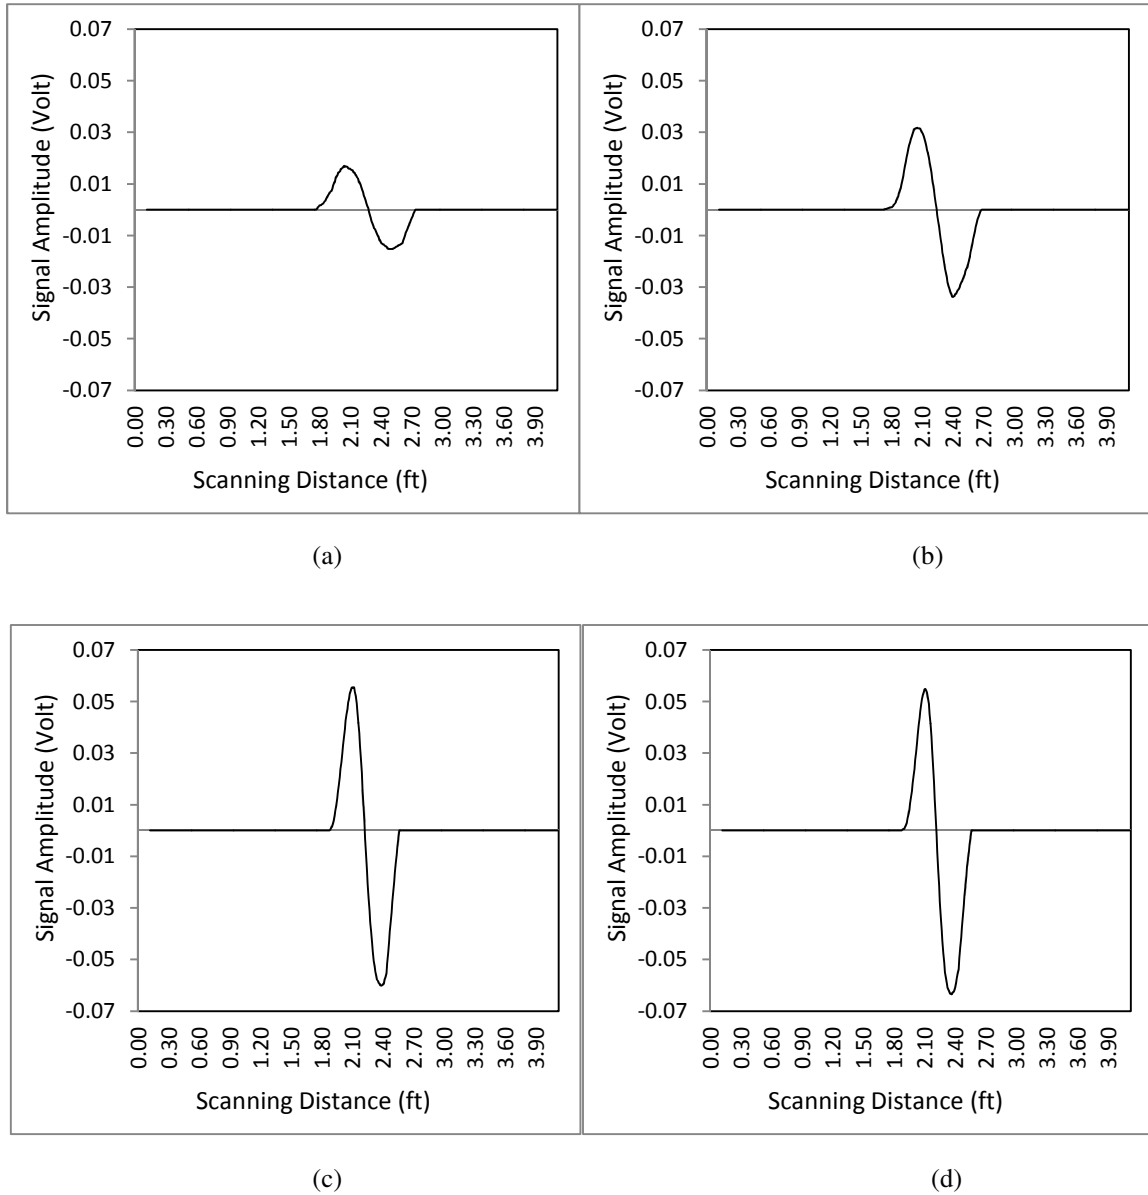
Figure 5.13 MFL signals recorded from sensors 1 through 4 for one broken wire. Larger signal amplitude values are resulted from sensors that are located closer to defects, i.e., data from sensor 4 (d).

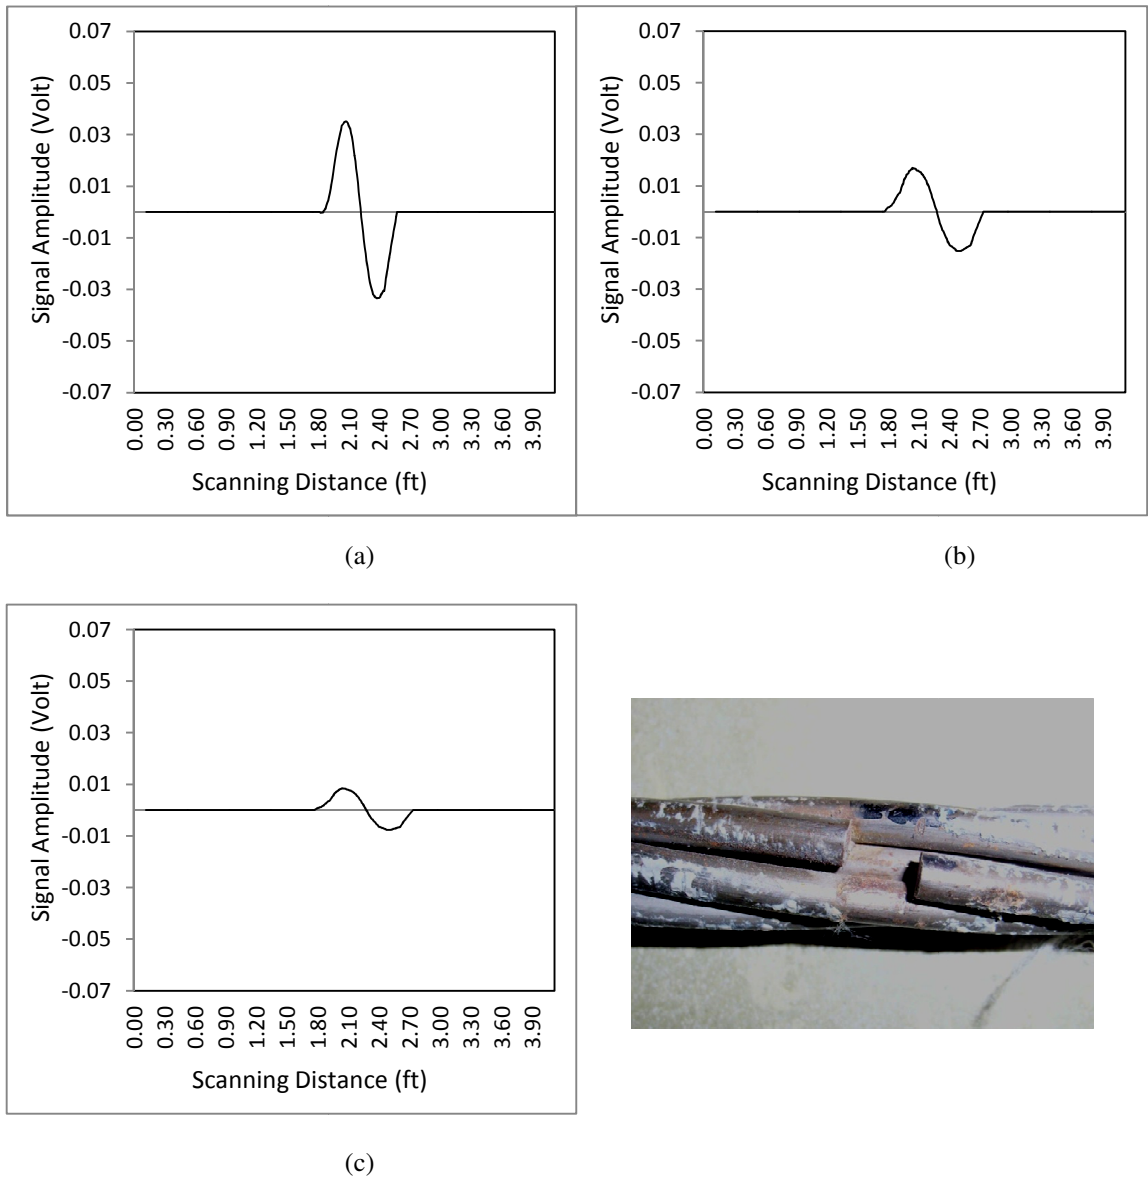
Figure 5.14 MFL signals recorded from sensors 5 through 7 for one broken wire. Larger signal amplitude values are resulted from sensors that are located closer to defects, i.e., data from sensor 3 (a).

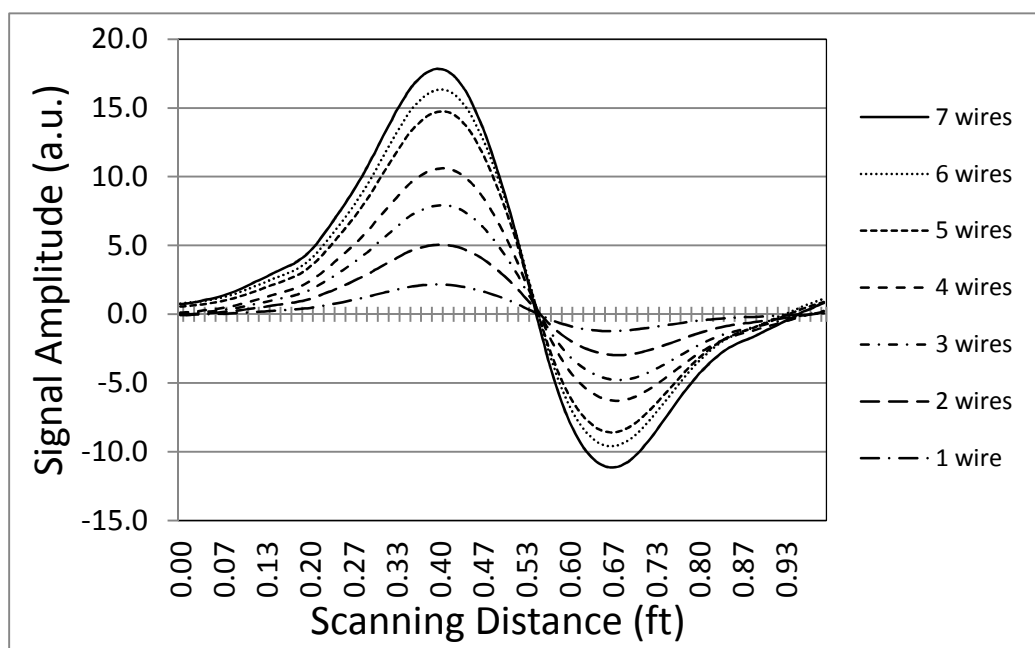
Figure 5.15 Relationship between the magnitude of the MFL signal and flaw size (number of broken wires).

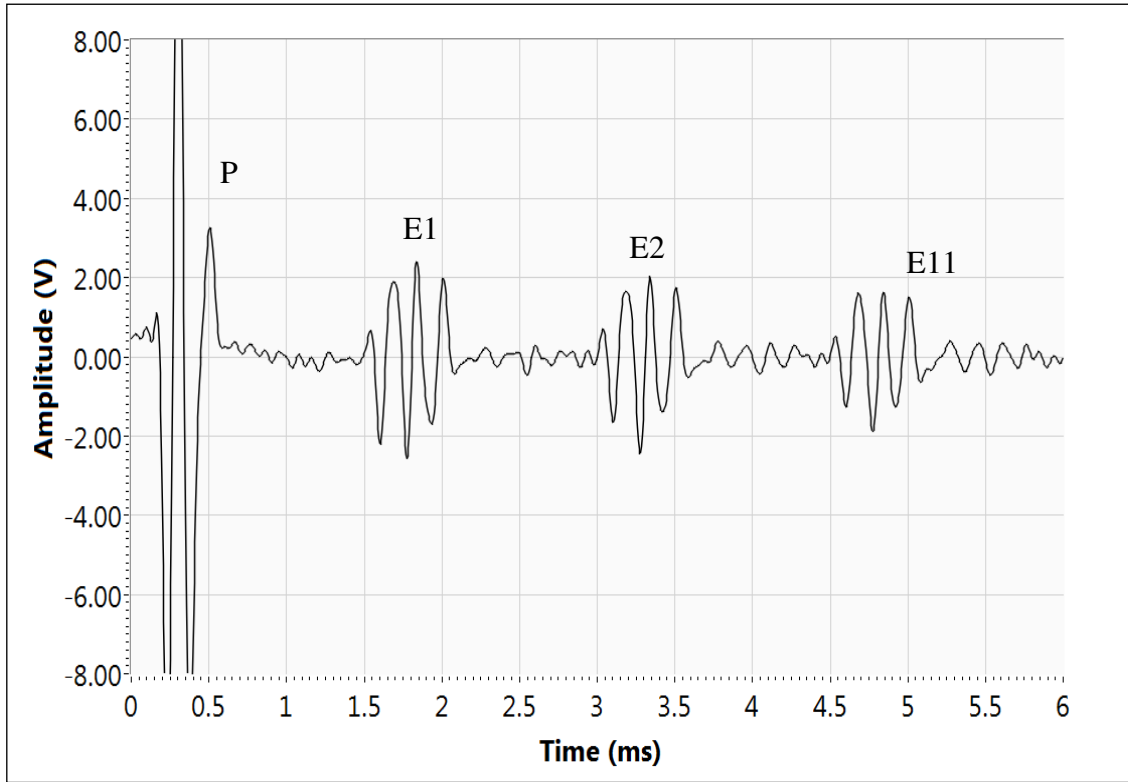
Figure 5.16 Wave reflections from the baseline strand with no flaws. P is the initial transmitted pulse, E1 is the reflection from the near-side end of the strand, E2 is the reflection from the far-side end of the strand, and E11 is at the round trip wave propagation initiated from the near-side end reflection.

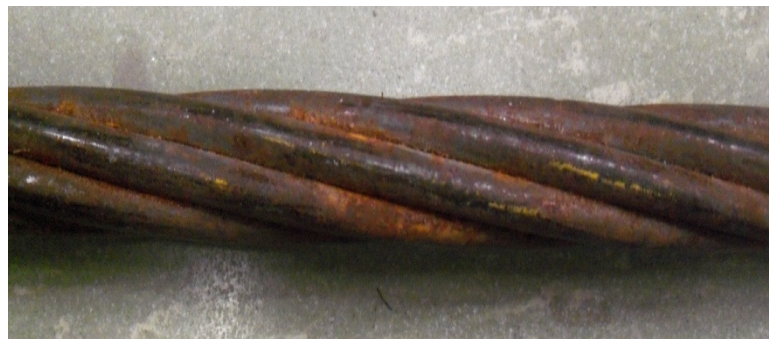
Figure 5.17 A 7-wire strand with no flaws used for baseline measurements.

The first experiment was conducted on a single strand with no flaws to obtain baseline measurements, as seen in figure 5.16 and figure 5.17. The horizontal scale in figure 5.16 is the time in milliseconds and the vertical scale is the signal magnitude in volts. The time scale is referenced to the start of the transmitted wave (point P), shown in the far left side of the graph. The graph shows the acquired signal taken over a 6 msec period. The reflection from the near-side end of the strand is shown at point E1 with a signal magnitude of 2.2 Vp-p. Point E2 is at reflected signal from the far-side end of the strand and E11 indicates reflections due to round trip waves initiated from the near-side end reflection. The location of the strand-end was verified by measuring the time it took for the incident wave to travel a round-trip distance from the transmitter coil to the end of the strand and back to the receiver coil. The velocity of wave propagation in the steel is assumed to be 16,978.3 ft/sec.

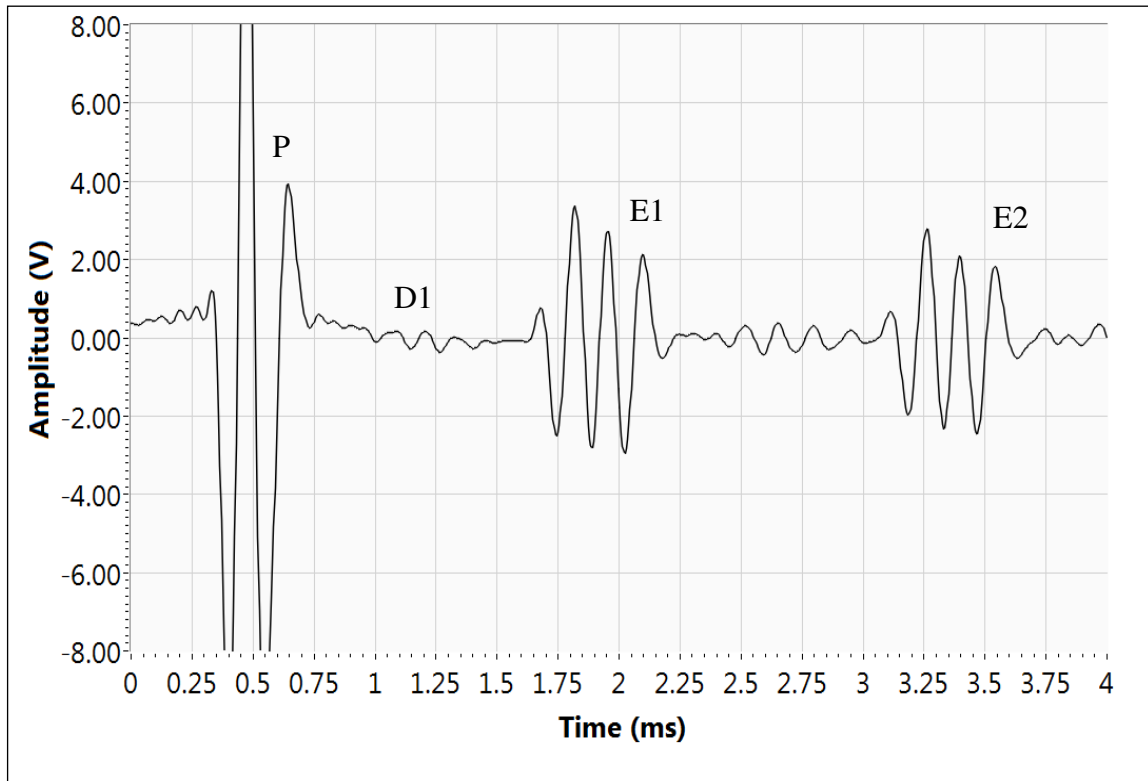
Figure 5.18 Wave reflections from the strand with one-broken-wire defect. P is the initial transmitted pulse; D1 is the signal reflection from the defect. E1 is the reflection from the near-end of the strand; E2 is the reflection from the far-end of the strand.

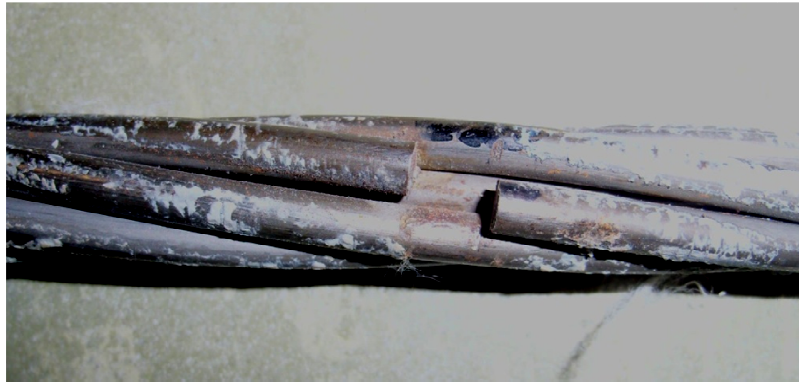
Figure 5.19 7-wire strand with one-broken-wire defect.

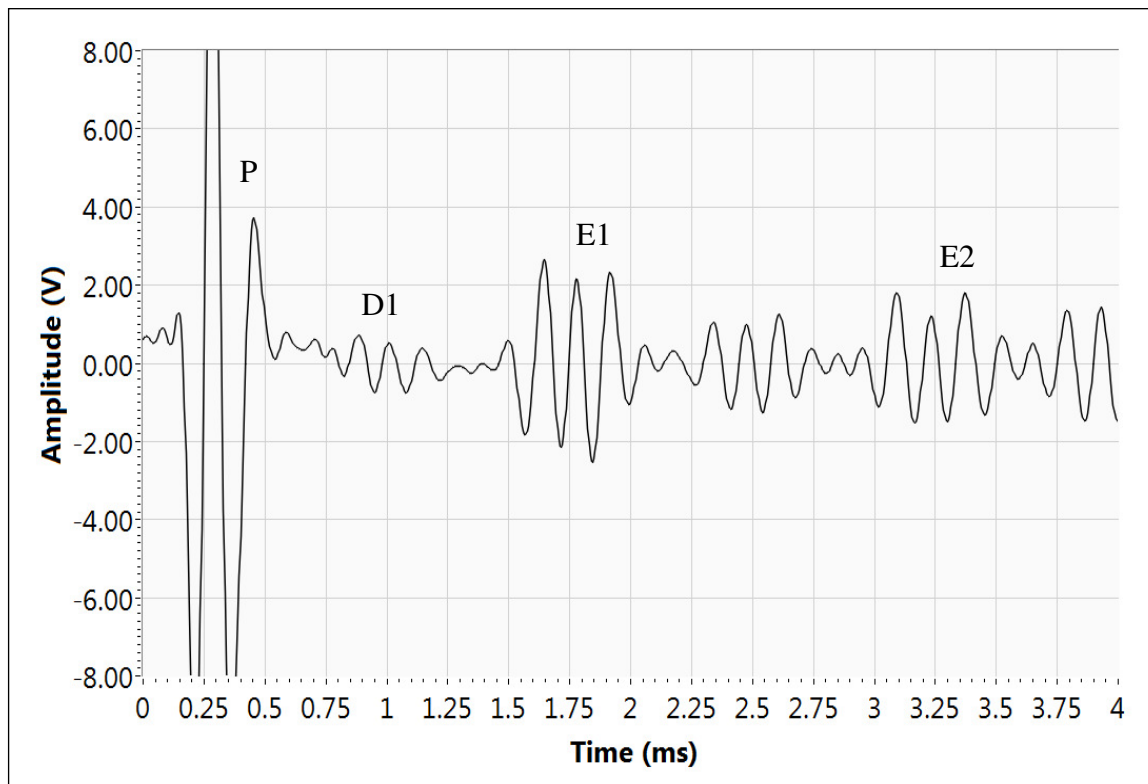
Figure 5.20 Wave reflections from the strand with two-broken-wire defect. P is the initial transmitted pulse; D1 is the signal reflection from the defect. E1 is the reflection from the near-side end of the strand; E2 is the reflection from the far-side end of the strand.

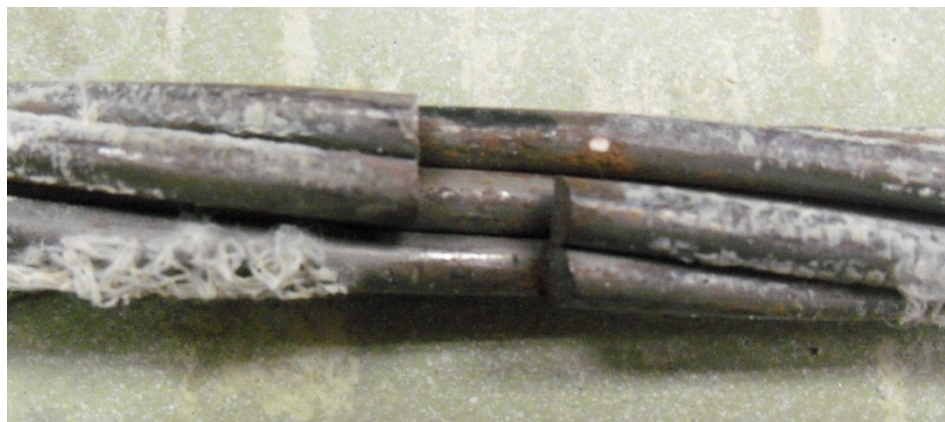
Figure 5.21 The 7-wire strand with two-broken-wire defect.

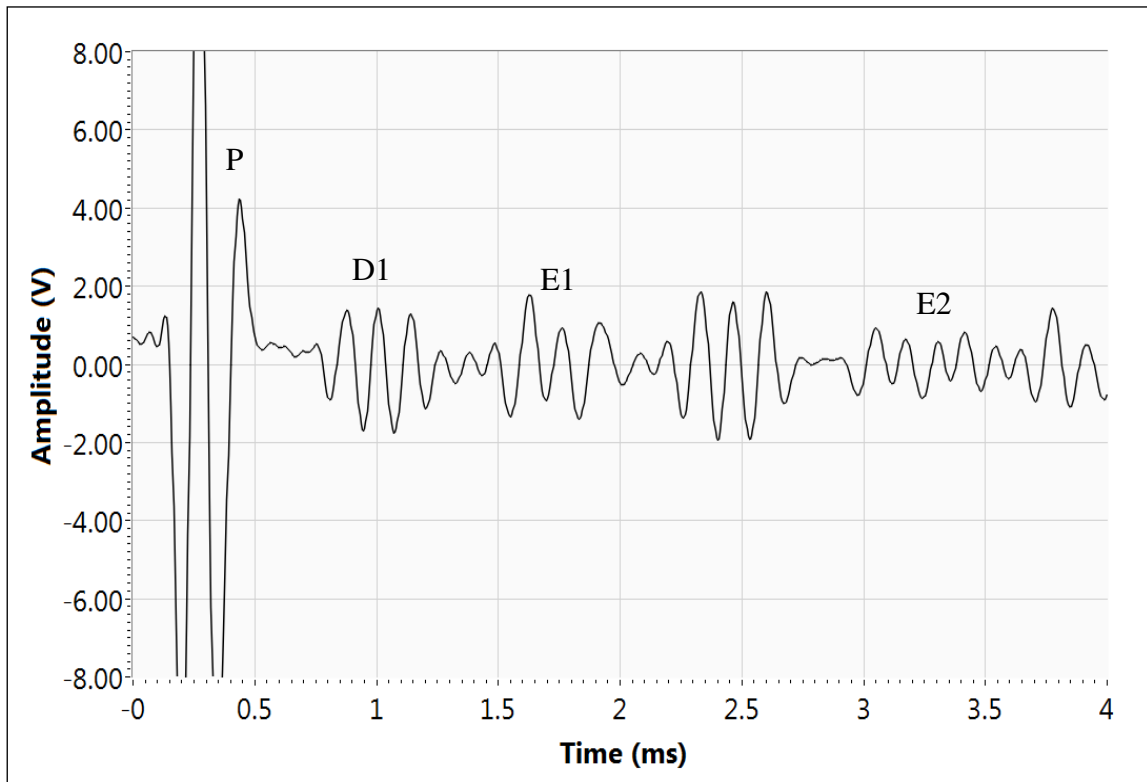
Figure 5.22 Wave reflections from the strand with the three-broken-wire defect. P is the initial transmitted pulse; D1 is the signal reflection from the defect. E1 is the reflection from the near-side end of the strand; E2 is the reflection from the far-side end of the strand.

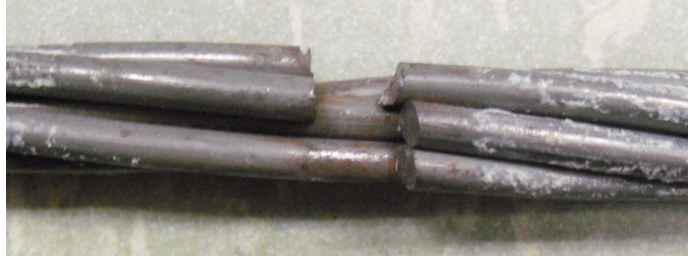
Figure 5.23 7-wire strand with three-broken-wire defect.

The 4th experiment was conducted on a strand with a three-broken wire defect. The result of the acquired signal is shown in figure 5.22 and the defect is shown in figure 5.23. Point D1 indicates the signal reflection from the three-broken wire defect with a signal amplitude of 1.8 Vp-p. E1 and E2 are the signal reflections from near-side end and far-side end of the strand, respectively. Consistent with the previous results, the magnitude of the reflected signal from the defect D1 is larger compared to two-broken-wire defect while E1 magnitude has decreased.

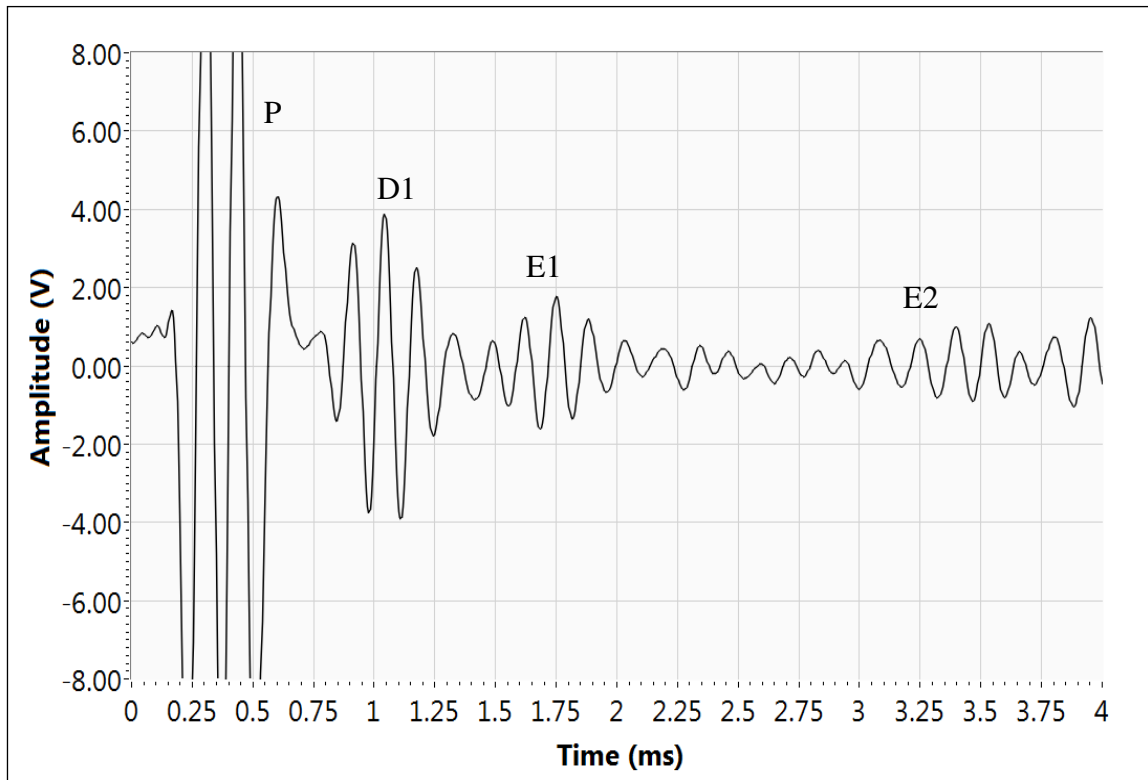
Figure 5.24 Wave reflections from the strand with the six-broken-wire defect. P is the initial transmitted pulse; D1 is the signal reflection from the defect. E1 is the reflection from the near-side end of the strand; E2 is the reflection from the far-side end of the strand.

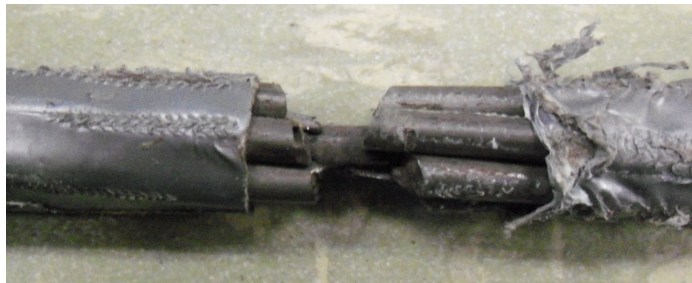
Figure 5.25 7-wire strand with six-broken-wire defect.

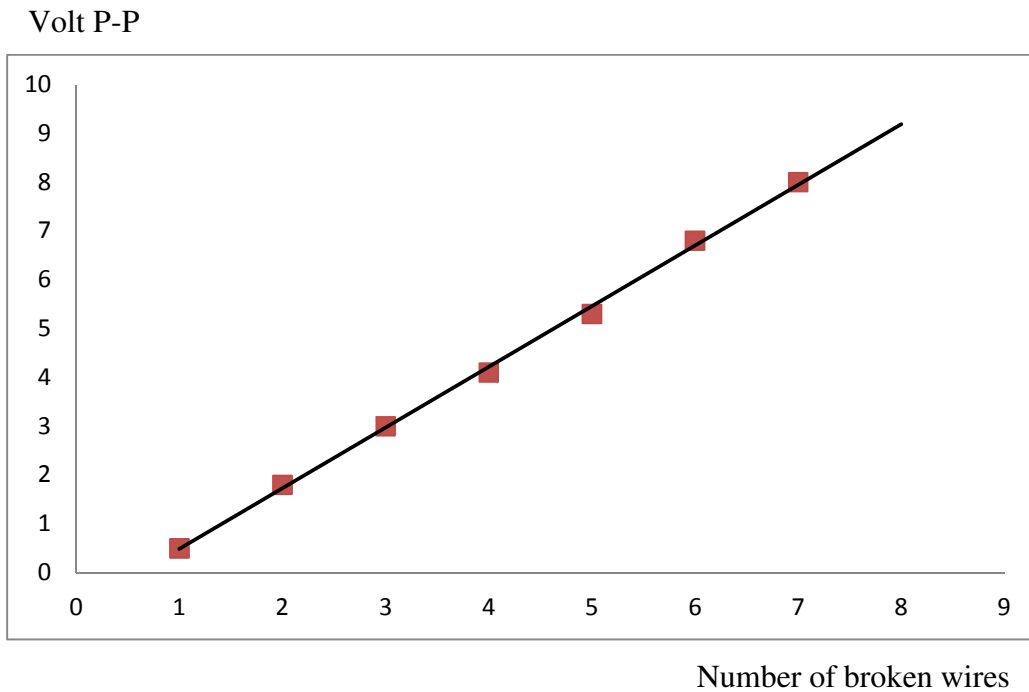
Figure 5.26 Graph to demonstrate the relationship between the magnitude of the reflected signal and the size of the defect.

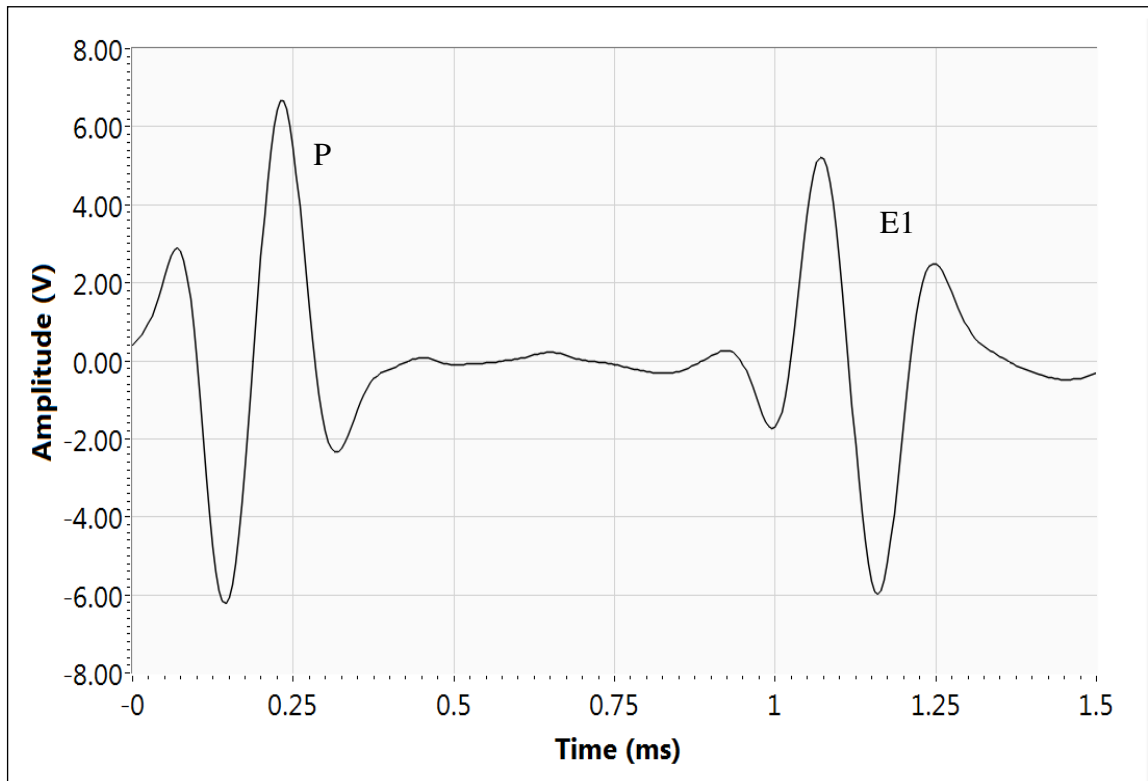
Figure 5.27 Wave reflections from the 13-strands anchorage area no defects (baseline measurements). P is the initial transmitted pulse; E1 is the reflection from the near-side end of the cable at the anchorage area.

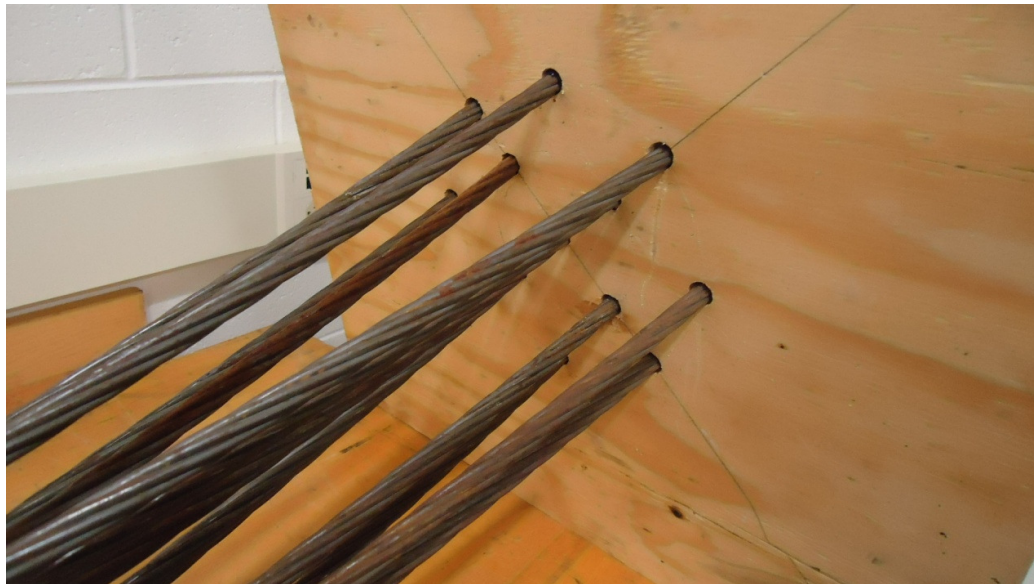
Figure 5.28 13-fan-out strands anchorage area.

The first experiment was conducted on the 13-strands anchorage model with no flaws to obtain baseline measurements, as seen in figure 5.27. The graph shows the acquired signal over a 1.5 msec period. The horizontal scale is the time in milliseconds and the vertical scale is the signal amplitude in volts. The time scale is referenced to the start of the transmitted wave (point P), shown in the far left side of the graph. The reflection from near-side end of the strand is shown at point E1 with signal amplitude of 11.0 Vp-p. The reflection from the far-side end of the cable is not shown here, since the defects are placed between the transmitting coil and the near-side end of the cable. Figure 5.28 shows the 13-strands spread out and anchored to a wooden termination plate to simulate the real cable anchorage area.
