System for Detection of Defects in Cables of Bridge Structures

SYSTEM FOR DETECTION OF DEFECTS IN CABLES OF BRIDGE STRUCTURES

Doctor of Philosophy

The University of Wisconsin – Milwaukee

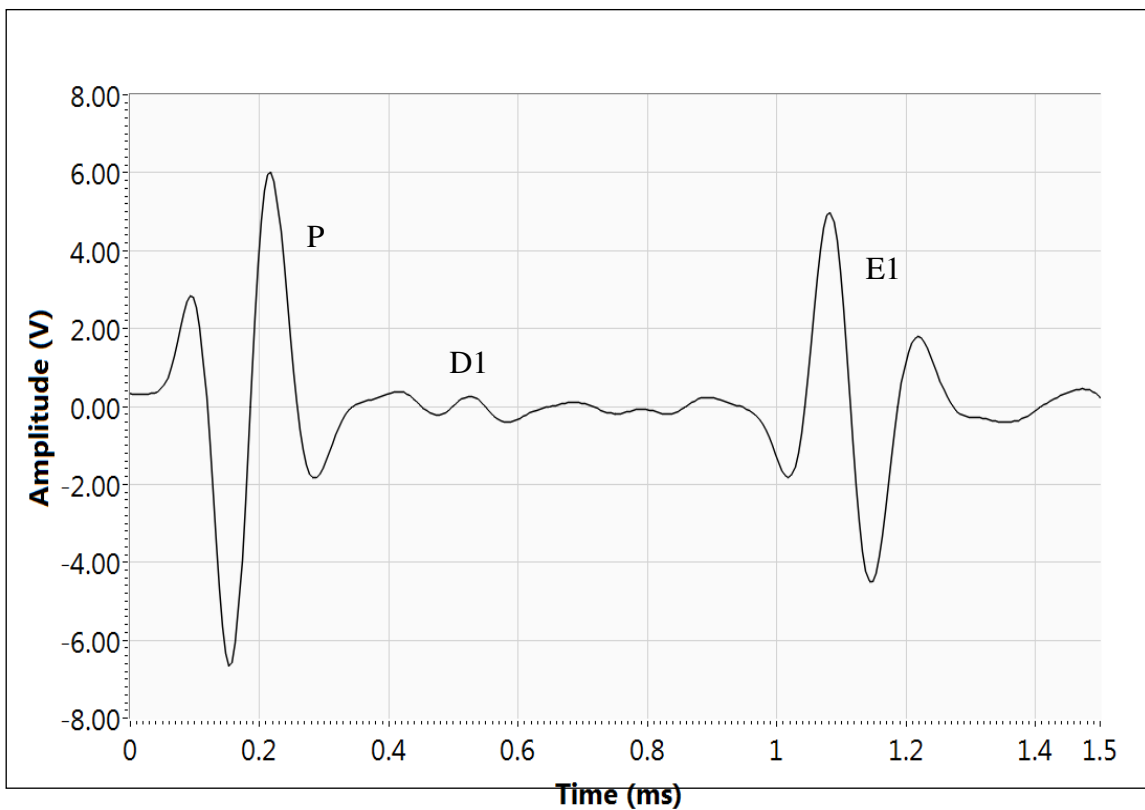
Figure 5.29 Wave reflections from the 13-strands anchorage area with one-broken-strand defect. P is the initial transmitted pulse; D1 is the signal reflection from the defect. E1 is the reflection from the near-side end of the cable

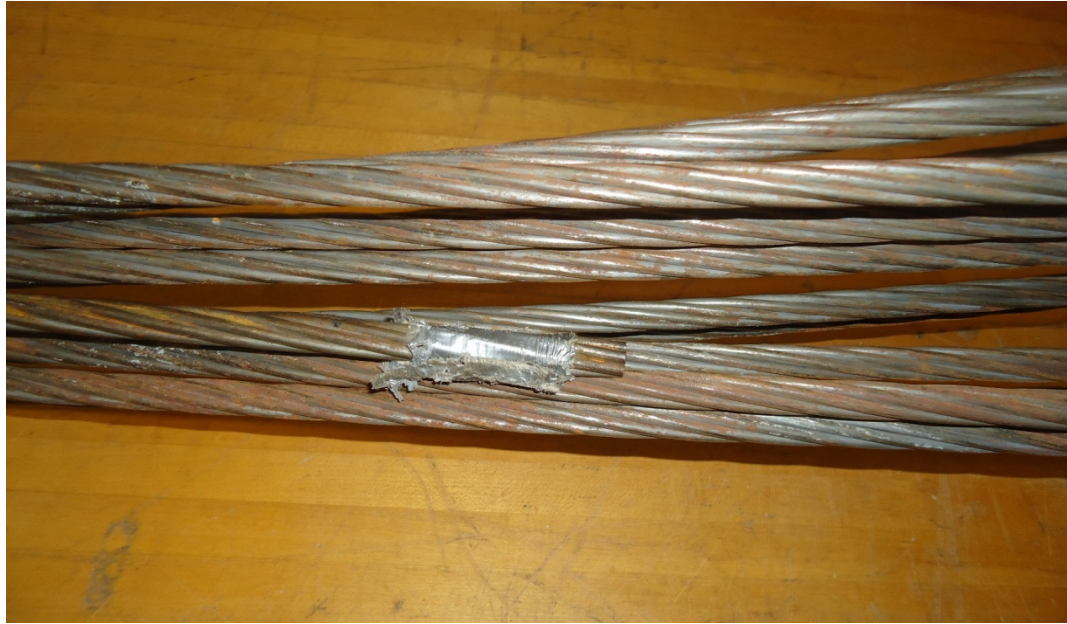
Figure 5.30 One-broken strand defect at the anchorage area.

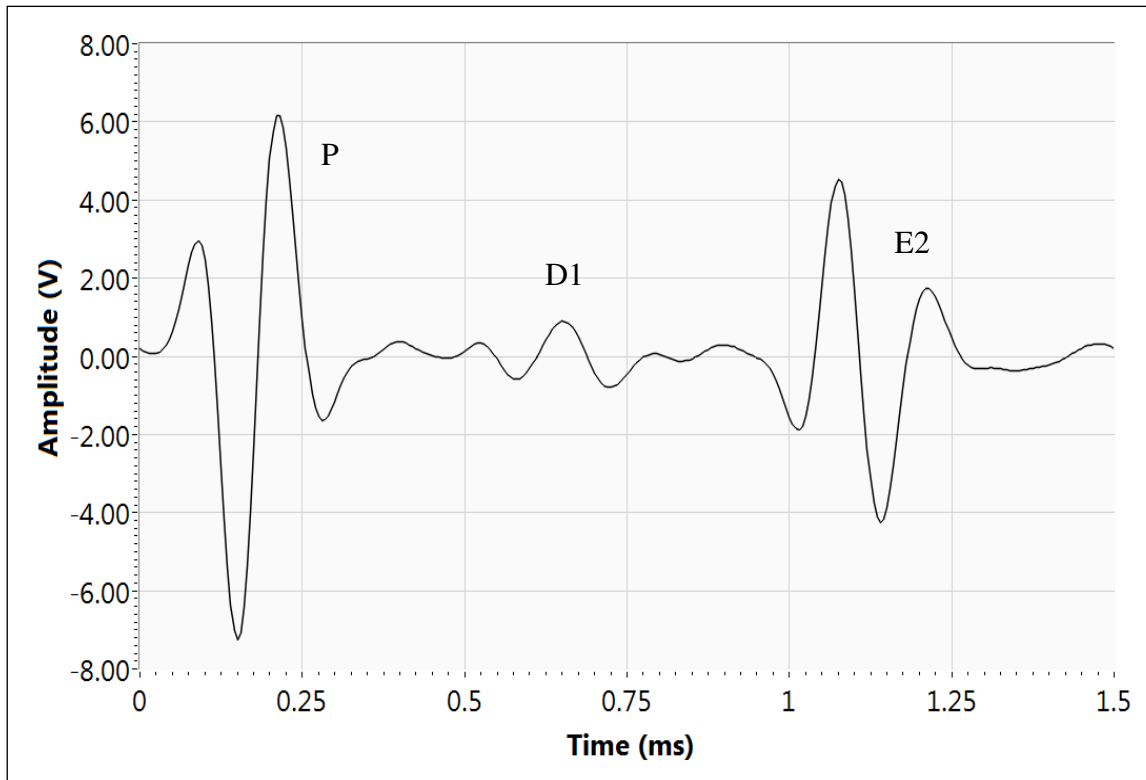
Figure 5.31 Wave reflections from the 13-strands anchorage area with two-broken strand defect. P is the initial transmitted pulse; D1 is the signal reflection from the defect. E1 is the reflection from the near-side end of the strand

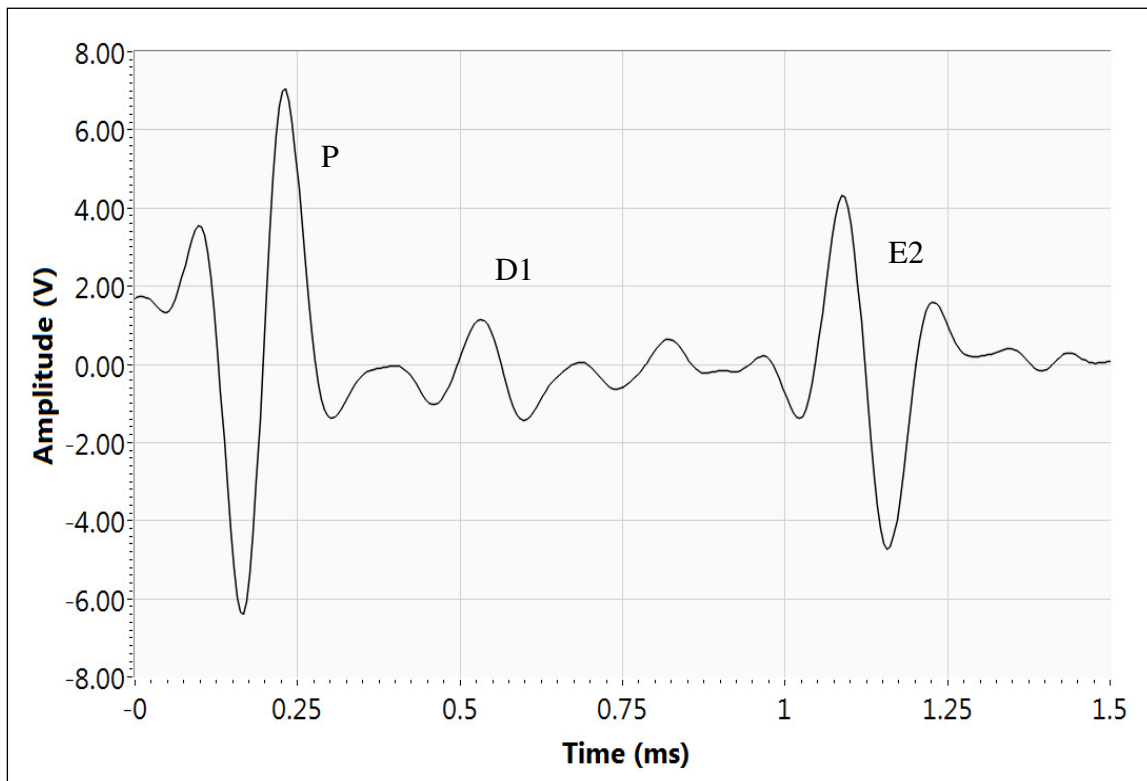
Figure 5.32 Wave reflections from the 13-strand anchorage area with three-broken-strand defect. P is the initial transmitted pulse; D1 is the signal reflection from the defect. E1 is the reflection from the near-side end of the strand

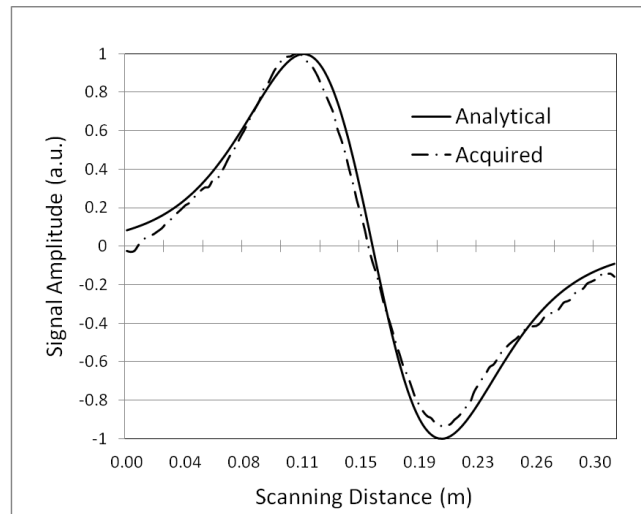
Figure 5.33 Acquired MFL signal and predicated signal based on the mathematical model in equation (3.2).

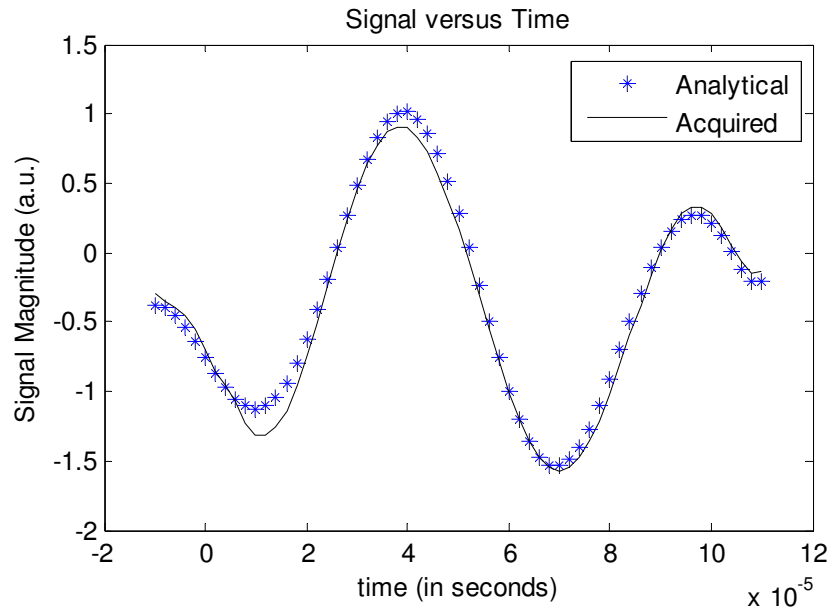
Figure 3.34 Acquired MS signal and predicated signal based on the mathematical model in equation (3.14).

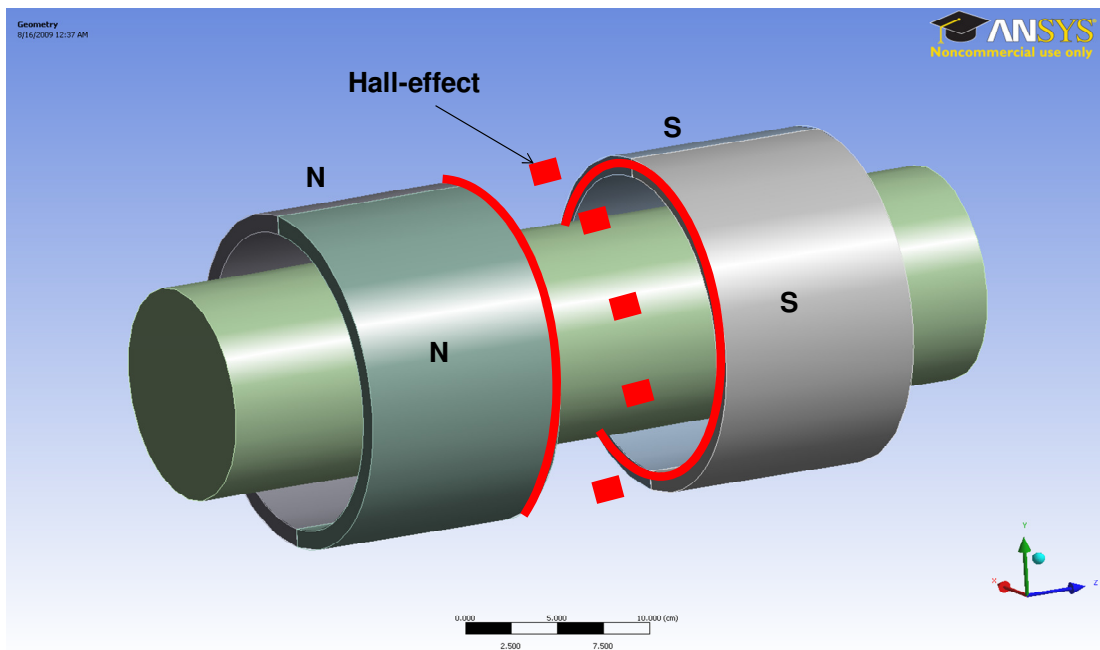
Figure 6.1 Integrated MFL/MS System; arrangement of MS coils and Hall-effect sensors with the circular magnets

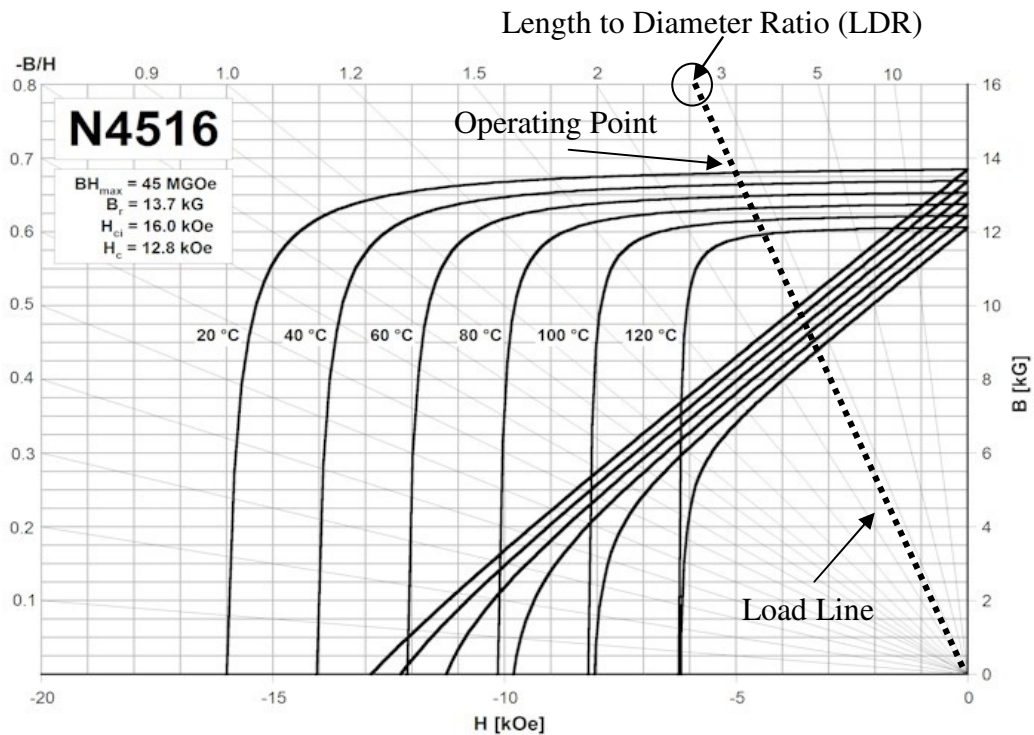
Figure 6.3 Typical H-B curves for the permanent magnets proposed in this study

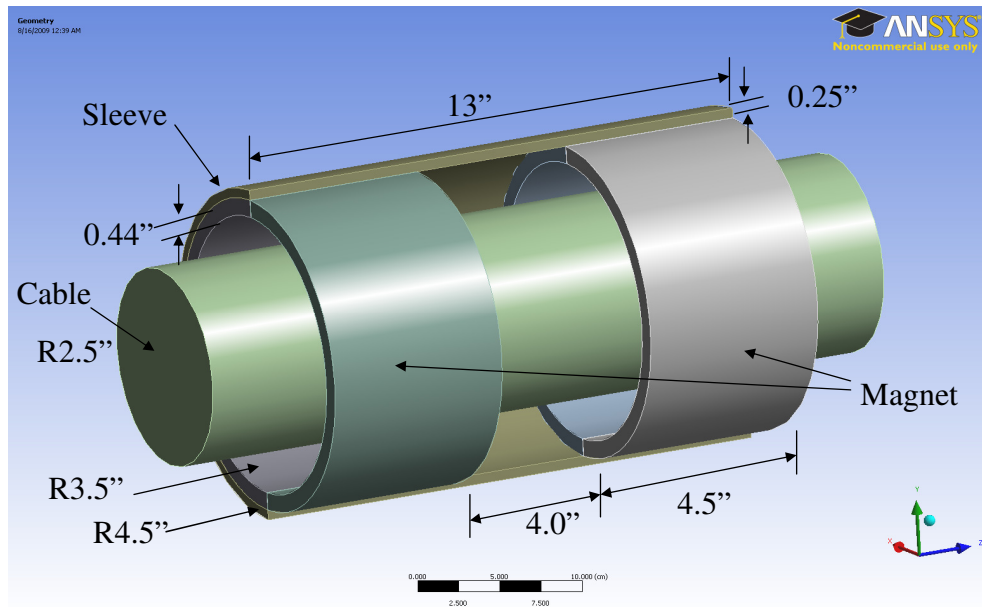
Figure 6.4 Conceptual design of the magnet

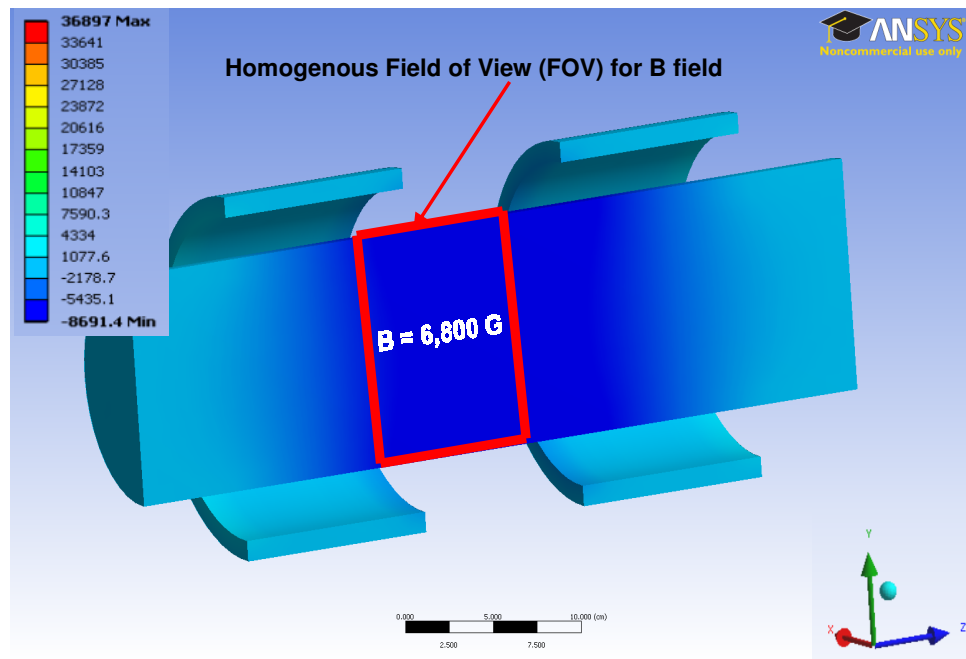
Figure 6.11 Magnets; showing homogeneity of the magnetic flux (B) in the Z direction, within the field of view - longitudinal sectional view is shown

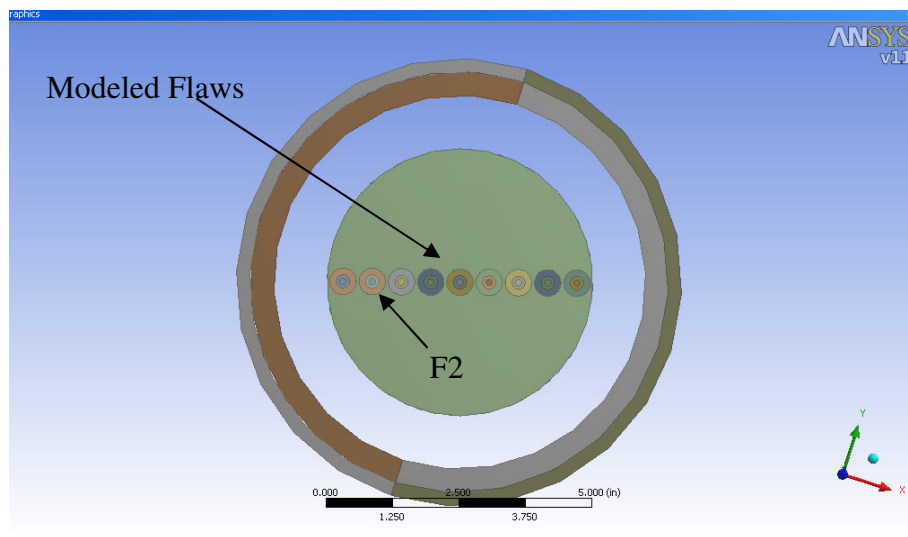
Figure 6.12 Magnets; showing different sizes of flaws and locations inside the cable- cross sectional view is shown

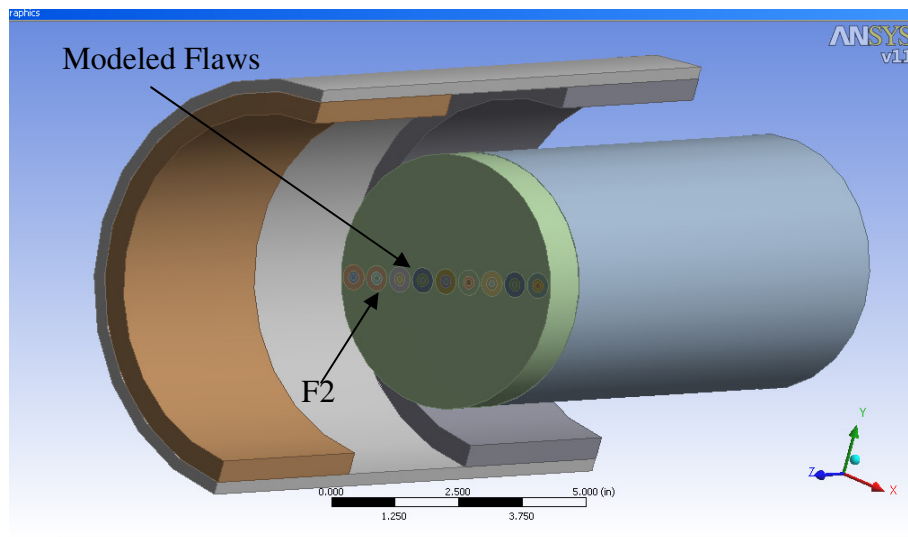
Figure 6.13 Magnets; showing different sizes of flaws and locations inside the cable- longitudinal sectional view is shown

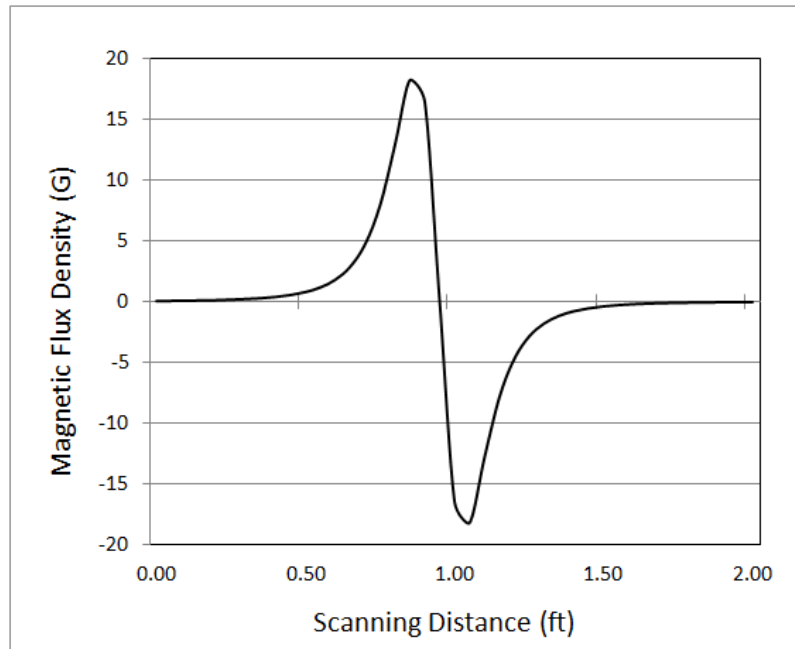
Figure 6.14 Magnetic flux density of MFL signal for 7-wire broken strand simulated flaw

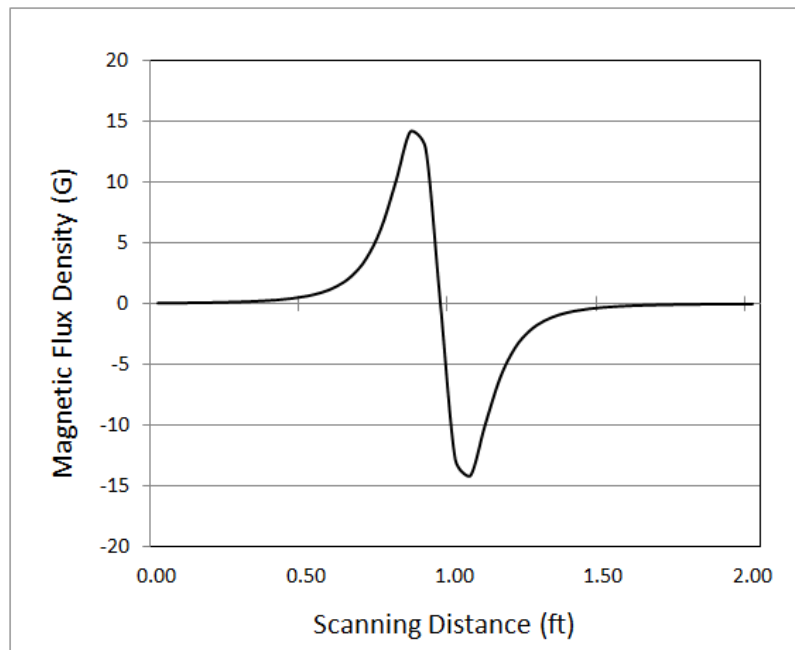
Figure 6.15 Magnetic flux density of MFL signal for 5-wire broken strand simulated flaw

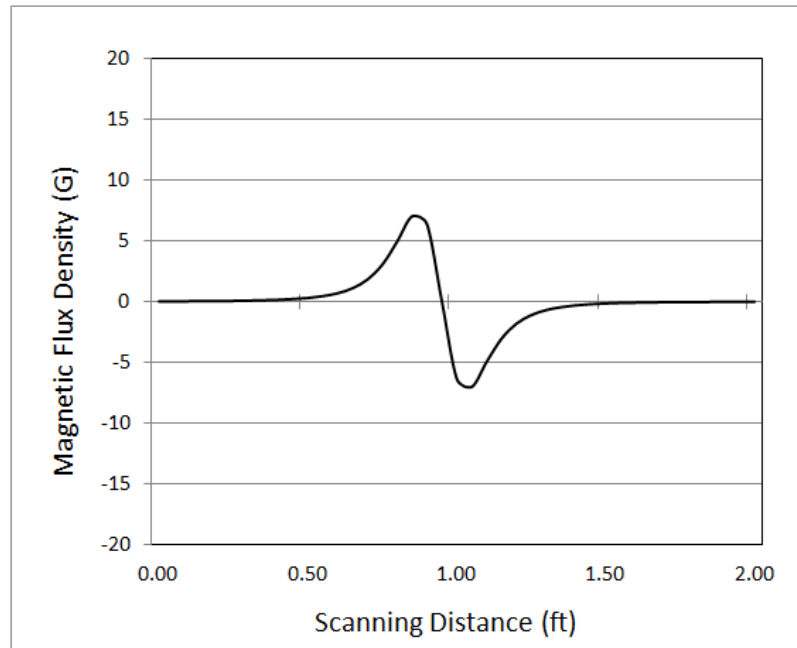
Figure 6.16 Magnetic flux density of MFL signal for 3-wire broken strand simulated flaw

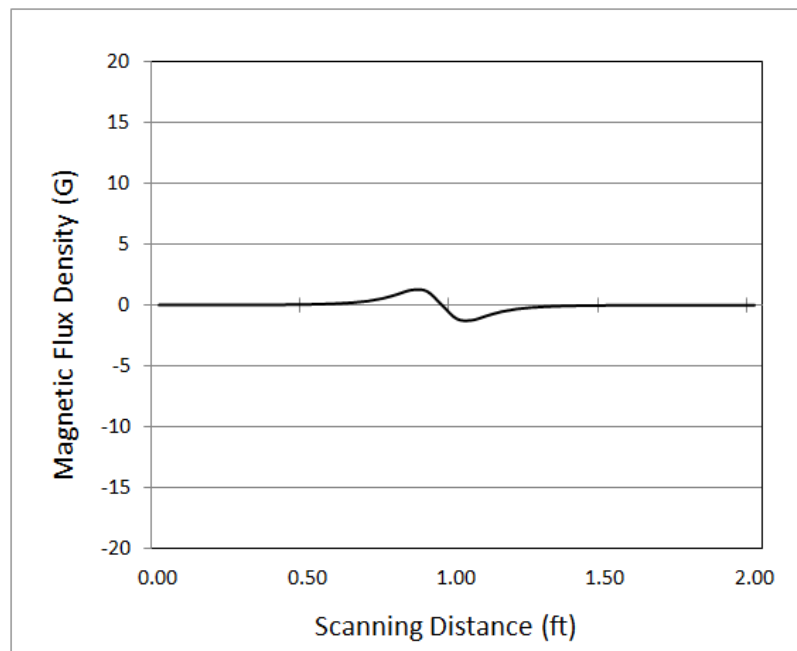
Figure 6.17 Magnetic flux density of MFL signal for 1-wire broken strand simulated flaw
