# Advanced Self-Healing Polymer Composites for Wind Turbine Blades

ADVANCED SELF-HEALING POLYMER COMPOSITES FOR WIND TURBINE BLADES

Master of Science

The University of Wisconsin- Milwaukee

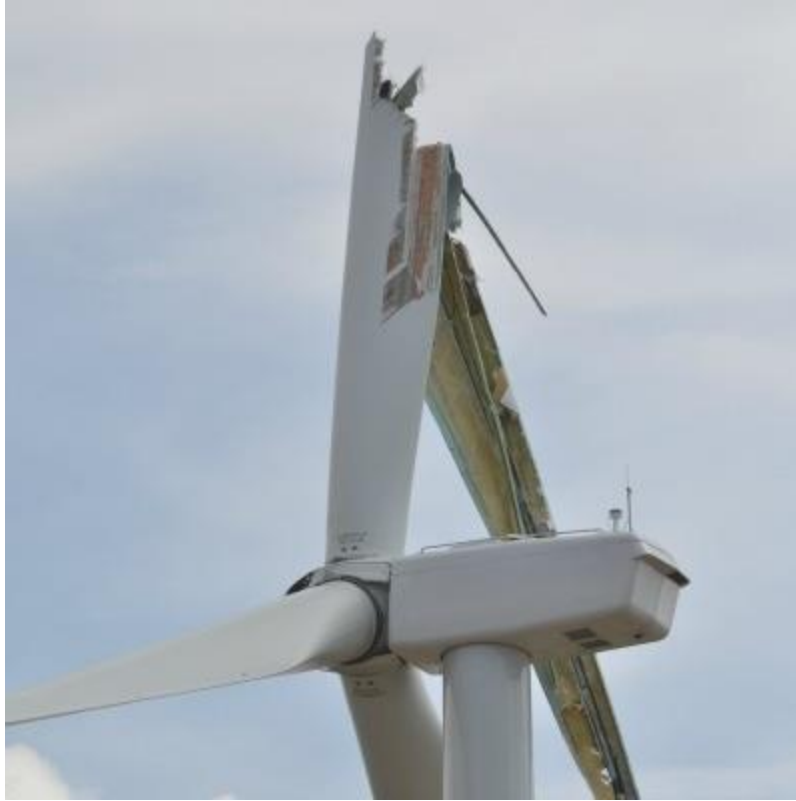
Figure 1: Photograph of a broken turbine blade at the Prairie Breeze wind farm in Nebraska [7].

Figure 1 shows one of the two blades that broke in a span of two weeks at Nebraska wind farm. With polymers and composites being increasingly used in structural applications in aircraft, cars, ships, defense and construction industries, several techniques have been developed and adopted by industries for repairing visible or detectable damages on the polymeric structures. However, these conventional repair methods are not effective for healing invisible micro-cracks within the structure during its service life. In response, the concept of self-healing polymeric materials was proposed in the 1980s as a means to heal invisible micro-cracks to extend the working life and safety of the polymeric components, which is a novel concept that can be used as an alternative to damage-tolerant design and repair the damaged structures [8].

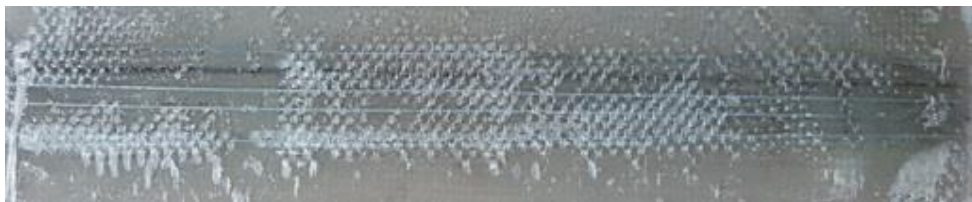
Figure 6: Photograph of the as-molded sample with floral stem wires embedded in it.

The second trial was conducted using floral stem which are used in gardening to vertically straighten and support the growth of a plant. Floral stem wires were used so that they could be pulled out of the cured sample. This trial had similar layup as the first trial; six layers of fiberglass with a layer of 1 mm diameter, floral stem wires in the middle of the composite. The stem wires were placed 6 mm apart and coated with wax before conducting the VARTM process. After the curing process as seen in Figure 6, it was found that, although the resin did not bond with the wires, a large amount of friction between the cured resin and wires was present. The process of pulling out the wire from the cured composite damaged the sample due to high friction between the wires and the polymer matrix making the method non-viable for practical applications.

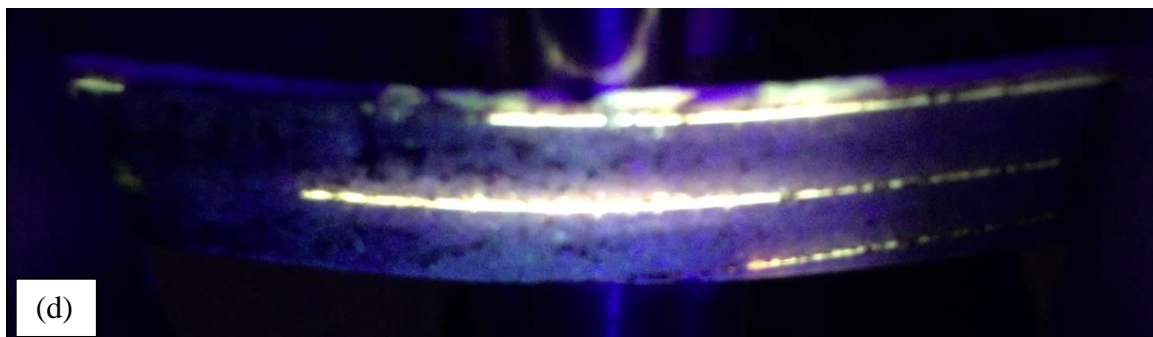
Figure 41: Photographs (a) to (g) of a specimen during three-point bending test showing evident signs of breakage, bleeding of the tubes and spreading of healing agent (glowing liquid) through the thickness of the composite. (a) being earliest and (g) being latest photograph. Image (a) is at the start of the test and (b) through (g) have 15s interval between the images to the end of the test (Specimen is S7B4)

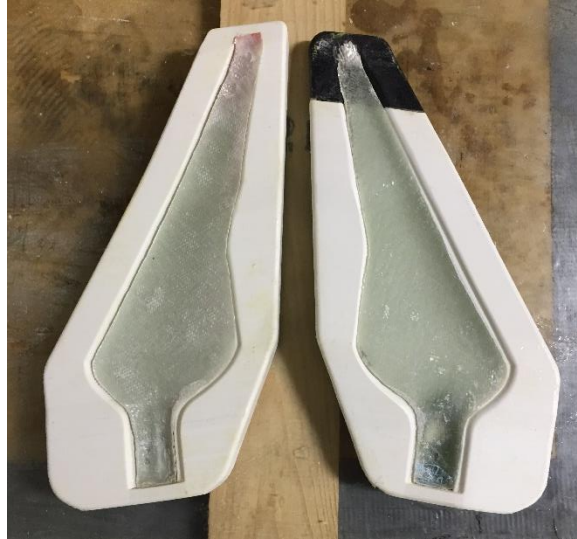
Figure 56: Photograph of both sides of molded pieces of wind turbine blade inside the 3D printed molds

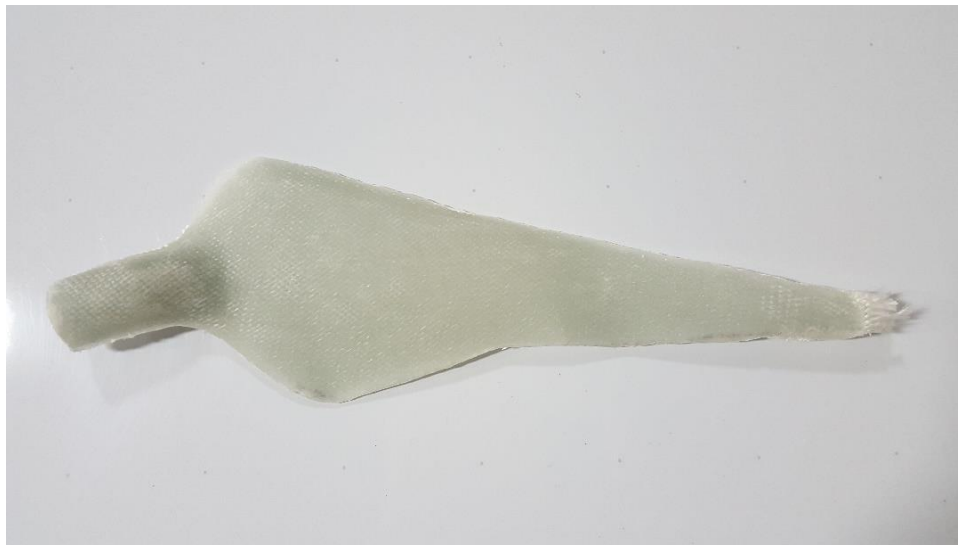
Figure 57: Turbine blade sample

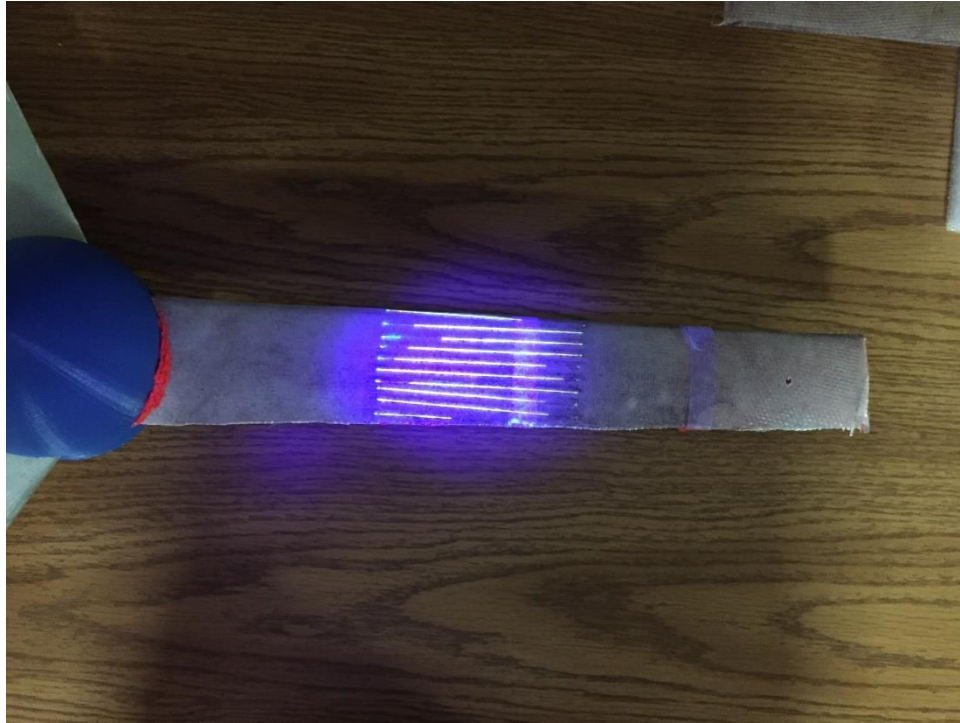
Figure 69: Photograph of a blade with self-healing characteristic fixed to scaled down wind turbine

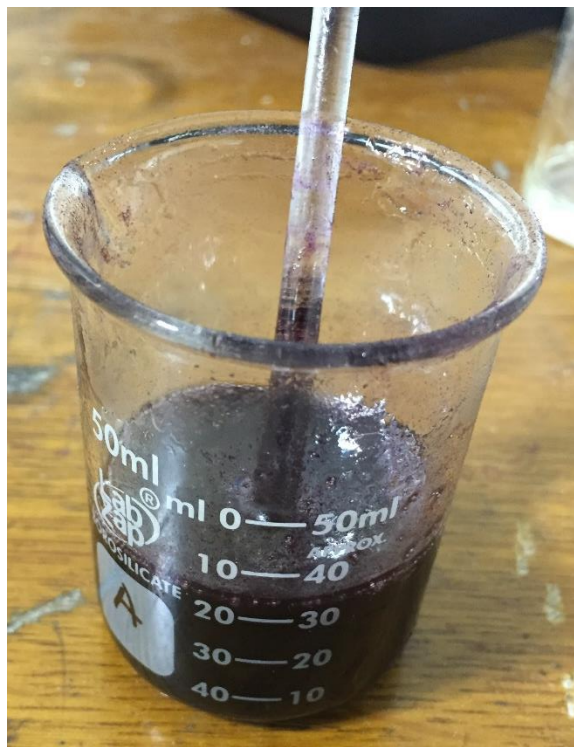
Figure 94: Concentrated Grubb's catalyst mixture used specifically around the tubes

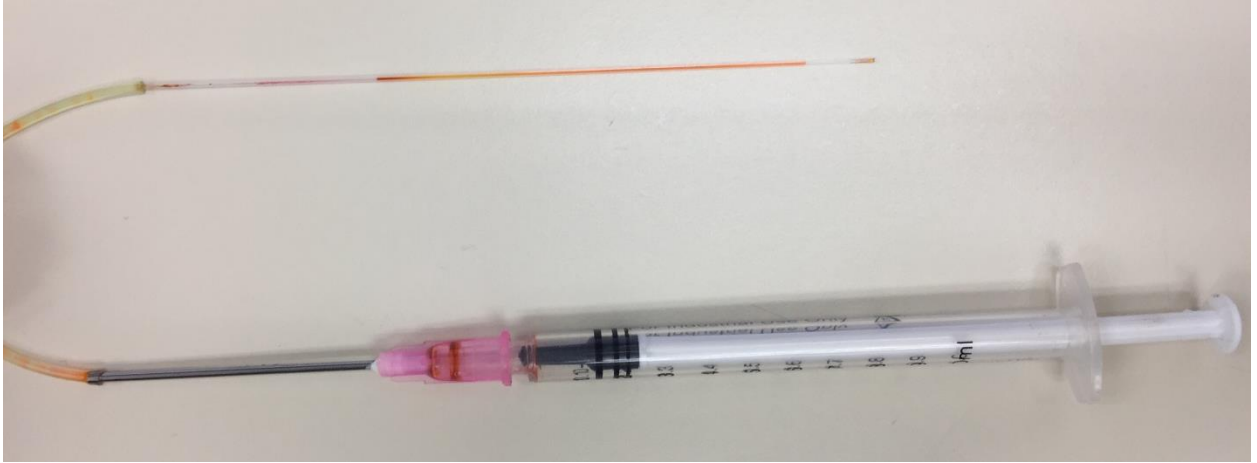
Figure 95: Tube and syringe combination used to fill the tubes with DCPD (colored stains are from UV reflective dye)
